Lost his leg during mooring operation

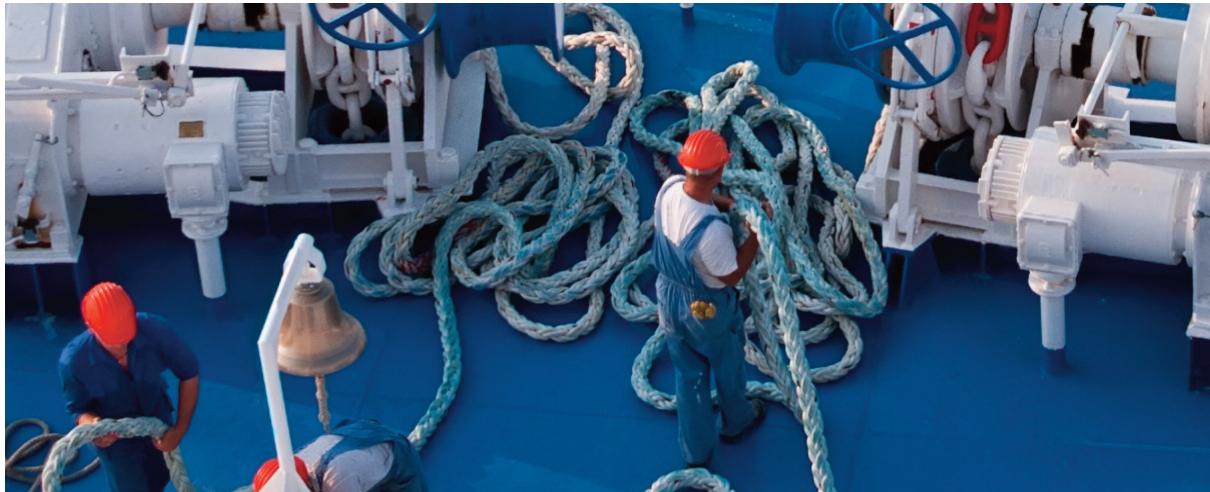
was caught between the mooring line and the fairlead. The mooring line's speed was now so fast that it cut through the Officer's clothes and he was bleeding badly. The mooring line was actually cutting through the Third Officer's leg which was cut off just below the knee.

The Chief Officer realized that the mooring rope was stuck in the propeller and screamed over the VHF to the Master to stop the engine. The Master pushed the emergency stop and the propeller stopped. The Third Officer was still standing but in severe shock and he finally collapsed. The Chief Officer ran over to give first aid and the gangway was rigged. A first aid team from shore side came on board and helped. It took about 30 minutes for an ambulance to arrive and take the Officer to hospital. The Third Officer survived, but is now disabled and can never work at sea again.

- The vessel had a risk assessment for the mooring operation, but it did not include the risk of the mooring line getting stuck in the propeller, as the mooring line should be floating in normal circumstances. This time the mooring line was lowered too quickly and ended up under the surface. The propeller blades are only 2 metres below the surface so the lines were sucked into the propeller.

- Another risk was that the mooring line was partly around the bollard, with a bight and a right angle to the normal pull direction. This arrangement caused the snapback zone to cover the entire area between the bollard and railing. When the rope ran out rapidly and got caught in the propeller it snapped back to where the Third Officer was standing. The Officer was actually outside the normal snapback zone, showing the importance of evaluating each situation independently. Although a normal operation, mooring is also a high risk operation and the risks need to be evaluated every time..

- It is important to always be aware of your surroundings and not stand too close to fairleads and ropes. Inexperienced crew members should be trained about these risks.

- When lines are prepared on deck the line-up should be in direct line with the expected movement of the rope.
- When passing lines to shore, they should be controlled and slowly passed to prevent the lines running below the water. This is also applicable for floating mooring lines.
