Missing gasket caused cargo hold flooding

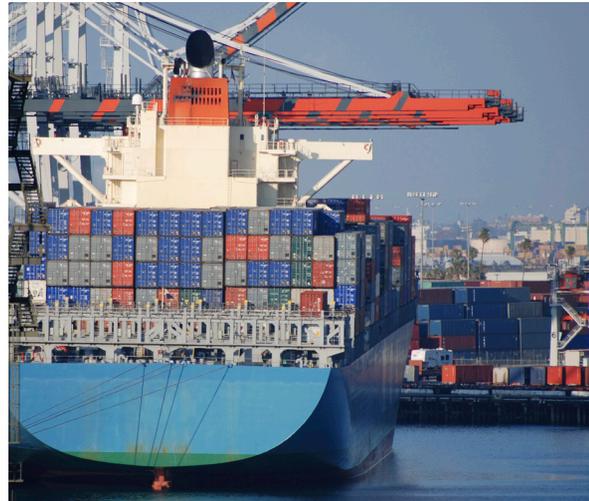
The vessel was fitted with both cargo hold bilge alarms and high-level alarms. These were monitored from the bridge. There was no bilge alarm until 10 hours after the flooding. The bilge alarm is included in the list of Monthly inspection of critical equipment which had not been completed correctly, as it had been inspected a couple of days previously and found at the time to be in good condition. The bilge sensor was actually broken and heavily corroded, which takes a long time to happen. There was a failure in the visual inspection and no proper soundings

were taken. If this had been done it is likely that the flooding would have been discovered earlier.

The crew discharged the water using the ballast pump, bilge pump and a portable bilge pump. Afterwards the crew inspected the cargo hold and discovered that the tank which had been inspected was missing a gasket to the manhole. The ballast tank was pressure tested and it was discovered that water was leaking from the manhole. A gasket was refitted and the ballast tank was pressure tested again and no leakage was discovered.
