Crack in cargo hold cover caused wet damage

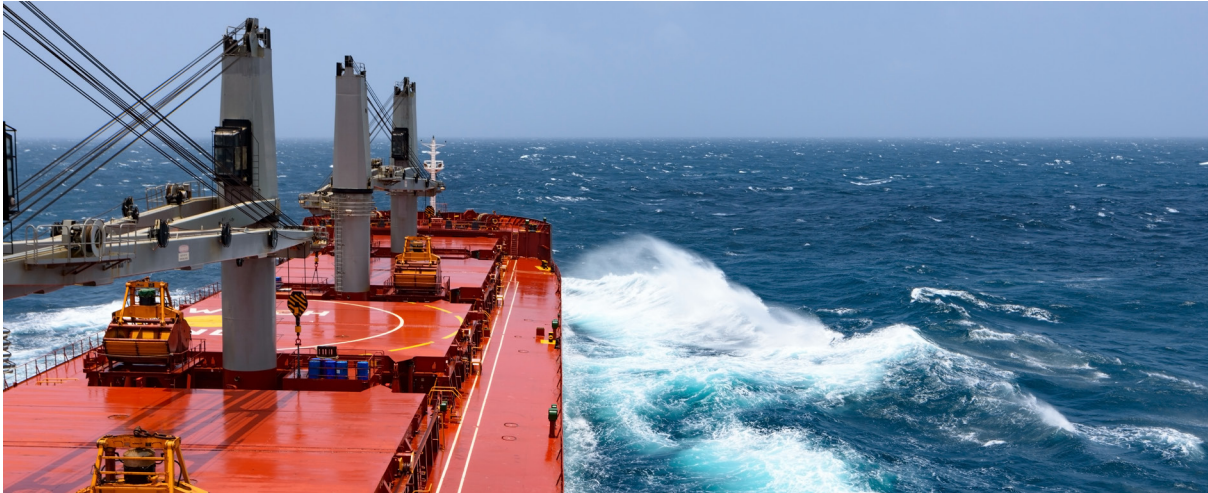
When the vessel was alongside, and the cargo hold hatches were removed, puddles could be seen in hold 1. It is important to be aware that zinc concentrate may liquefy if shipped with a moisture content in excess of their transportable moisture limit (TML) as per the IMSBC code. Puddles of water will obviously exceed the TML. When the chief officer inspected the hatch coaming and cover for hold 1, a crack was found on the hatch coaming. The drain pipes for the non-return drain valves were full of debris and

cargo. It should be a PMS job to check that the drain pipes and drain valves are not clogged and that the float (ball inside) moves freely.

Hatch covers, and coaming steel structures are heavily loaded elements. Their condition has a direct effect on the load carrying capacity and the safety of the vessel. The steel construction should always be inspected after an unusual loading case, and there should also be regular checks as per the PMS.

When repairs are carried out, only steel approved by the classification society should be used. High tensile steel is commonly used for cargo hatches and coamings. The classification society should be contacted before making any structural steel repairs.
