Lack of communication caused serious main engine damage

Main Engine Lubricating Oil Outlet diaphragm

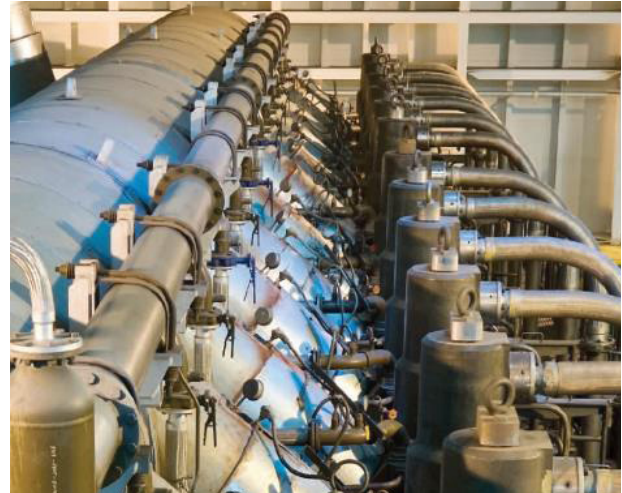
The chief engineer decided to partially change 3,000 litres of lubrication oil for the crank case. Afterwards a third sample was taken and the water content was 0.019%. The engine was stopped, and a full change of the lube oil was completed. A crosshead bearing was opened for inspection. No damage was found. However, one of the rubber

diaphragm seals for draining the crankcase to the system lubricating oil tank was found to be defective. This caused the water flooding into the engine room to contaminate the lube oil.

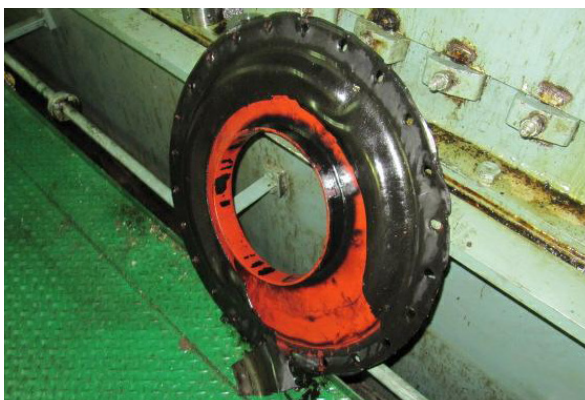
In all cases excessive quantities of water on the tank top have entered the main engine sump tank via the defective diaphragm and subsequently contaminated the main engine lubricating oil system, resulting in severe damage to the main engine bearings and journals.

Failed diaphragm

- ▶ Inspect the diaphragm sealing in the crankcase oil outlet every 32,000 hours of operation, and replace the diaphragm if indicated by the inspection.

In line with the recommendation issued by MAN Diesel A/S, Copenhagen, we recommend that all diaphragms are replaced in connection with every relevant scheduled inspection of the ship.

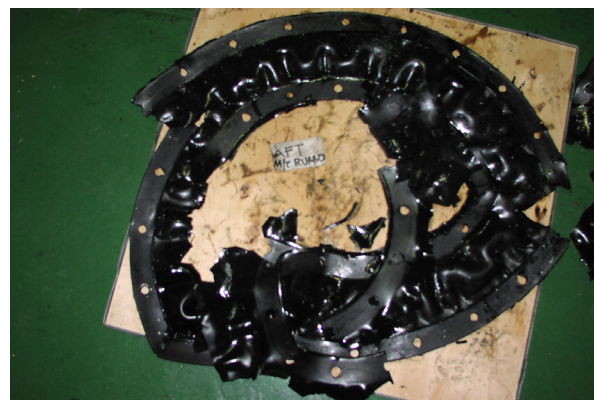
Deteriorated diaphragm
