Grounding because of missed waypoint

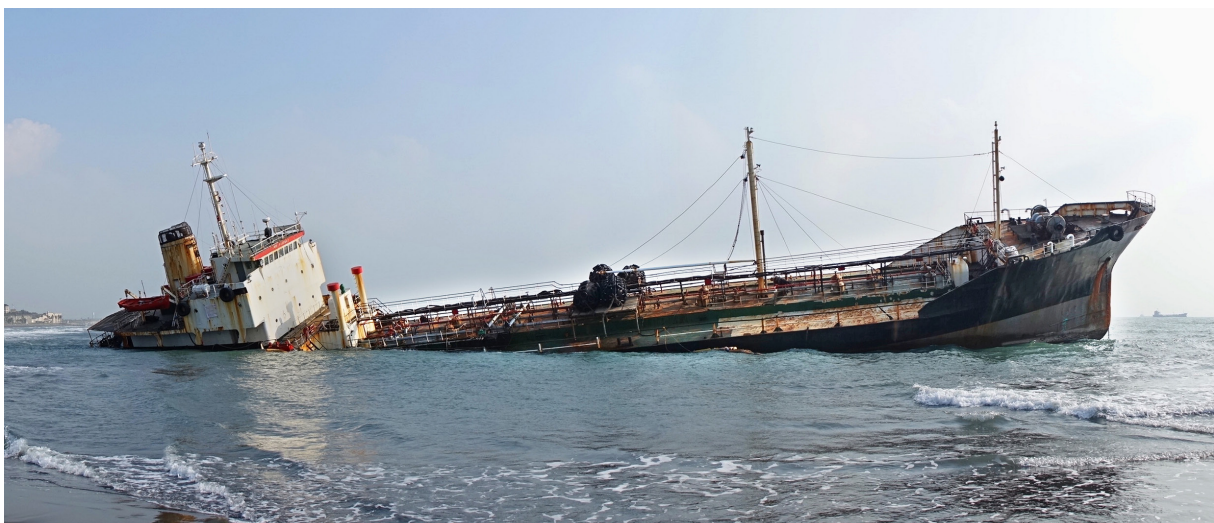
The vessel traded frequently in this area, so the voyage was not unusual. It was discovered that the navigation officer had forgotten to insert a waypoint in the GPS. This meant that the course took the vessel straight over a shallow area where the vessel ran aground.

- When creating the passage plan it is suggested that the plan is double checked by another officer to ensure all waypoints have been selected.
- The passage plan needs to be signed by all OOWs and the Master.
- It is prudent to do a two-person check of the passage plan and navigational equipment before departure.
