The Swedish Club

MONTHLY SAFETY SCENARIO

NOVEMBER 2022

Faulty propeller caused vessel to strike the quay and crane

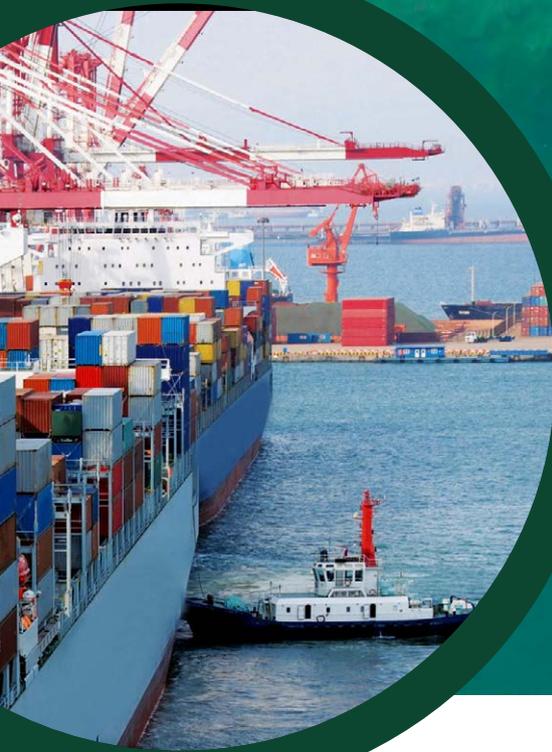
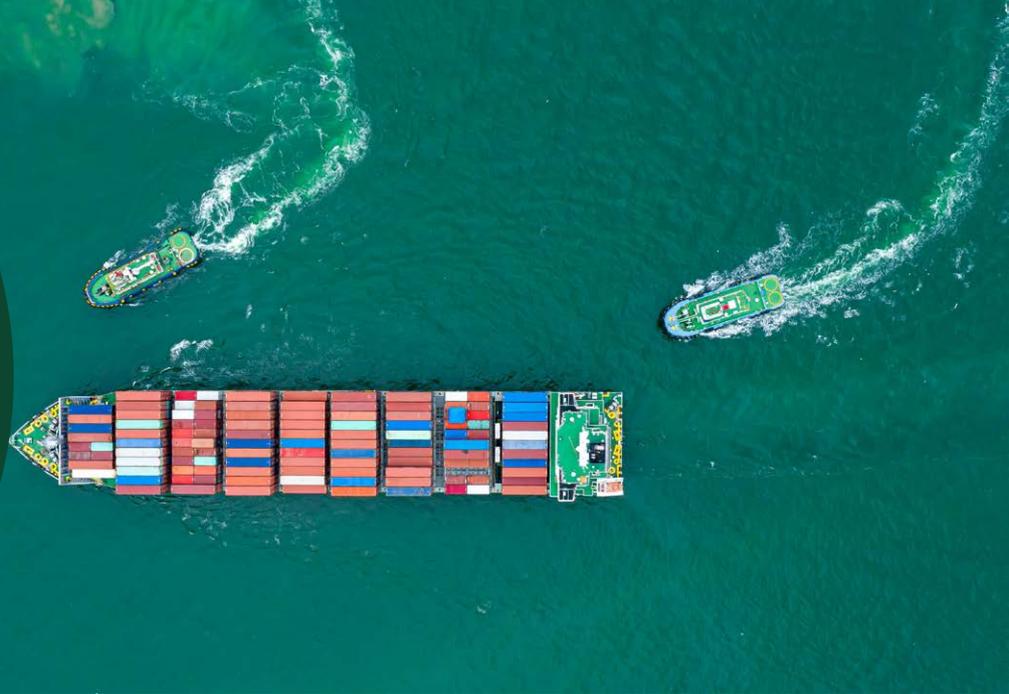
not be stopped. Moments later, the starboard quarter of the vessel struck the berth and front leg of a gantry crane. The impact caused minor damage to the vessel and berth. The front leg of the gantry crane was knocked off the rail, but the crane was still standing. The crane was repaired and back in operation later the next day. However, the damage to the crane resulted in other liner vessels scheduled to call at the berth being delayed.

Inspections on board revealed that the CPP hub was leaking hydraulic oil and the propeller pitch control system had lost oil pressure. A feature of

some CPPs is that if the oil pressure of the pitch control system is lost, the system will automatically place the blades at full astern pitch. The rationale for this is that the main engine can be operated in both directions (right- or left-hand turning). With the blades fixed at full astern, the vessel can still be manoeuvred by starting and stopping the main engine in different directions despite the inoperable propeller pitch control.

The container vessel needed repairs to the controllable pitch propeller (CPP) hub and temporary repairs to the shell plating before sailing.
