## MONTHLY SAFETY SCENARIO

NOVEMBER 2021

# Overflow while bunkering

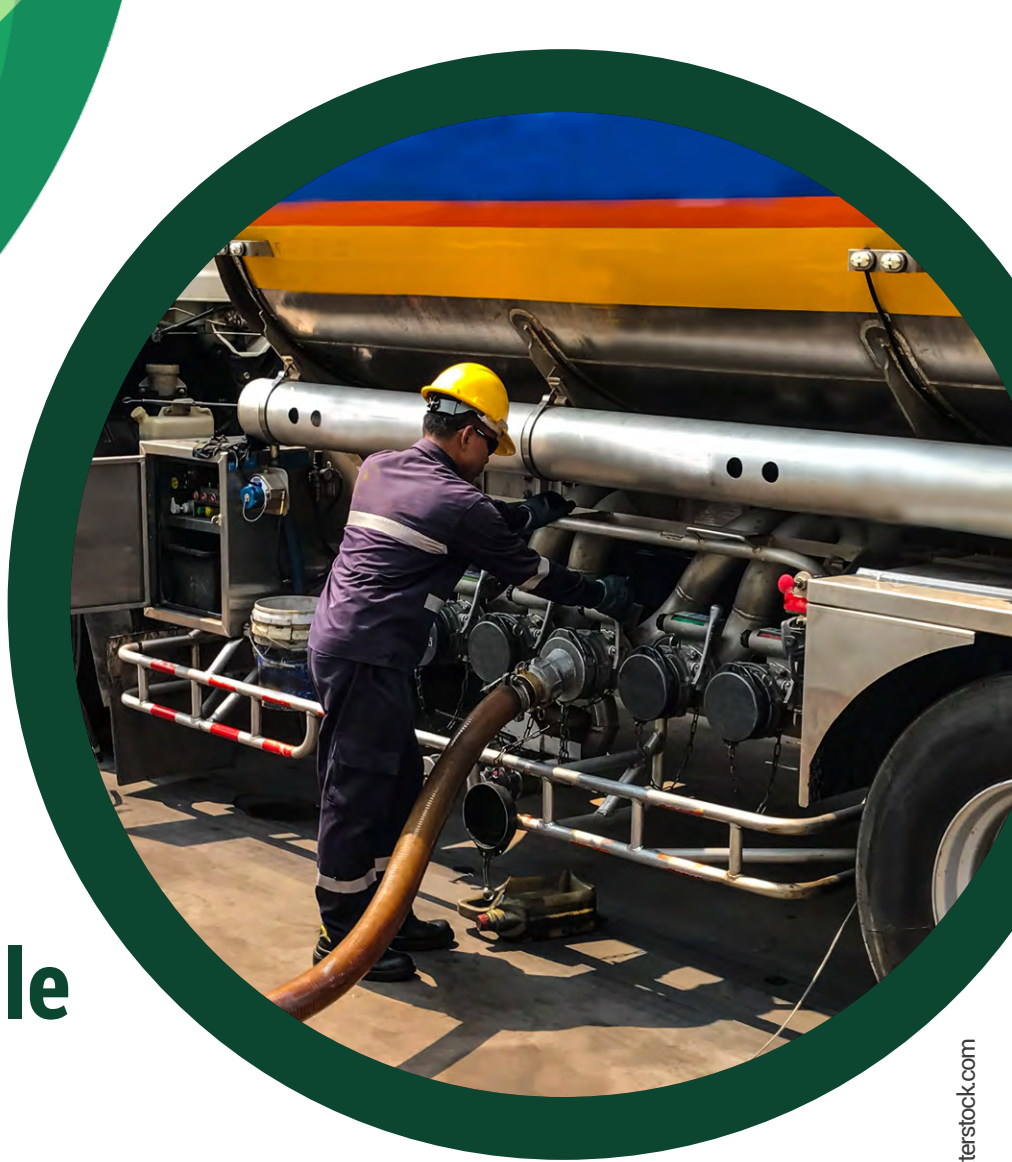
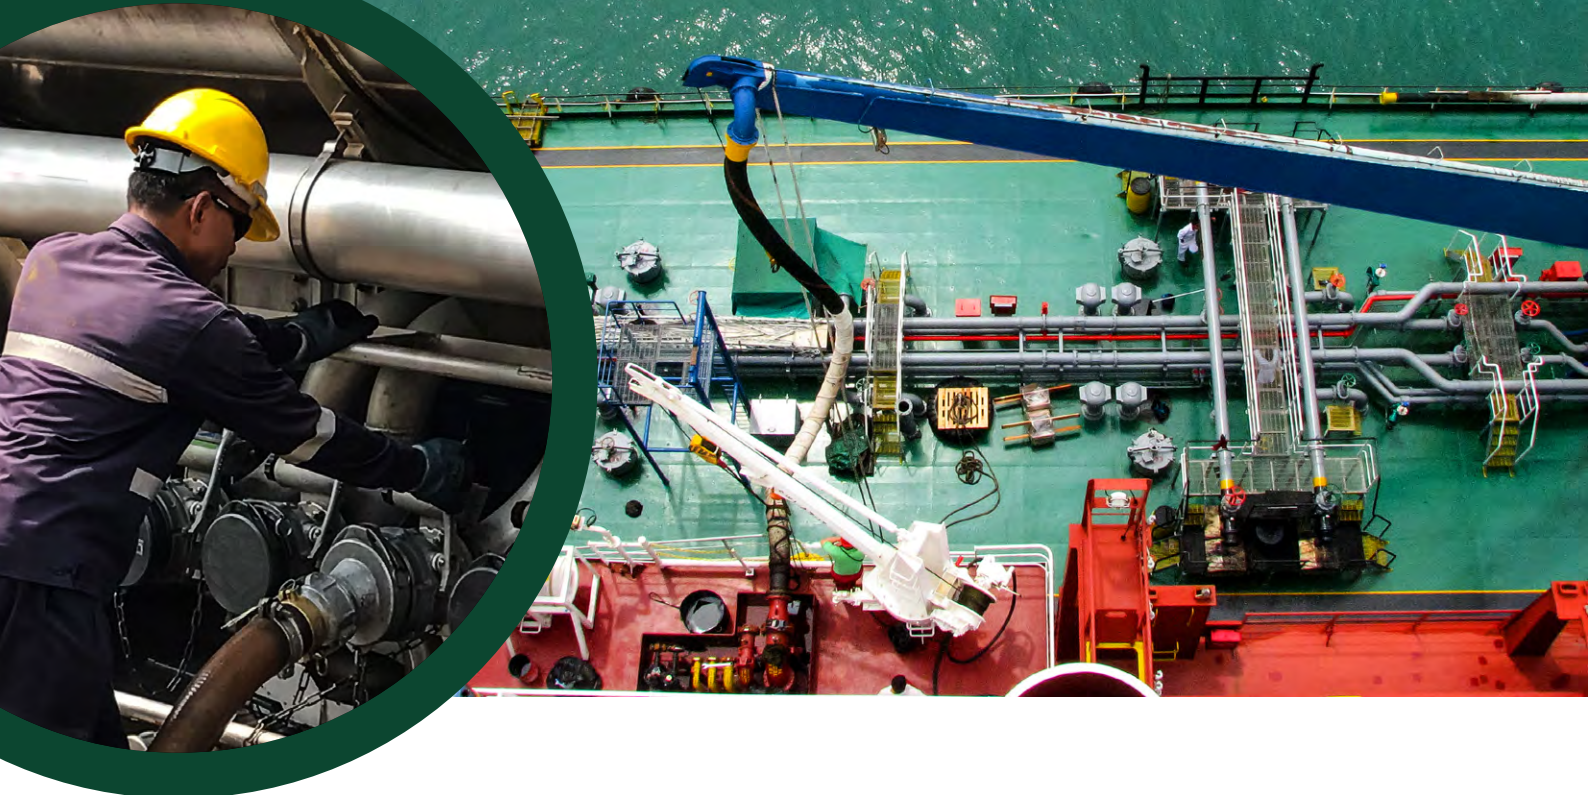
Oil was overflowing from a blind flange on the port side bunker station. The Third Engineer waved to the fuel truck driver to stop pumping, and he also pushed the emergency stop by the bunker station. The fuel truck driver stopped immediately. The Chief Engineer had heard the AB over the radio and closed the valves to the tank. He had not noticed anything unusual on the gauges and had not suspected that oil was overflowing. The Third Engineer and the oiler ran over to the port side with absorbent pads from the Shipboard Oil Pollution Emergency Plan (SOPEP) equipment. However, there was too much oil, and it was spreading into the harbour. Fortunately, there were favourable winds which pushed the oil back towards the vessel and berth.

When the engineers investigated the port bunker station, they found that bolts on the blind flange were loose. This allowed the oil to overflow. Both the port side and starboard side bunker lines are connected and there is no valve in-between; this is a common system. It is however very important to check that the flange bolts and valves for the bunker station not being used are closed and secured.

The bolts for the blind flange were re-tightened. The line was pressure tested and found not to be leaking. The oily water in the harbour was pumped into immediate bulk container (IBC) tanks which were supplied by the authorities. The vessel was fined and had to pay for the entire cleaning operation. The vessel was not detained and was allowed to sail after the hull had been cleaned.
