Dealing with
**engine
room
fires**

By **Peter Stålberg**
Senior Technical Advisor

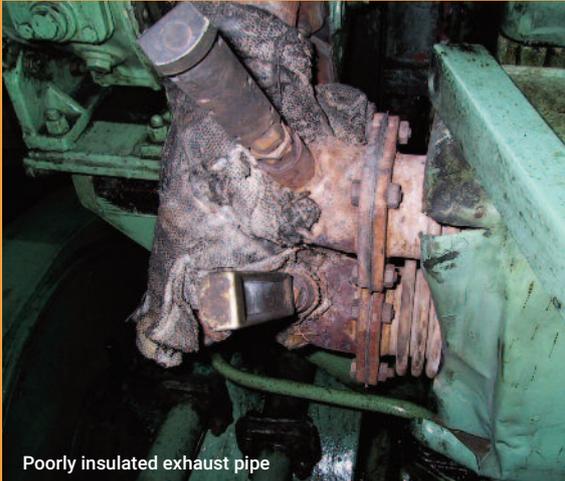
condition. "Over time, however, when overhauling engine room machinery and removing/refitting exhaust pipes, the insulation will deteriorate," explains Stålberg. "An exhaust pipe system insulated to 95% is not good enough – it must be 100% intact – always."

Poorly insulated exhaust pipe

- Ensure that the insulation covering heated surfaces is always in good condition.
- Use thermal imaging at regular intervals to spot and identify inadequate insulation and hot surfaces.

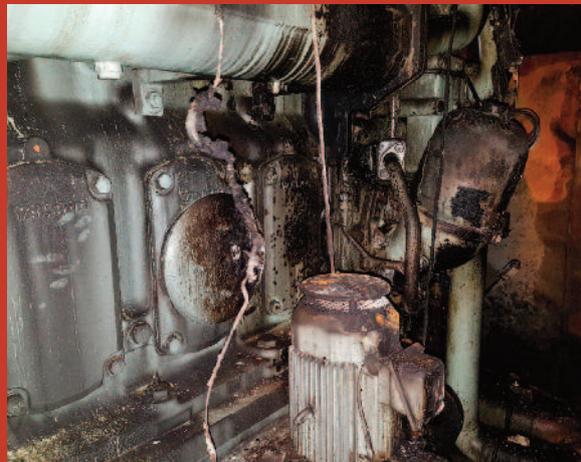
The survey concluded that the main cause of the fire in the engine was related to the failure of the aft fuel oil high pressure pipe of unit No. 4. The pipe had fractured and severed completely at the thrust bushing at the fuel pump side.

According to the information provided by the ship's staff it is unknown if the correct tightening pressure of 190 Nm was applied as recommended in the MAN service instruction manual.

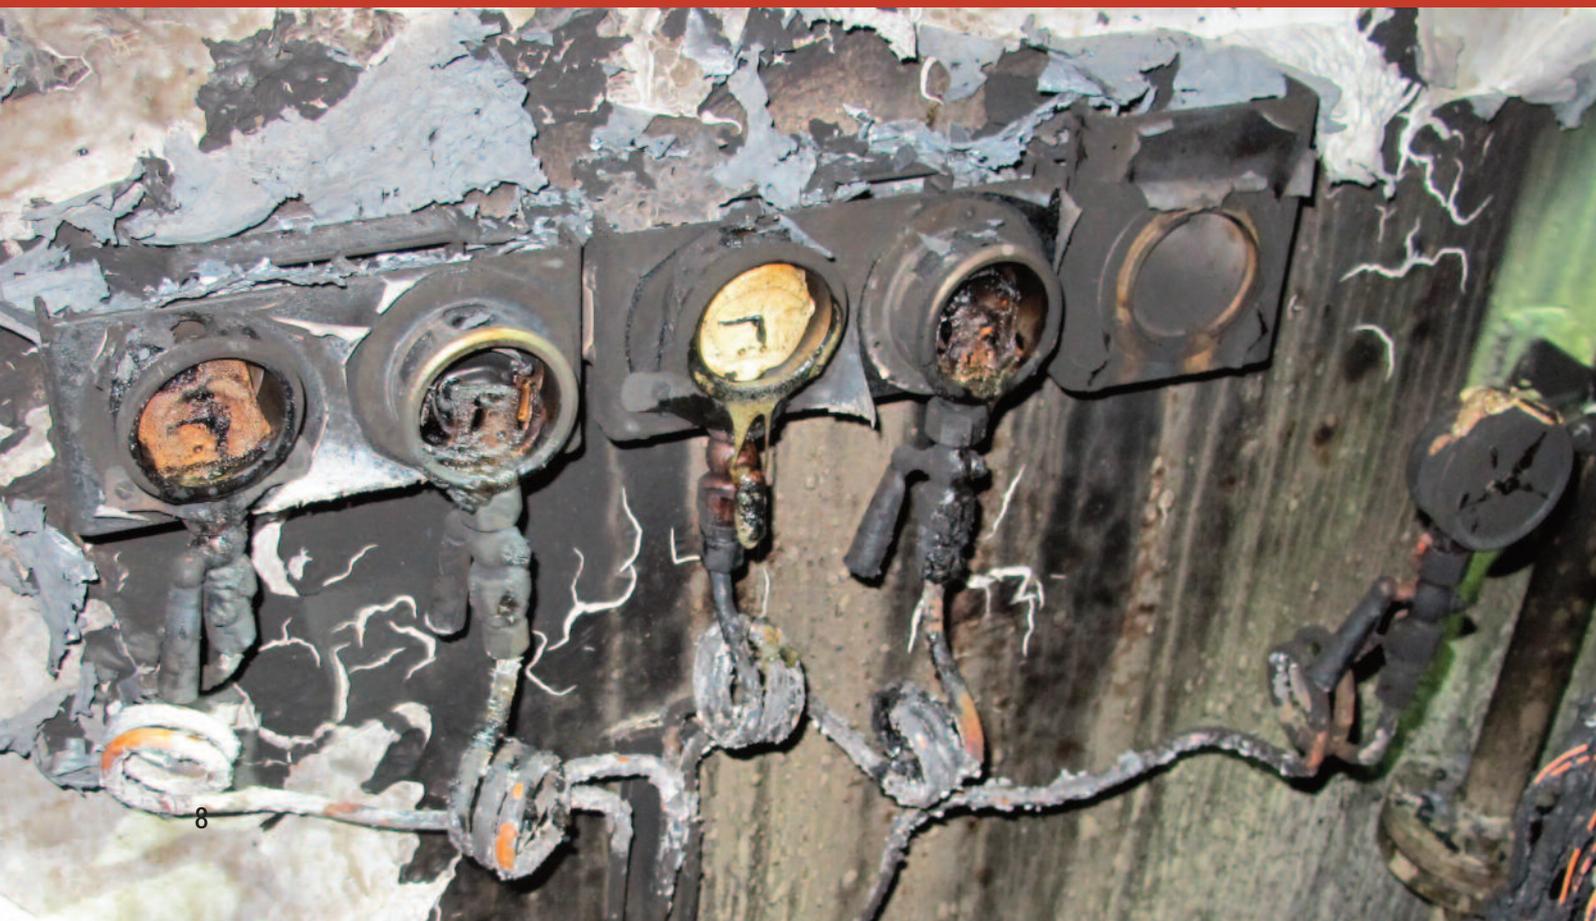
The fire was caused by the diesel oil fuel duplex filter vent screw vibrating loose. This allowed a high pressure stream of fuel to come in to contact with the deck head above the operating auxiliary engine No.2.

When the stream of fuel made contact with the deck head, the diesel oil spread over the turbocharger exhaust outlet casing and the hot exhaust protection covers of the auxiliary engine, creating the vapour to spontaneously ignite. The full pressure of the diesel oil leaking from the vent hole continued to feed the fire.

Once the fire broke out it rapidly spread, overheating and melting the various components within the automation control panel which was fitted directly behind the auxiliary engines on the third deck level. This meant that the backup automatic start sequence of the standby auxiliary engine was not possible.

As to the cause, we have seen similar cases where a vent screw or sampling point has vibrated open. It could be that when someone has changed filters or taken samples, they quickly fastened the screw by hand and forgot to tighten it properly later. This would be the result of a poor maintenance routine – a checklist would have eliminated this hazard.
