Oil spill while bunkering

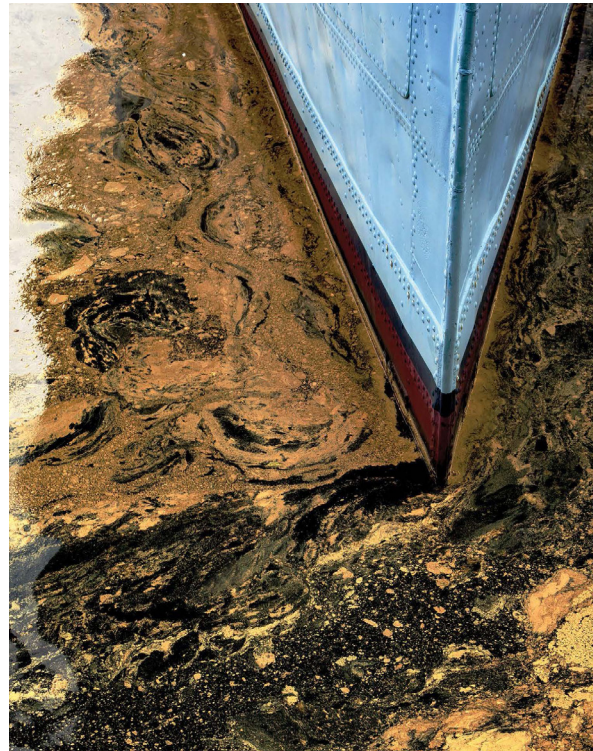
The 3rd Engineer reported over the radio that oil was overflowing from the starboard side bunker station. He believed it was from the sounding pipe of 2S. He ran to get some oil pads and rags from the portside and started to clean up as well as he could, but oil was still pouring over the side of the vessel and into the water.

The Chief Engineer rushed to the starboard side bunker station and confirmed that oil was overflowing. More than 2 MT of oil spilled into the water. The crew used sawdust and absorbent pads on deck to try to soak up the oil.
