Grounding when not using bridge equipment efficiently

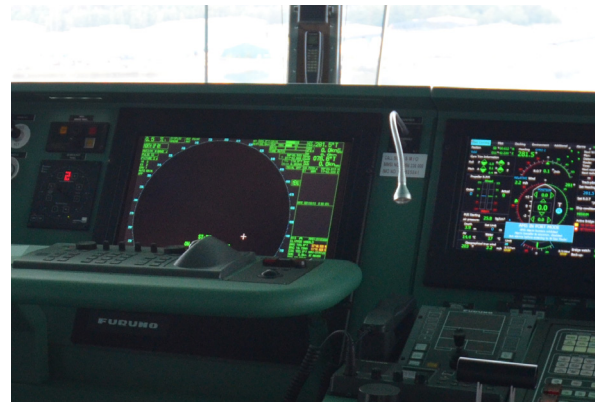
The vessel had run aground on a bank which was outside the fairway. The vessel was clearly visible outside of the channel on the ECDIS and radar. This was also confirmed when the position was plotted.

There was a leading line for the approach, but for some reason it was disregarded. The passage plan was not berth to berth. If the plan had been berth to berth there would have been a planned route into the port which would have highlighted the discrepancy in the vessel's position on the ECDIS. The bridge team did not monitor the vessel's progress with all the available means. ■
