Poorly planned maintenance led to engine room flooding

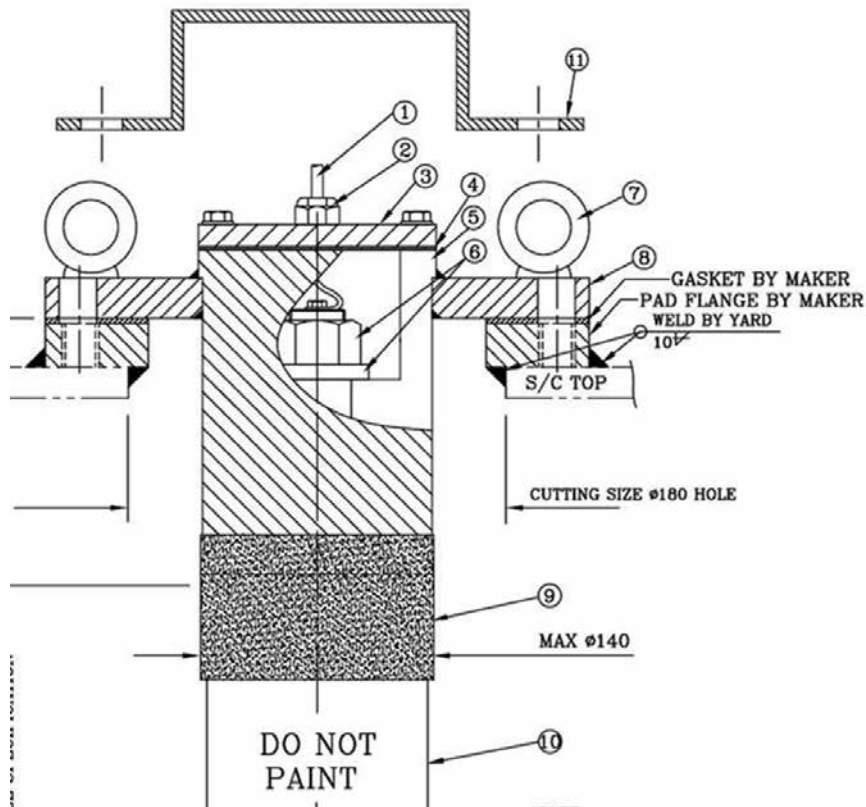
Technical description

The small cover (item 3) is underside the lid. There is a small chamber where the anode cable (item 1) is connected to the anode (item 10). The chamber is isolated from water.

The anode mounting flange (item 8) is what the oiler removed. It is used to secure the anode assembly to the seawater chest. The anode (item 10) is submerged in the seawater chest.

The oiler should never have touched the mounting flange.

This is a critical job and a risk assessment should have been issued by the chief engineer and inspected by an engineer before the job commenced.
