Corrosion of distance piece on SOx scrubber discharge water line

ClassNK

Technical Information

No. TEC-1205
Date 9 April 2020

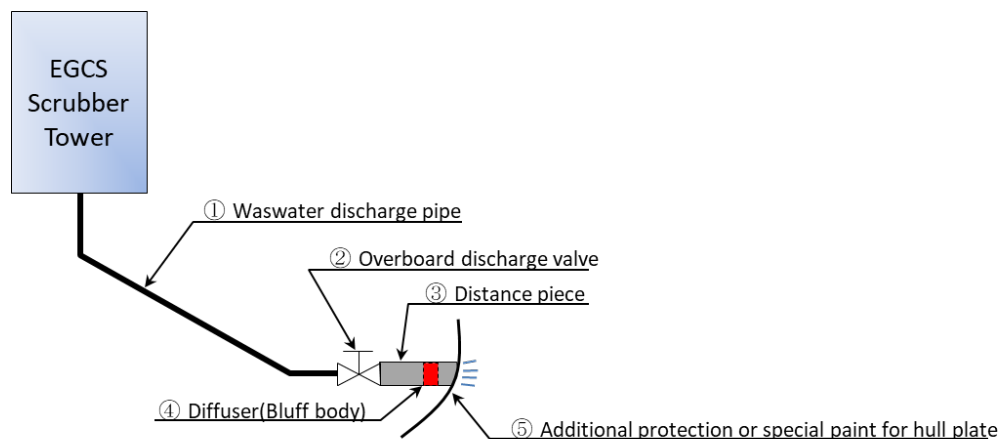
Figure 1 SOx scrubber discharge water line

Recently, ClassNK has received several reports for incidents that sea water leakage was detected from distance piece attached to hull on SOx scrubber discharge water line (See Figure 1).

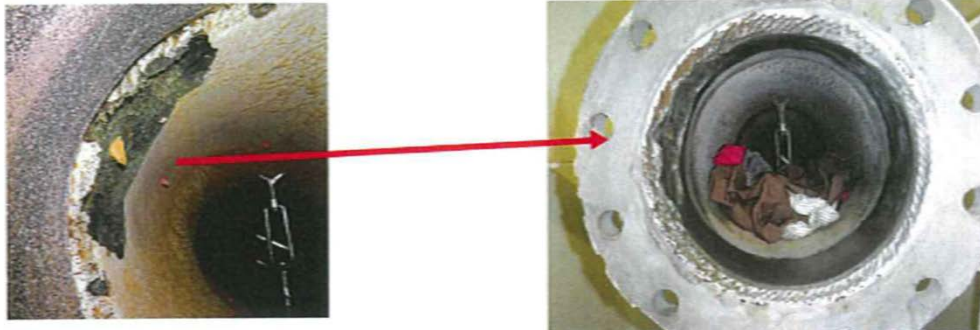
Leakages have been detected around welds between "distance piece" and "flange (See Picture 1) or bluff body (See Picture 2)".

Having inspected the distance pieces internally, the corrosion occurred/progressed around the welds and caused the leakages finally.

Picture 1 Corrosion around weld between distance piece and flange

- To inform the above incidents of the masters of your vessels on which SO_x scrubber is installed and instruct them to inspect the discharge water lines especially around the distance pieces externally from E/R with more attentions and frequencies.
- To inspect the distance pieces internally when there is an opportunity of arranging a diver for hull cleaning, etc.

If a leakage were detected, temporary countermeasure to stop it (e.g. covering the distance piece with cement box) should be taken immediately, and Occasional Survey by the surveyor should be arranged as soon as possible.

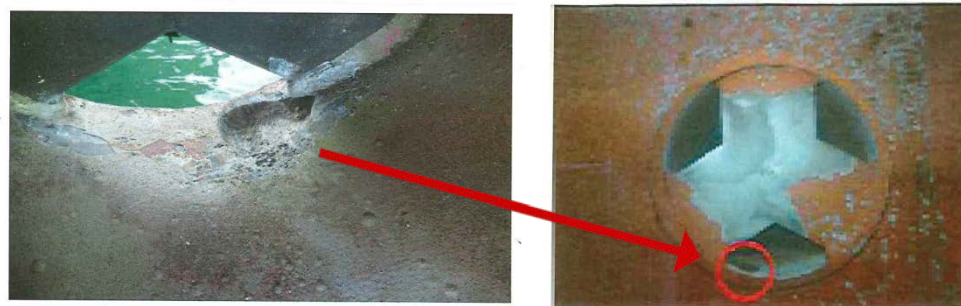
Picture 2 Corrosion around weld between distance piece and bluff body
