Contact while berthing

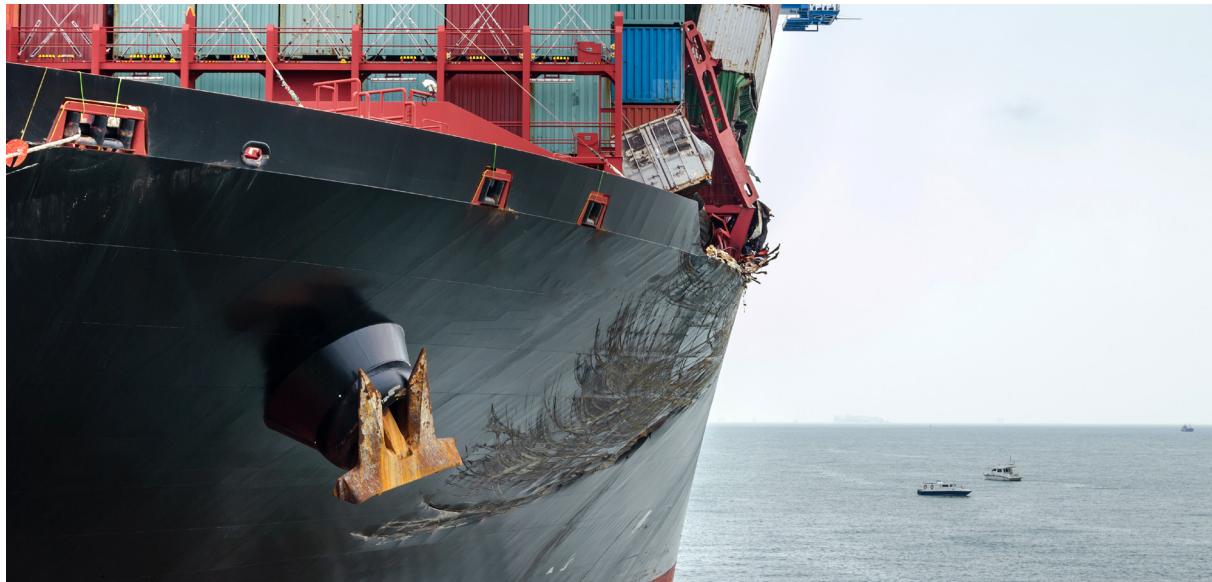
It was early morning and a 150 m LOA and 14,900 DWT general cargo vessel, vessel A, was sailing up a South American river with a pilot on board. The Master and pilot had carried out a pilot briefing where the pilot presented the plan for berthing. The vessel would be berthed portside alongside, between two vessels which were already berthed. The Master asked the pilot if any tugboats would be necessary, but the pilot did not believe so as there would be a 200 m gap between the berthed vessels, giving vessel A about 50 m clearance from the berthed vessels.

Despite the Master's efforts to turn the bow to starboard the vessel continued turning to port and the bow collided with the berthed vessel. The vessel's superstructure was forward, so the bridge wing also caused damage to the berthed vessel.

- When the Master approached the berth, he should have evaluated if the available tugs should be used or not. If he was unsure about the clearance, he should have asked the pilot for tug assistance before berthing.

- It is important that the Master and pilot discuss what is anticipated and how to carry this out in the safest way. When the vessel was sailing up the river there were strong currents and some wind. During the manoeuvre the Master had the conn but needed constant updates from the pilot and Chief Officer about how strong the current was. These discussions should also have taken place during the pilot briefing. Having an NNW course and NE winds on the starboard bow will push the bow to port, especially when the vessel is lining up for the final approach and altering slowly to port and slowing down. The current will also make the approach more difficult as more power must be used during the final manoeuvre as the current would push the bow to starboard.

- The entire bridge team should be involved in berthing. In this instance the Chief Officer was by the radar and ECDIS and was the person who could have informed the Master about changing current or wind. The current also took the pilot by surprise. An efficient bridge team are assigned roles where they all know what they are expected to do and what the other persons are supposed to do. If someone makes a mistake this should be identified by a member of the bridge team. The Chief Officer was on the bridge and he should have supported the Master with information. This is further explained in our Bridge Instruction booklet (see appendix (i)).
