Main Engine Lubricating Oil Outlet diaphragm

In 2007, the Swedish Club published a Member alert, The "Forgotten" Rubber membrane, where we reported about a number of main engine claims caused by water contaminated lubricants. The incidents caused by failure of the lubricating oil outlet diaphragm connecting the main engine crankcase and sump tank.

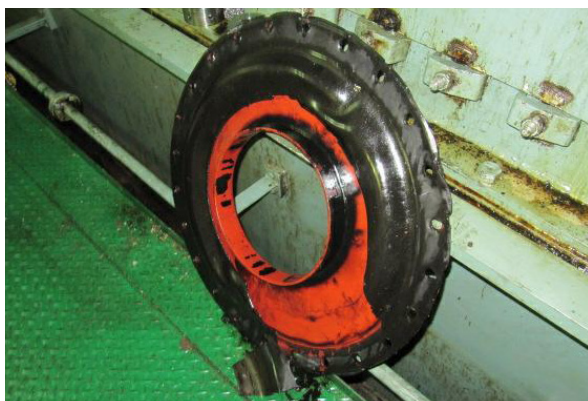
In all cases excessive quantities of water on the tank top have entered the main engine sump tank via the defective diaphragm and subsequently contaminated the main engine lubricating oil system, resulting in severe damage to the main engine bearings and journals.

Failed diaphragm

In line with the recommendation issued by MAN Diesel A/S, Copenhagen, we recommend that all diaphragms are replaced in connection with every relevant scheduled inspection of the ship.

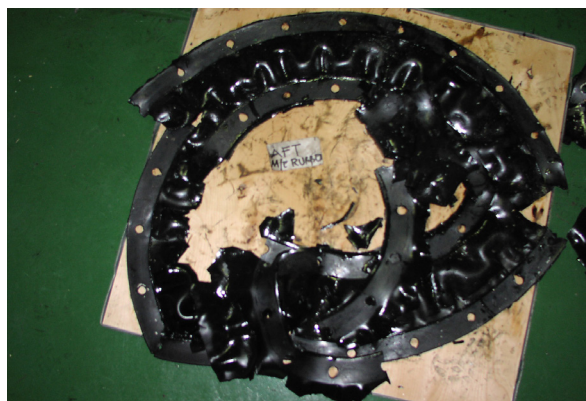
Deteriorated diaphragm
