The
Swedish
Club

Dealing with

engine room fires

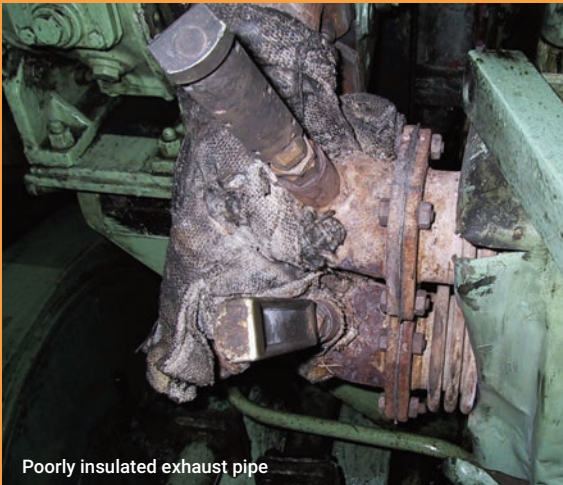
condition. "Over time, however, when overhauling engine room machinery and removing/refitting exhaust pipes, the insulation will deteriorate," explains Stålberg. "An exhaust pipe system insulated to 95% is not good enough – it must be 100% intact – always."

Poorly insulated exhaust pipe

- Ensure that the insulation covering heated surfaces is always in good condition.
- Use thermal imaging at regular intervals to spot and identify inadequate insulation and hot surfaces.

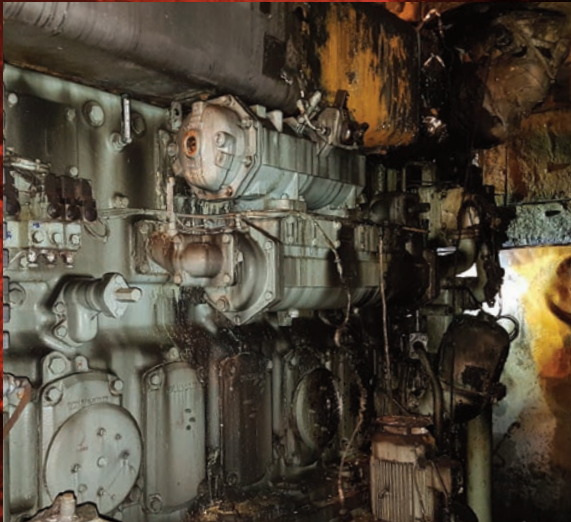
The fire was triggered by a diesel oil leak from the port side engine coming into contact with the hot metal of the engine. This leak was caused by a broken pipe from the return line of cylinder fuel pump no. 3 of the port side main engine.

Further investigation showed that the emergency quick closing valves were not properly shut when remotely activated by the Chief Engineer at the time of the casualty.

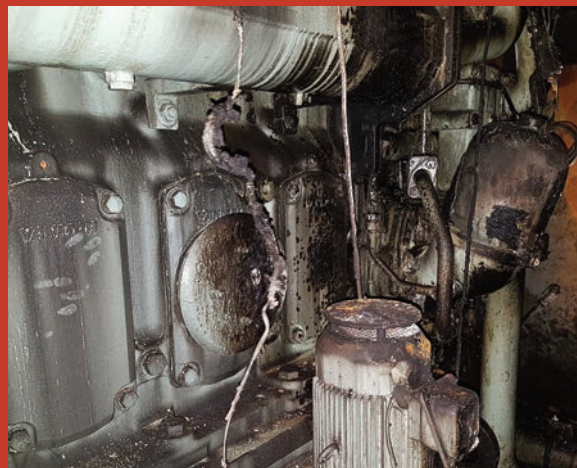
The survey concluded that the main cause of the fire in the engine was related to the failure of the aft fuel oil high pressure pipe of unit No. 4. The pipe had fractured and severed completely at the thrust bushing at the fuel pump side.

According to the information provided by the ship's staff it is unknown if the correct tightening pressure of 190 Nm was applied as recommended in the MAN service instruction manual.

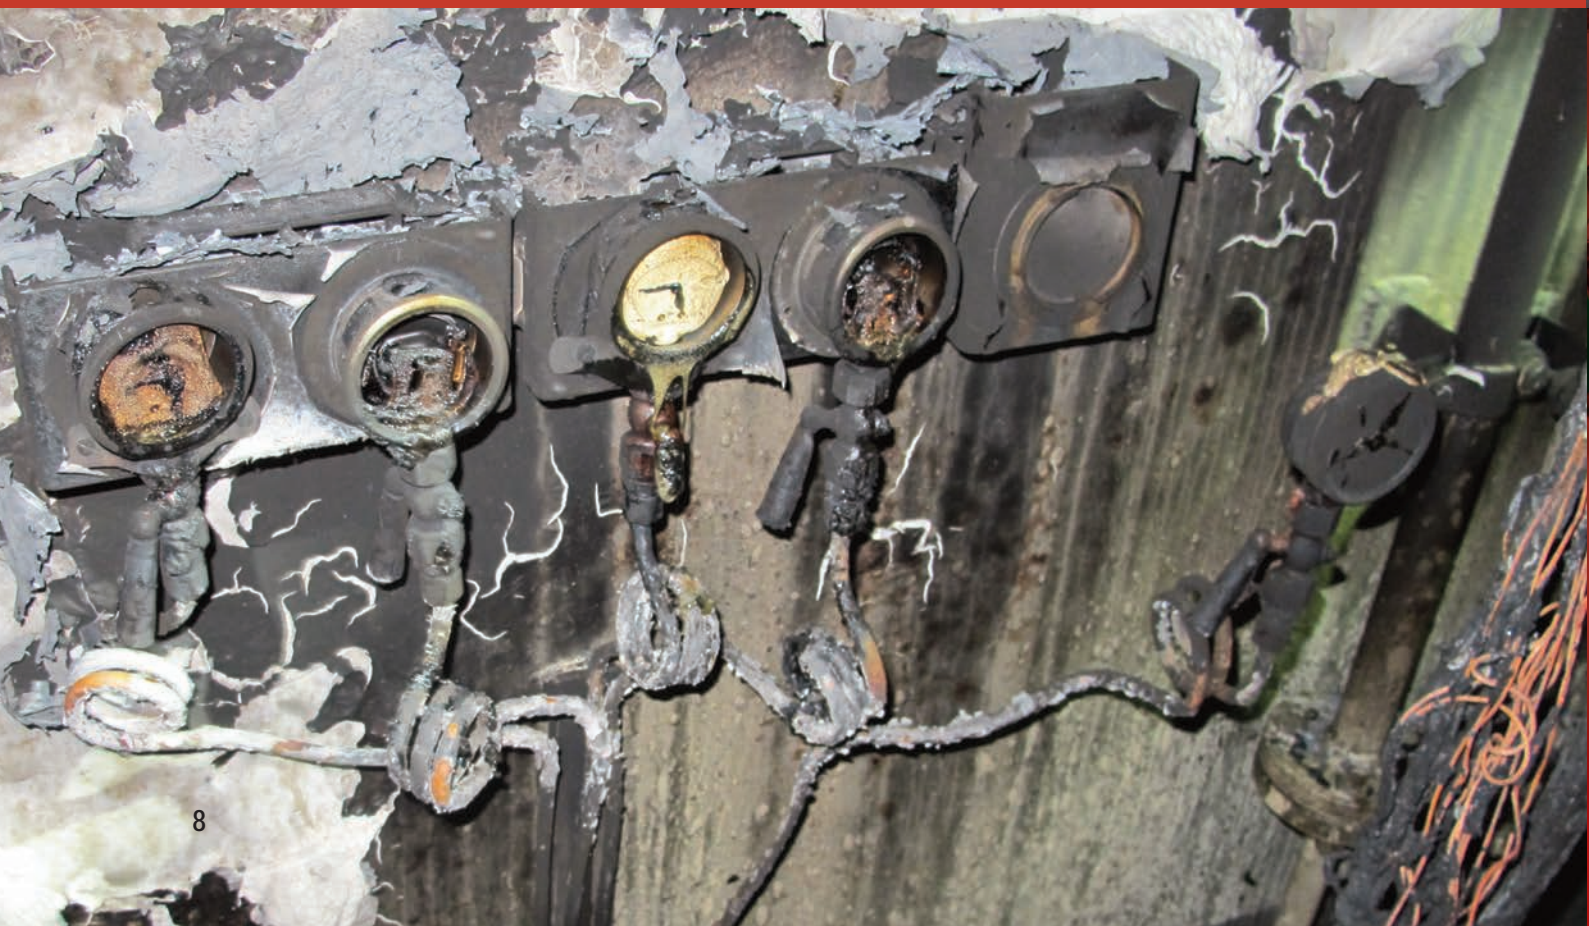
The fire was caused by the diesel oil fuel duplex filter vent screw vibrating loose. This allowed a high pressure stream of fuel to come in to contact with the deck head above the operating auxiliary engine No.2.

When the stream of fuel made contact with the deck head, the diesel oil spread over the turbocharger exhaust outlet casing and the hot exhaust protection covers of the auxiliary engine, creating the vapour to spontaneously ignite. The full pressure of the diesel oil leaking from the vent hole continued to feed the fire.

Once the fire broke out it rapidly spread, overheating and melting the various components within the automation control panel which was fitted directly behind the auxiliary engines on the third deck level. This meant that the backup automatic start sequence of the standby auxiliary engine was not possible.

As to the cause, we have seen similar cases where a vent screw or sampling point has vibrated open. It could be that when someone has changed filters or taken samples, they quickly fastened the screw by hand and forgot to tighten it properly later. This would be the result of a poor maintenance routine – a checklist would have eliminated this hazard.
