# Hyundai Lifeboat Investigation Report

- Boat type : HDL 71CTA

JULY 16, 2013

**HYUNDAI**  
HYUNDAI LIFEBOATS CO., LTD.

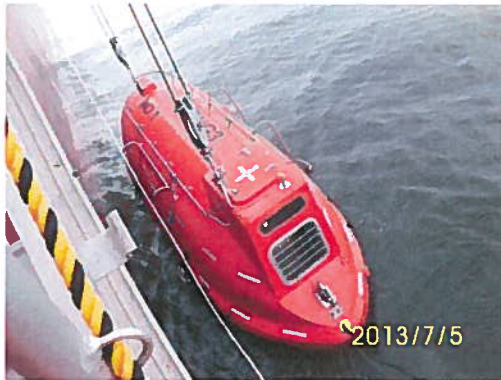
- 1) [REDACTED] the vessel conducted abandon ship drill and lifeboat was lowered in the choppy water.
- 2) AFT davit link was detached from the hook, but the hook was not released. [Figure 1]
- 3) The captain decided to lift up the lifeboat by only FWD hook as nobody was in the lifeboat. [Figure 2]

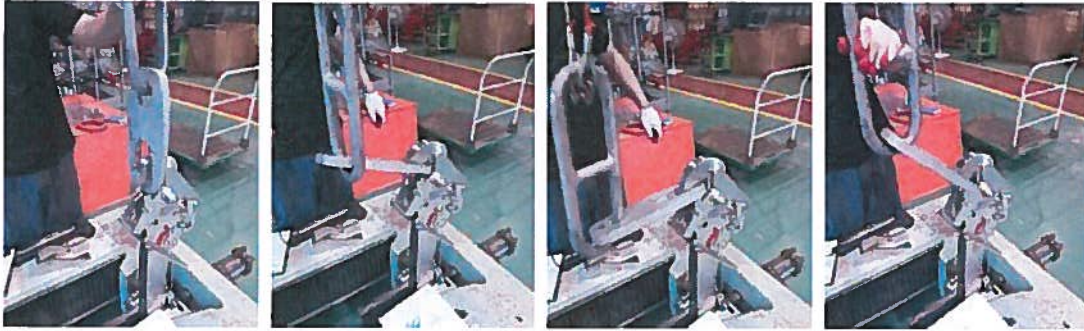
a) Repetitive UP & DOWN motion of davit link using crane : The self locker was not opened.

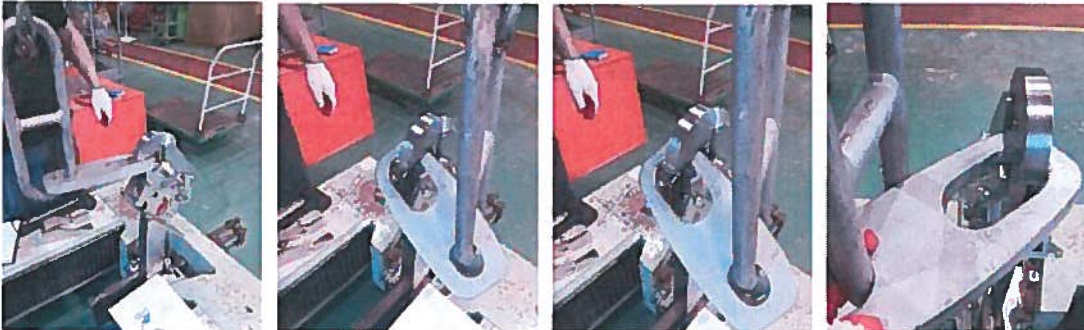
b) Checking a rotary motion of davit link using crane : The self locker was not opened.

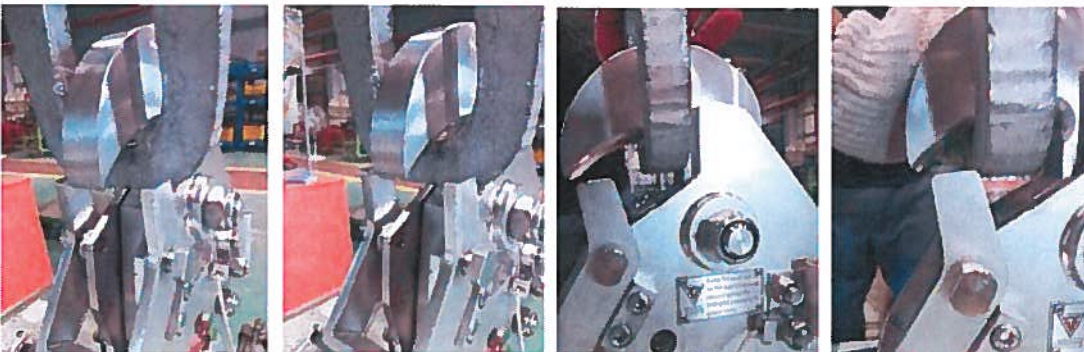
c) Checking the possibility of release under the on-load condition : The self locker was not opened.

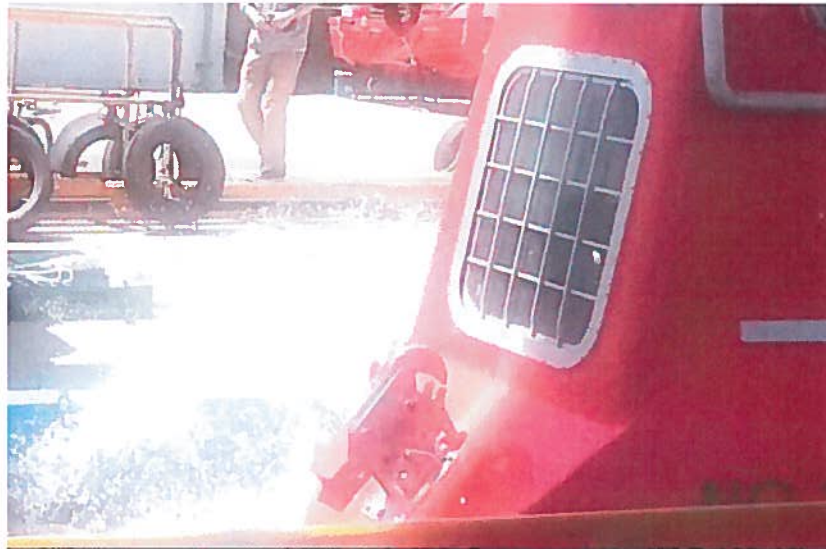
- d) Checking the 'self locker' if it is opened by impact to the water surface : The self locker was not moved.

*\* Test condition: The lifeboat was above the water and released. (On-load release)*

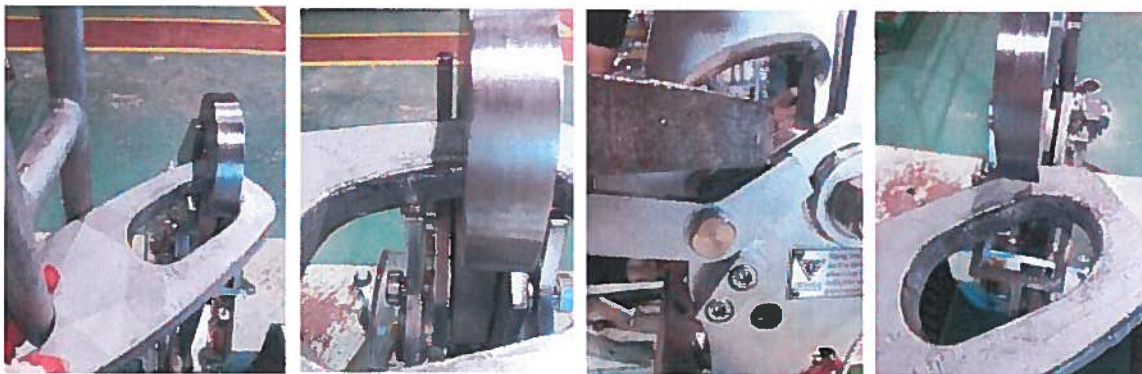
- e) We made the davit link is in abnormal position and applied a) and b) motion to the link : The link was detached as below :

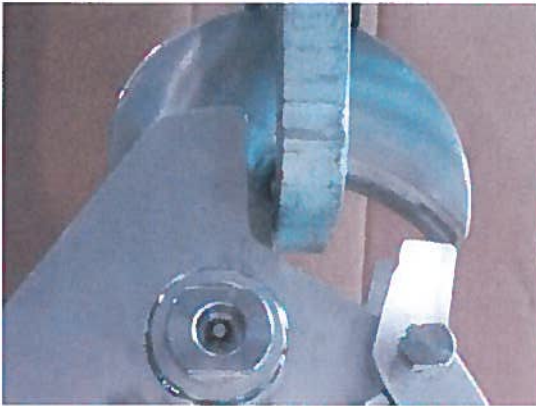
[Figure 3] Normal condition of link

- 1) When the lifeboat was lowered into the water with normal condition of link as [Figure 3], the davit wire was loosen and it caused the davit link was in abnormal position as [Figure 4].
- 2) The davit link of this abnormal position pushed the self locker and subsequently repetitive UP & DOWN motion by waves to the davit link made the self locker to be opened. Finally, the davit link was detached through the gap between hook and opened self locker.

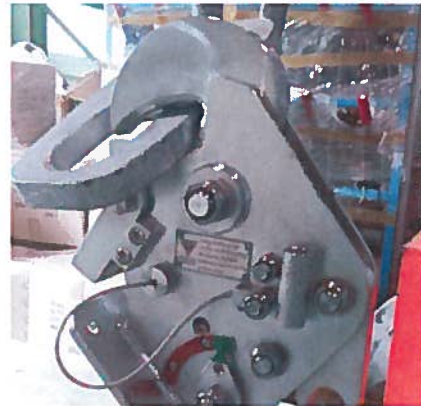
[Figure 4] Abnormal condition of link

Actually, the link used

was rectangular type and this type's link can push the self locker.
