MONTHLY SAFETY SCENARIO

JUNE 2023

Grounding in restricted visibility

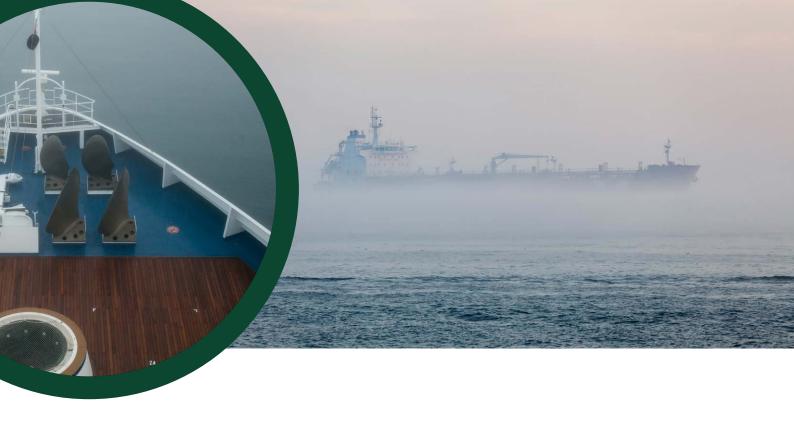
At the time of departure there was a flood tide, and the current pushed the vessel towards the opposite bank.

There was some interference on the radar display, so the pilot was confused about the vessel's position. The pilot ordered dead slow but the flood tide continued to push the vessel towards the opposite bank. Neither the pilot nor the Master could see any of the banks in the fog. The Chief Officer did not provide any information about the vessel's position.
