The Swedish Club

MONTHLY SAFETY SCENARIO

MARCH 2022

Injured during cargo operation

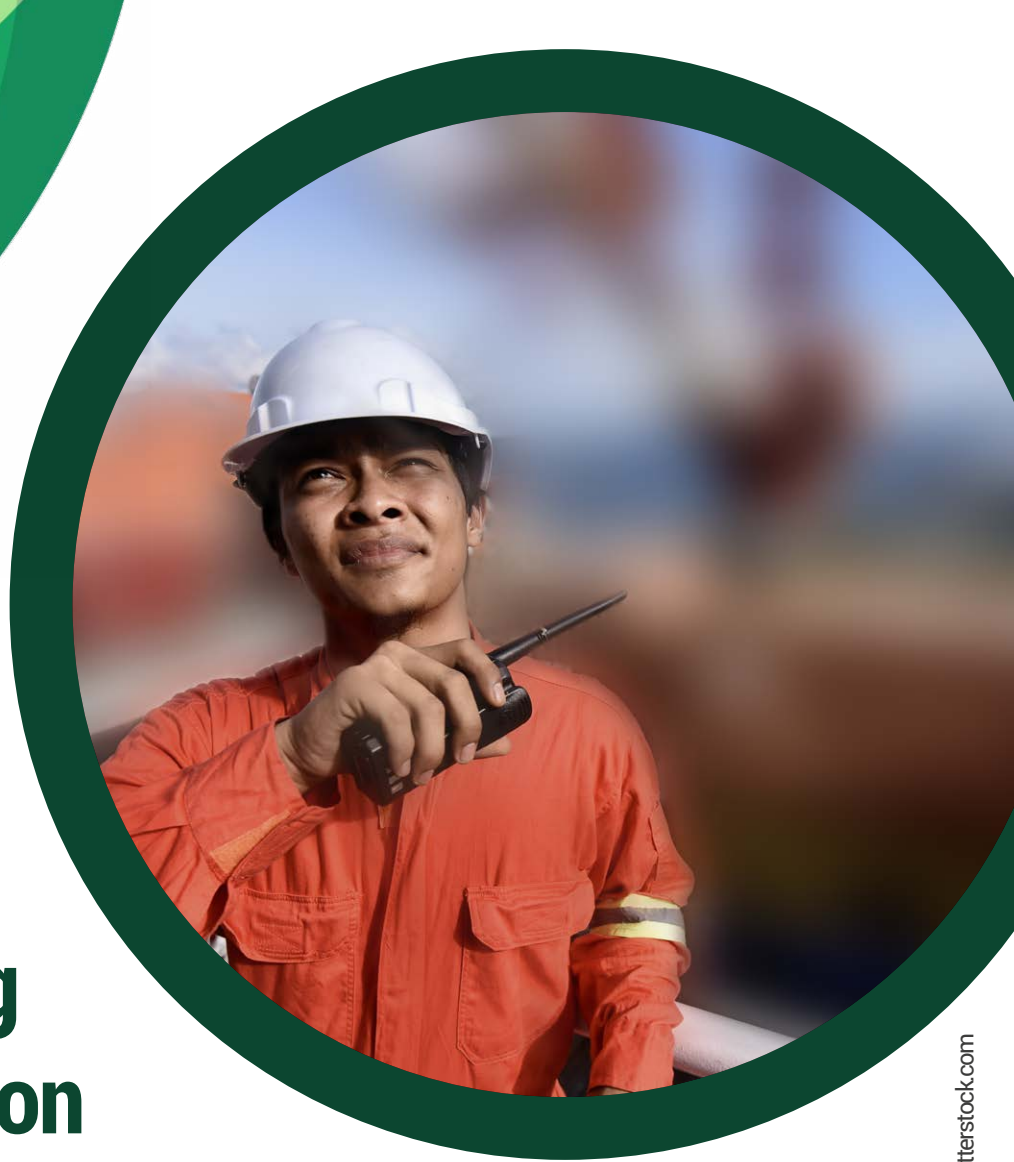
As the hatch was lifted it swung into the coaming of cargo hold 3 and became stuck. Two ABs tried to push the stuck hatch cover, at which point the web sling snapped and broke and the cargo hatch cover fell onto the coaming of hold 4.

One of the wires was slightly loose and hit one of the ABs on his arm, and another wire hit the other AB in the head.

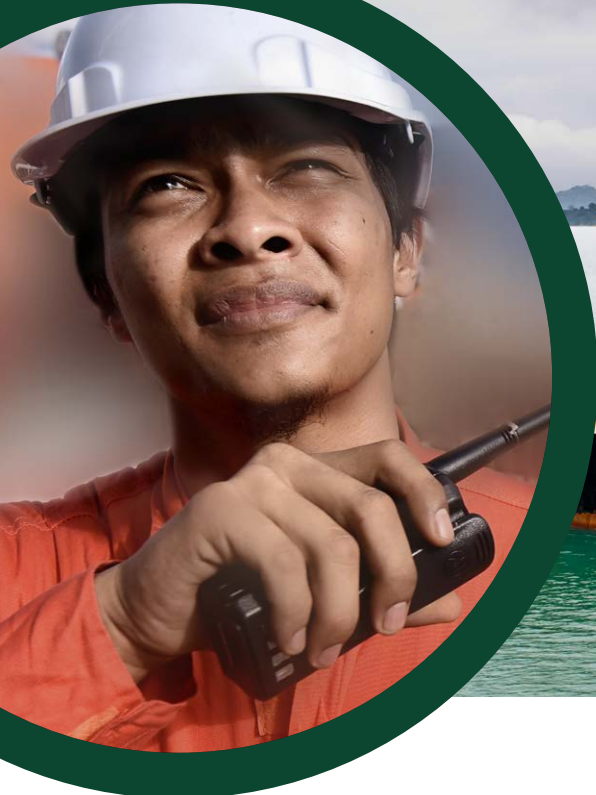
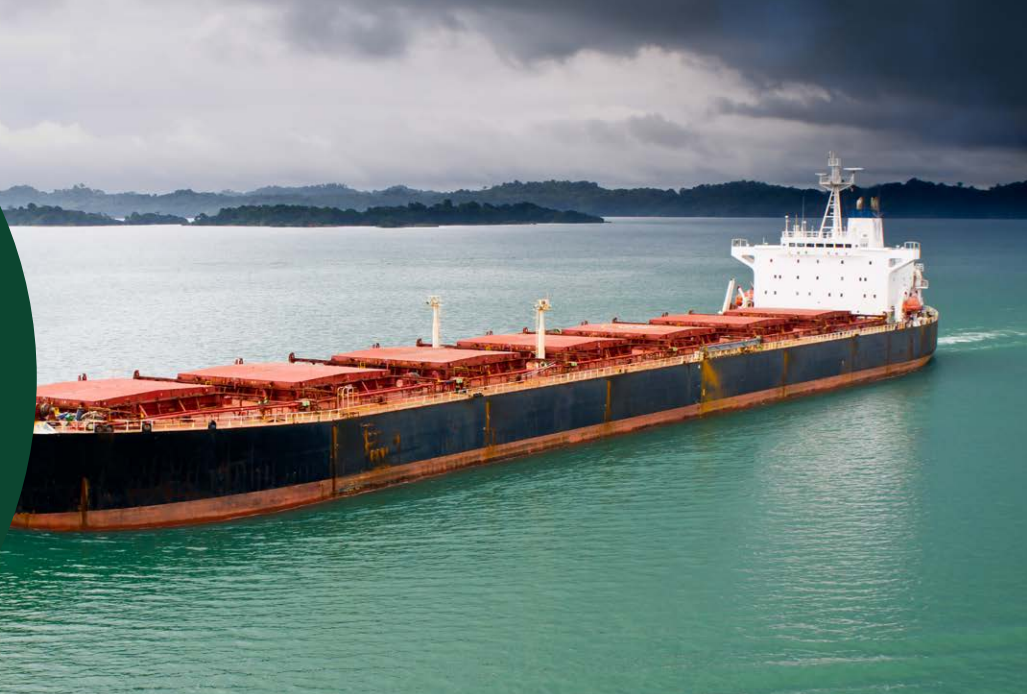
During a later inspection it was found that the web sling was in a poor condition. It was soiled with oil stains and some broken fibres. The web sling had a Safe Working Load (SWL) of 10 tonnes with a safety factor of 6:1. This means that the sling would have broken if more than 60 tonnes was applied in a straight pull. This would only apply if the web sling was in a good condition. There were no certificates for the web sling. The cargo hatch cover weighed less than the SWL of the web sling.

It seems that the web sling broke because the hatch was stuck, and the crane continued to be briefly used. When the ABs approached the hatch and tried to free it, the sling broke.
