## Flooding of the bow thruster room

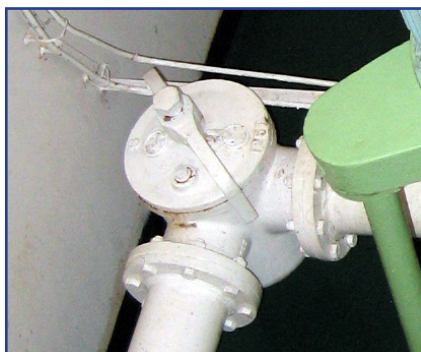
Fig 1 Clamp design

The Club has experienced a number of incidents where the bow thruster room is flooded and therefore making the bow thruster and emergency fire pump inoperable. In a majority of cases flooding has been caused by either corroded pipes or a failure in the suction strainer.

It is our opinion that this type of strainer with a single clamp holding the cover in place is, despite being class approved, a substandard design (fig 1). The only way to avoid these unnecessary and expensive incidents is to replace the existing strainer with a strainer where the cover is bolted to the housing (fig 2).
