**Action code: IMMEDIATELY****Product Safety Warning Letter**

Total Solutions &amp; Power (TSP) accumulators

SL2016-614/PRP  
May 2016**Concerns**

Product safety warning letter concerning accumulators produced by TSP.

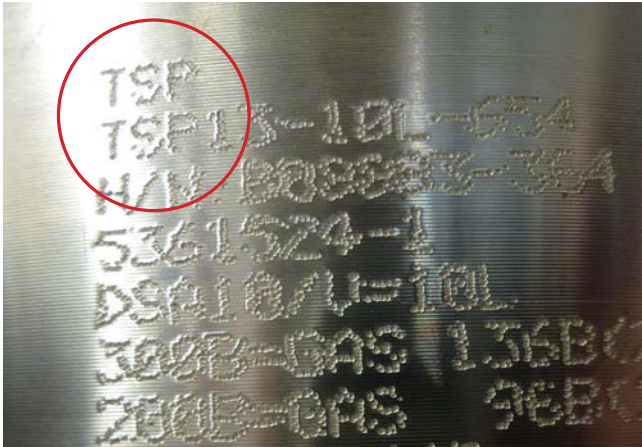
Fig. 1: TSP accumulator

With reference to a few incidents reported, one of the TSP accumulators installed has suffered from breakage, and parts of the accumulator body were ejected into the engine room causing damage to the engine. Accordingly, such breakage poses a serious potential threat to property and persons and may potentially even result in bodily injuries and/or fatal casualties.

A root cause analysis by TSP of one of the failed components has identified the cause to the thread design in the accumulator made by the maker TSP.

The TSP accumulator can be identified as shown in Fig. 1.

TSP has informed us that they have designed a protective guard to be installed on their accumulators as a counter measure. Accordingly, in case your engines have accumulators installed that are made by TSP, you should immediately contact TSP directly for installation of the protective guard.

1. As always, ensure that the safety instructions of the Instruction Manual are strictly followed.
2. At the first opportunity, check the nitrogen pressure in the accumulators.
3. The operating personnel should minimise their presence/stay in the vicinity of the running engine and should never be in the vicinity of the affected hazardous area in front of or above the accumulators while the hydraulic system is pressurised, which means during engine running and engine start-up.
