Product Safety Warning - Updated Information

Total Solutions & Power (TSP) accumulators

SL2016-616/PRP
May 2016

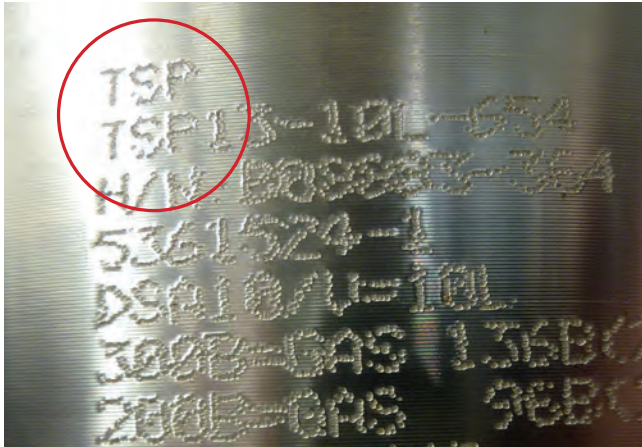
Fig. 1: TSP accumulator

The TSP accumulator can be identified as shown in Fig. 1.

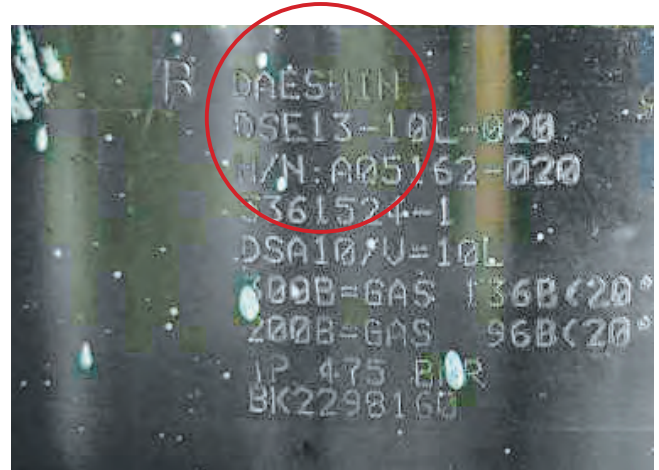
Fig. 2: 10L accumulators produced in 2013

TSP produced 10L accumulators in 2013 which are marked Daeshin, see Fig. 2. These must also be exchanged.
