# UNITED STATES COAST GUARD

## MARINE SAFETY ALERT

Safety Alert 17-16

#### **MAN B&W Cooling Jacket Failures** ***Using the correct bolts is essential!***

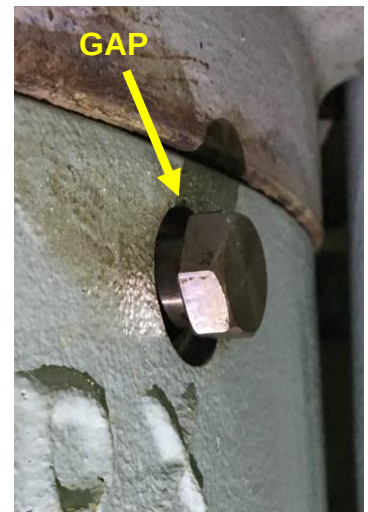
By design, the shoulders of these bolts are longer than the cooling jacket wall thickness. New replacement bolts will often have even longer shoulders. When the bolts are properly tightened there will likely be a gap between the bottom of the bolt head and the outside of the jacket cover. (Image A) The extra shoulder length allows the cooling jacket to position itself concentrically on the bottom of the cylinder cover and facilitate any movement or slight expansion of the o-rings. It also allows for some expansion of the cast iron cooling jacket. If the cooling jacket is slightly positioned non-concentrically on the cylinder cover, some of the bolt head's bottom surface areas may appear as if the bolt is fully tightened against the outside of the jacket cover.

Image A: Properly secured cooling jacket bolt.

- Owners, managers and operators ensure that their vessel engineering staffs have access to all available manufacturer service letters for propulsion, electrical generation, steering and other critical equipment; and
- Senior engineering personnel on vessels with MAN B&W MC-C and other similarly constructed engines using the same cooling jacket cover securing method *review* the applicable maintenance procedures and ensure that persons assembling these components know that the shoulder bolts may not butt up against the cooling jacket cover, as breakage may occur if forced, and that regular bolts with no shoulders should never be used.

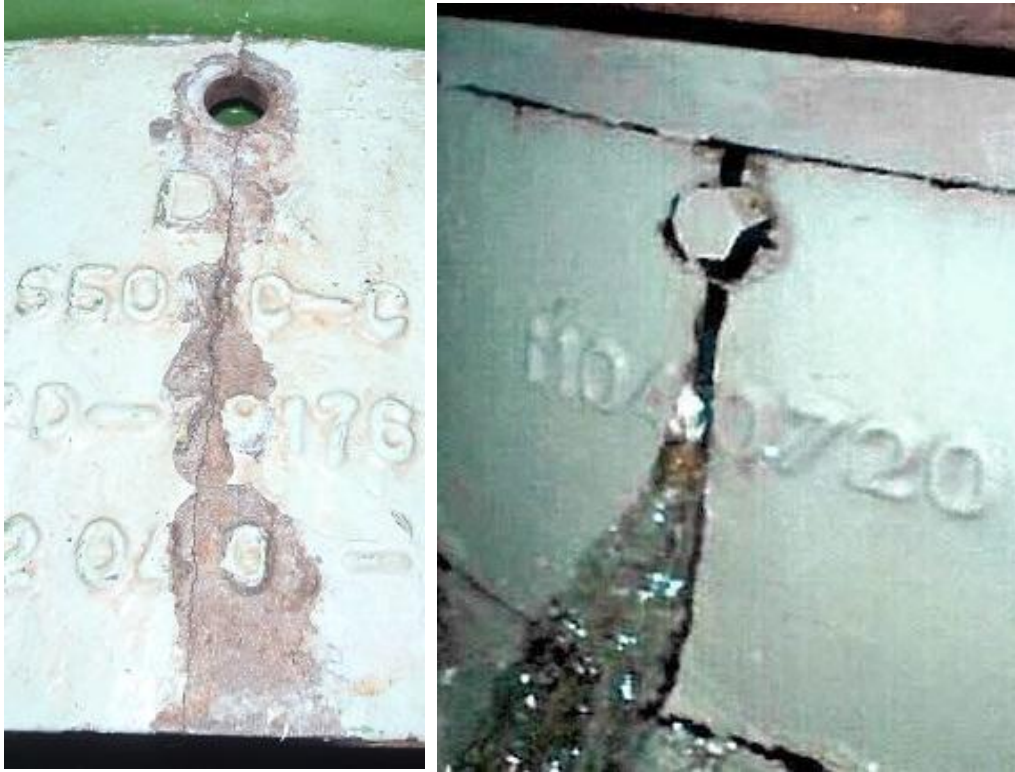
Photographic examples of fractures:

In the past, cooling jackets have fractured vertically through the bolt holes that secure the jackets to the cylinder cover. (Photographs - next page.) These fractures have caused a loss and reduction in cooling water that eventually resulted in the overheating of the cylinder cover. That then caused an automated slow-down of the engine and reduced the ship's maneuverability. These fractures can be caused by the following:

- Stress corrosion cracking
- Inadequate coolant water treatment
- Excessive rust and scale development
- Use of wrong bolts to secure cooling jacket
- Blockages of coolant flow throughout jacket space and cylinder cover passages
- Overheating / thermal expansion of cylinder cover causing excessive stress on jacket cover
