The
Swedish
Club

engine damage

Introduction

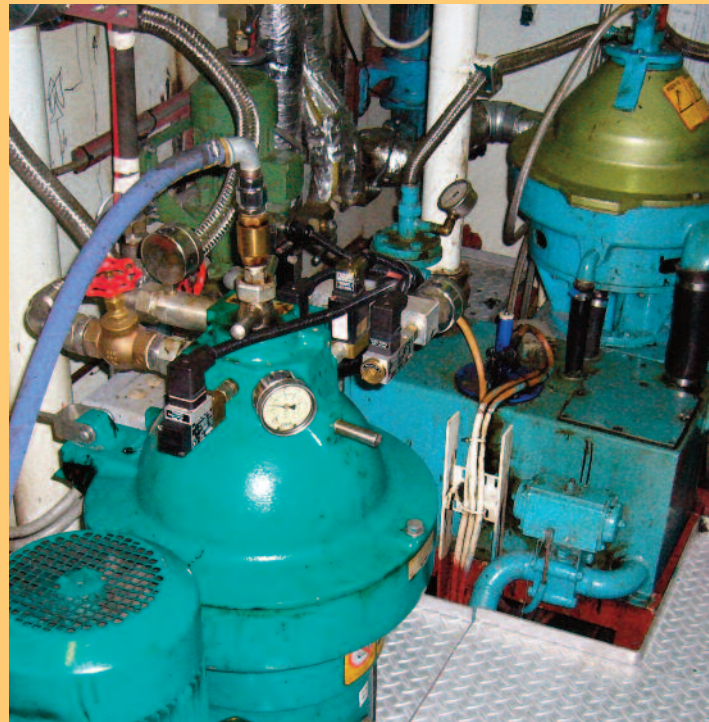
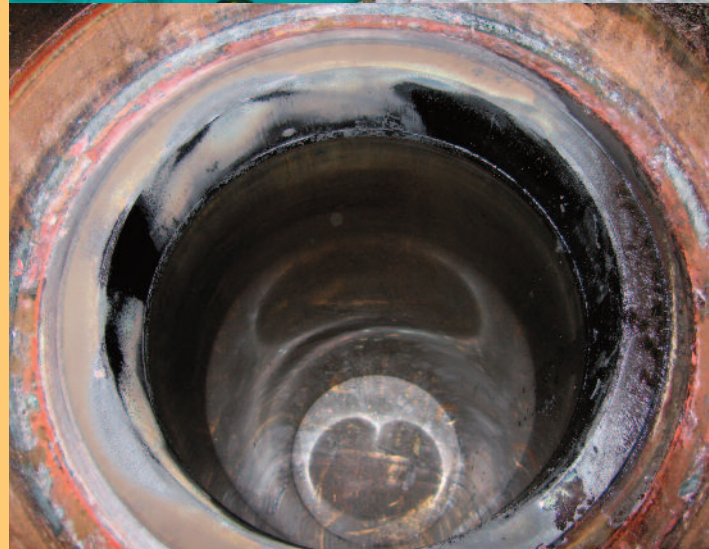
“A few hours later I heard a knocking noise and saw a leak coming from the no. 2 cylinder cover on the no. 1 diesel generator.”

The primary cause of the breakdown was failure of the purifiers. With both purifiers having damaged seals, it is highly probable that the impurities and water contained within the fuel oil were not removed before being burnt by the main engine and diesel generators. Finally, the purifiers were stopped and the vessel continued to consume the fuel without any purification. As a result, the engines were not able fully to burn the fuel being fed and suffered overheating and internal damage

To consume untreated heavy fuel is never a good idea. In hindsight, with the fuel treatment system out of order the engine crew should have immediately switched over to marine gas oil whilst the problem with the purifiers were rectified.

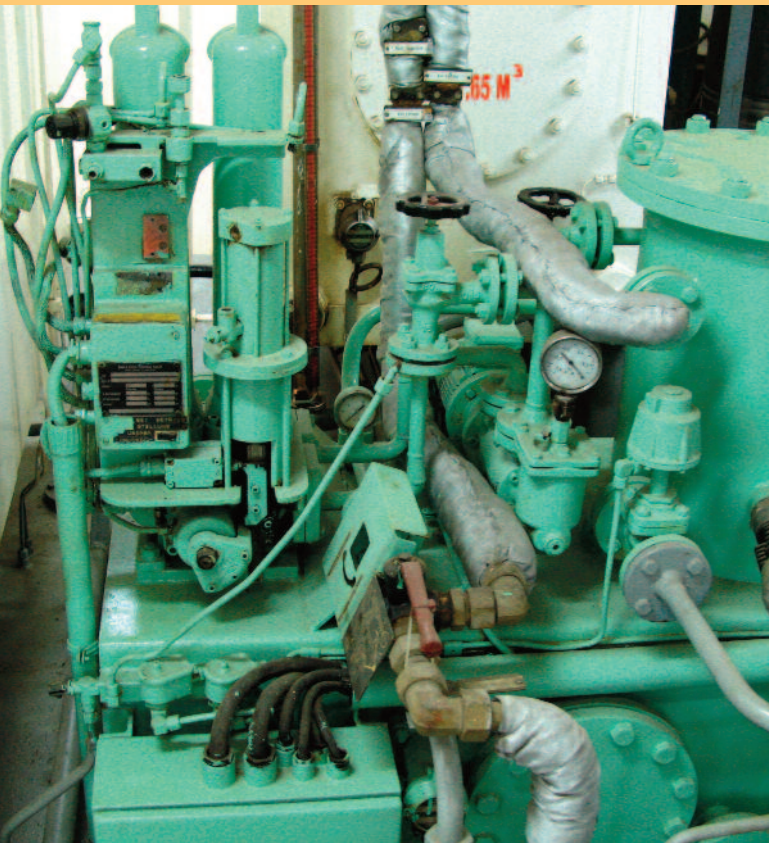
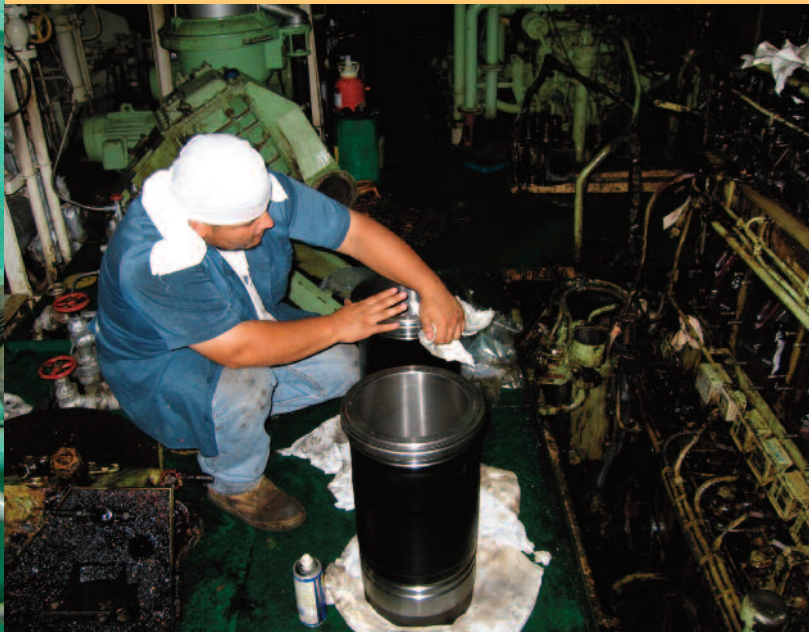
The investigation revealed that the casualty originated from careless handling of the mesh filter elements in the lube oil filter for the no. 2 generator. Filter cartridges in steel mesh, which are quite fragile, are cleaned by means of ultrasound washing in a dedicated basket. Instead of using the specified basket the engine crew had tossed the filter elements directly into the cleaner where they had sustained damage when rubbing against each other during the cleaning process. As the filter disintegrated, broken parts of the filter element spread throughout the lubrication oil system of the no. 2 diesel generator engine and caused severe damage to bearings and journals.

The initial contamination of the oil in the no. 2 diesel generator caused metal particles to contaminate the lubricating oil system. Subsequently, the contaminated lubricating oil entered the no. 3 diesel generator through the lubrication oil drain tank, causing damage to its major moving components.

The root cause for the casualty was the inability of the engine crew to follow the manufacturer's instructions on procedures for maintenance.

In addition, one can always argue that having an interconnected lube oil system for different engines is not good practice and should be avoided to safeguard from contamination of both engines lube oil systems should there be problems with the other.
