CPP failure caused heavy contact with lock gate

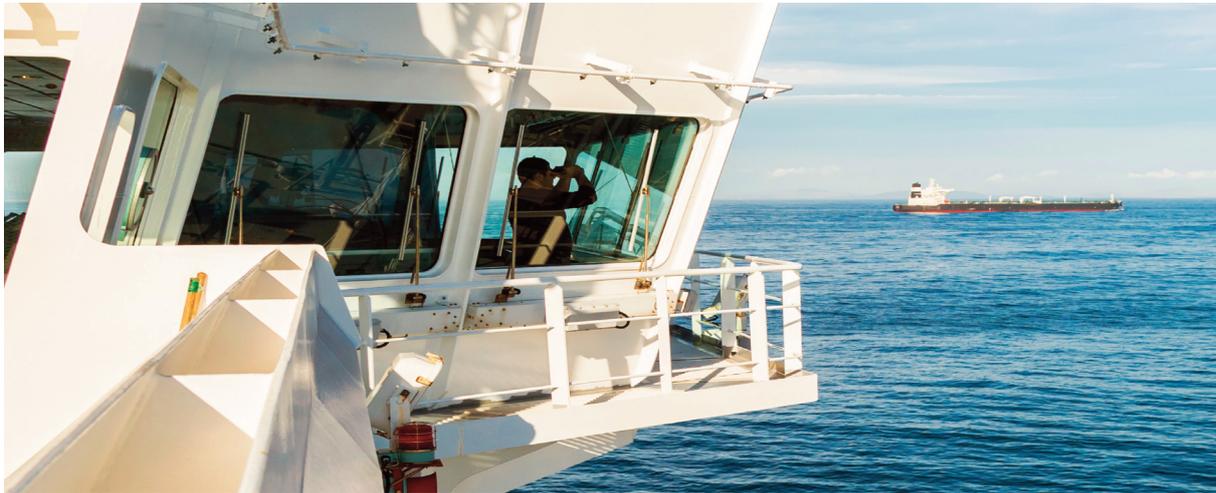
The vessel proceeded towards the lock and was in the final approach when the Master realised that the CPP was not responding correctly and the vessel was rapidly approaching the lock. The Master attempted to recover control of the CPP system, but the pitch was stuck at approximately 40% ahead, causing the vessel to accelerate.

The Master panicked and was unsure what to do, so he shouted on the radio to the mooring parties to get the lines ashore and stop the vessel. The forward mooring party managed to get the forward spring secured to a bollard but no other lines were attached. The pilot ordered the tug that was standing by beside the vessel, to push the vessel towards the quay. This caused the vessel to make heavy contact with the quay, but unfortunately did not slow it down enough. The vessel continued towards the lock at a speed of about three knots, the forward spring broke with a loud bang, and finally the vessel made heavy contact with the outer lock gate.

The vessel was boarded by port state and class inspectors. The vessel sustained damage to its bulbous bow, the tug sustained minor damage and the lock gates sank. Fortunately there were no injuries or pollution. However there were costly repairs to both the lock and vessel.

- Ensure that the OOW understands why it is important to test all equipment as per the checklist, both for departure and arrival. This highlights the importance of carrying out the checks required by the SMS.

- The Master did not save the vessel's Voyage Data Recorder (VDR) – this was done by a port state inspector two hours after the incident. Always save the VDR, as soon as possible after an accident. It is important to have procedures that ensure that any evidence of what may have caused an accident is not removed or cleared in order to understand and learn why the accident happened.

- Always try to establish why an accident happened so it can be shared with the fleet. The near misses that had been reported to the company were never acted upon – there is no point in having a near miss reporting system if nothing is then done about the reports. Near misses and best practices should be shared within the fleet.
