9

Injury

For more information about The Swedish Club Casebook
please contact Loss Prevention Team at
lossprevention@swedishclub.com

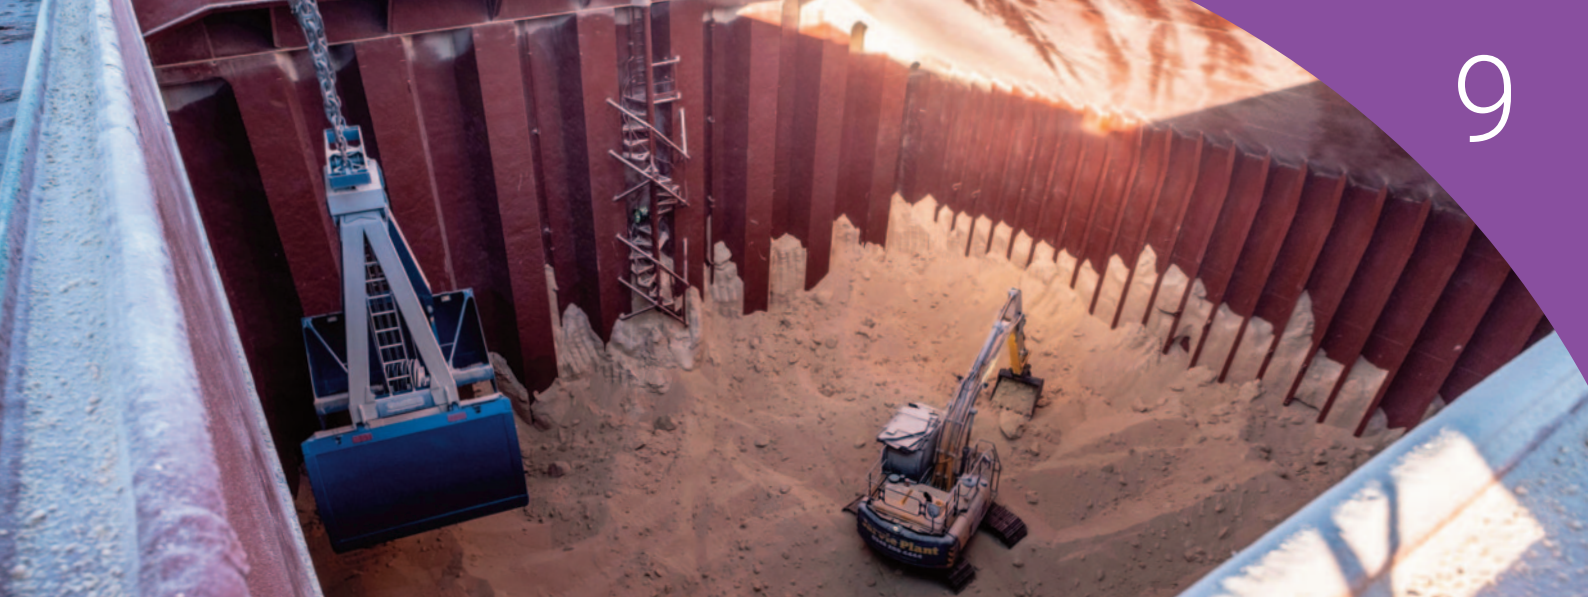
9.1 Fatal fall from ladder

Climbing up the last ladder he only used one hand as he had the tea cup in the other. He was not wearing a safety harness. When he was almost at the top he slipped and fell down. Unfortunately, he did not hit the platform below but fell more than 20 metres and landed at the bottom of the cargo hold.

It was later found that a steel bar was missing from one of the lower railings at the beginning of the spiral ladder. The railing was most likely damaged during the loading by one of the crane grabs, or an excavator as it was covered by the cargo when it arrived at the discharge port.

- After both loading and discharging, the Chief Officer should inspect the ladders to ensure they have not been damaged during the cargo operation.
- This accident highlights the minimal effort it takes to do a job safely, and the consequences of not making that effort.

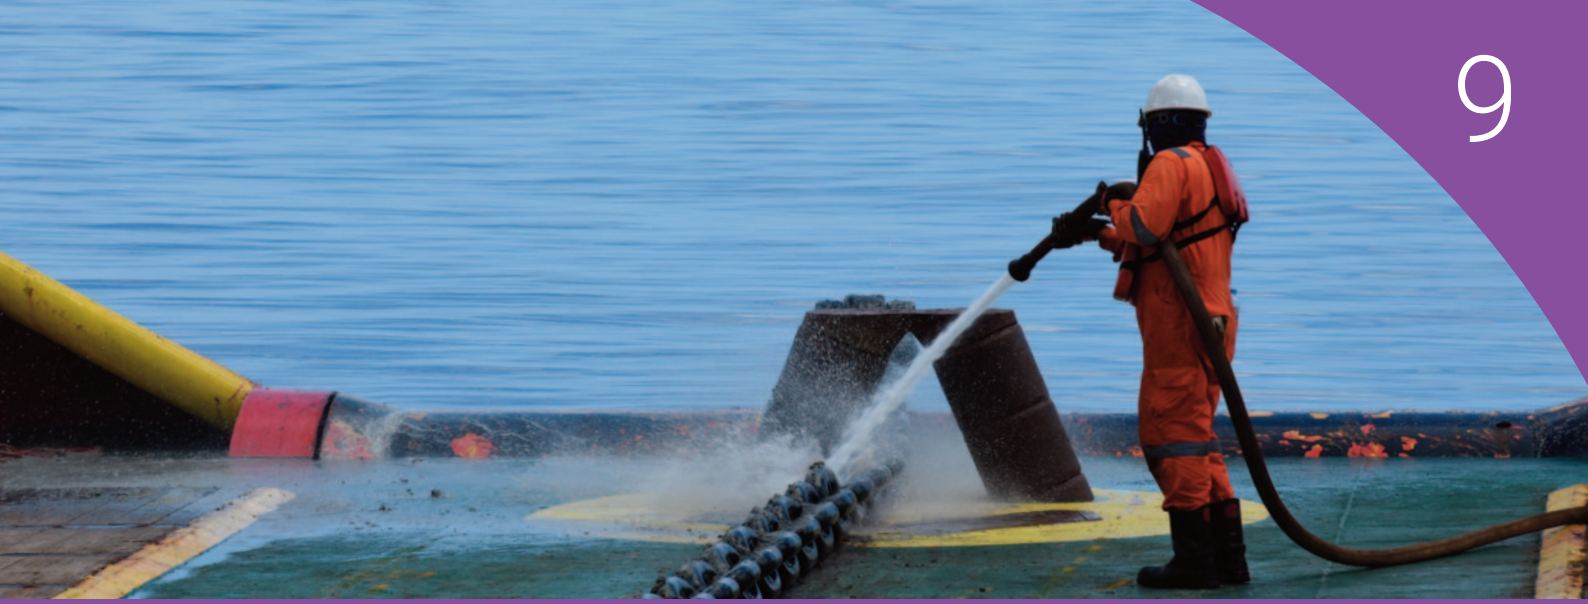
Lost balance while washing down caused serious injury

The harness became tangled with the fire hose and so the AB briefly unhooked it so he could untangle the safety cord. At the same time the pressure in the hose changed causing the AB to lose his balance and fall 16 metres down into the cargo hold.

- If two persons had been assigned for this job it would have meant that the AB could work on his assigned task by washing down and the other AB could assist with the hose.

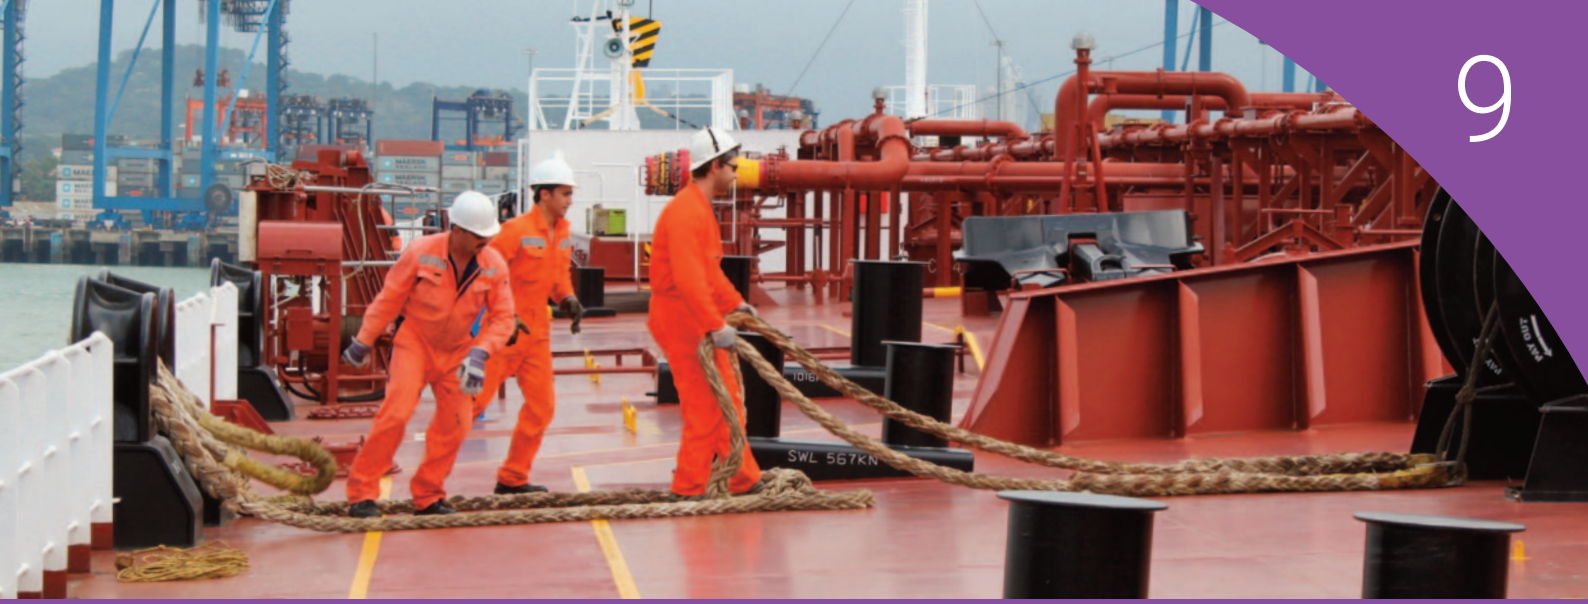
9.3 Injury during mooring operation

caught between the mooring line and the fairlead. The mooring line was now coming out very quickly and began cutting into the Third Officer's leg, with such a speed that his leg was cut off just below the knee.

- The vessel had a risk assessment for the mooring operation, but this did not include the risk of the mooring line getting stuck in the propeller, as the mooring line should be floating in normal circumstances. This time the mooring line was lowered too quickly, ending up under the surface. As the propeller blades were only 2 metres below the surface the lines were sucked into the propeller, which caused the accident.

- In addition the mooring line was partly around the bollard, with a bight and a right angle to the normal pull direction. This arrangement caused the snapback zone to cover the entire area between the bollard and railing. When the rope ran out rapidly and got caught in the propeller it snapped back to where the Third Officer was standing, even though he was not inside the normal snapback zone.

- This shows the importance of everybody involved in the operation being aware of the risks of potential snap back zones. Mooring a vessel is a normal operation, but the risks need to be evaluated every time, as it is a risk operation.

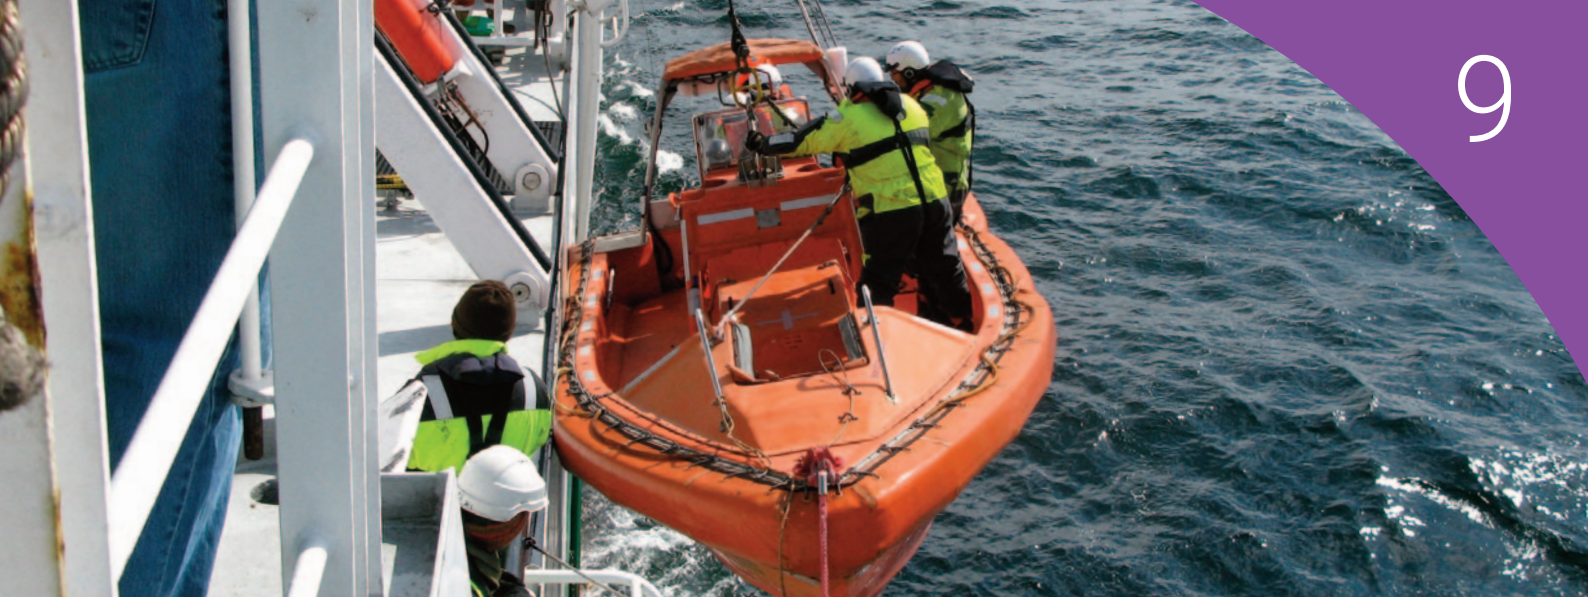
Rescue boat accident

This sudden increase in power caused the wire to break and the boat to fall more than 20 metres into the water, taking the crew members with it.

It transpires that the electronic proximity switch was not working because moisture had penetrated the electronics. This happened when the rescue boat was washed down using the high-pressure hose - the proximity switch's electronic cover was also washed down and moisture entered the system causing a short circuit.

- The over-compensation by the winch motor causing the wire to break may have been prevented if the correct fuse had been in place.
- According to the manufacturer's manual, the winch operator should stop the winch before the proximity switch is activated. There were no marks on the davit to indicate to the operator when to stop.
