Corroded pipe causing oil spill

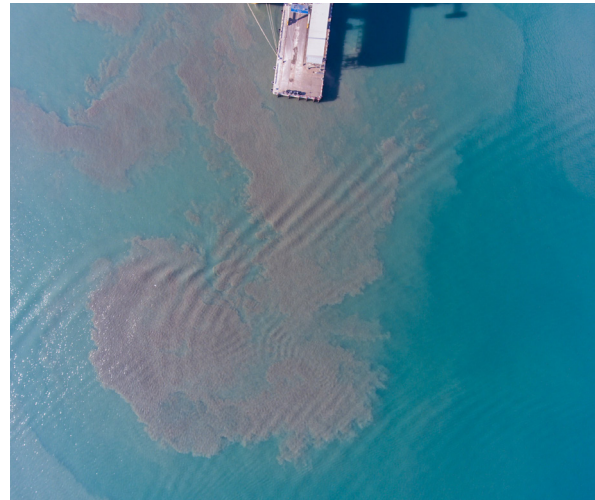
The OOW, who was in the cargo office, came out on deck to see what the AB was talking about. After a couple of minutes the OOW could see oil trickling down the side of the hull.

Straight after this the OOW ran out on deck again and the Master and Chief Engineer were already there. Oil was still trickling down the side even after bunkering had stopped. The Chief Engineer realised that the oil was escaping from the HFO tank, which was being bunkered and told the duty engineer to transfer all bunker from that tank into another empty HFO tank. When almost the entire bunker had been transferred the trickling ceased.

When all the bunker had been transferred and the tank was safe for entry, it was decided to inspect the HFO tank. The crew entered the HFO tank and discovered that the de-aeration pipe was fractured.

It was discovered that the pipe in the HFO tank had been fractured when the section in the cargo hold had been replaced causing stress to the section in the HFO tank. This caused HFO to enter the fractured section causing pollution.

The crew made temporary repairs to the pipe, but permanent repairs had to be completed at a shipyard.

- All pipes onboard the vessel should be included in the PMS and inspected at regular intervals to ensure there is no significant corrosion.
- There is a risk when a section of a pipe is replaced that this will cause fractures on the sections that have not been replaced.
- Pressure testing should be carried immediately after work has been carried out on any pipework. The thickness of the entire pipe should be measured.
- It is strongly advised that no pipes other than fuel pipes pass through bunker tanks. Other media passing through fuel tanks can lead to contamination of the bunker as well as contamination of other media.
