## Pollution

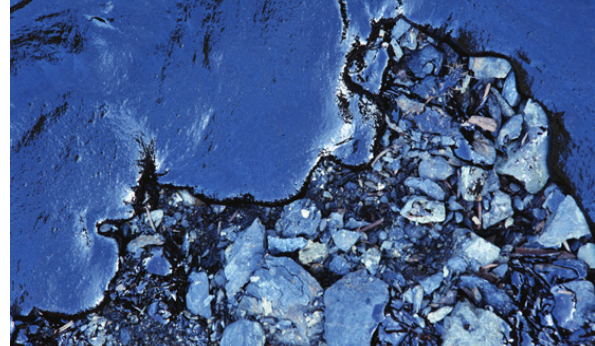
The fourth engineer was left in charge alone but without any means of communication with the barge or bridge. He was in charge of both the soundings on deck and of the fuel valves in the engine control room. He panicked while monitoring the loading of fuel into the second tank because he thought there was a risk of the tank overflowing which was not the case. He tried to contact the barge and chief engineer unsuccessfully. He then decided to close the valve at 50% and open the valve slightly to the first tank. The volume in the first tank was at 87% and the second tank was at 71%.

The fourth engineer then tried to contact the barge again to suspend the bunker operation but once again was unsuccessful. As there was no action taken on the barge or on the vessel itself the second tank finally overflowed through the sounding pipe and contaminated the vessel's deck and water in the harbour. At the time of the overflow it was raining heavily, causing the fuel on deck to overflow into the harbour. The pollution was contained in the vessel's vicinity by a mooring rope that was laid on the surface. No oil boom was placed around the vessel prior to bunkering. To stop the overflow the tank valve was closed and a wing tank valve was opened. Shortly afterwards the bunker operation was suspended and the barge left the vessel.
