# Container vessel made heavy contact with a wharf

A container vessel finished loading cargo at a container terminal on the morning of the accident date. Following loading, the plan was to depart later that morning for another port to load additional cargo.

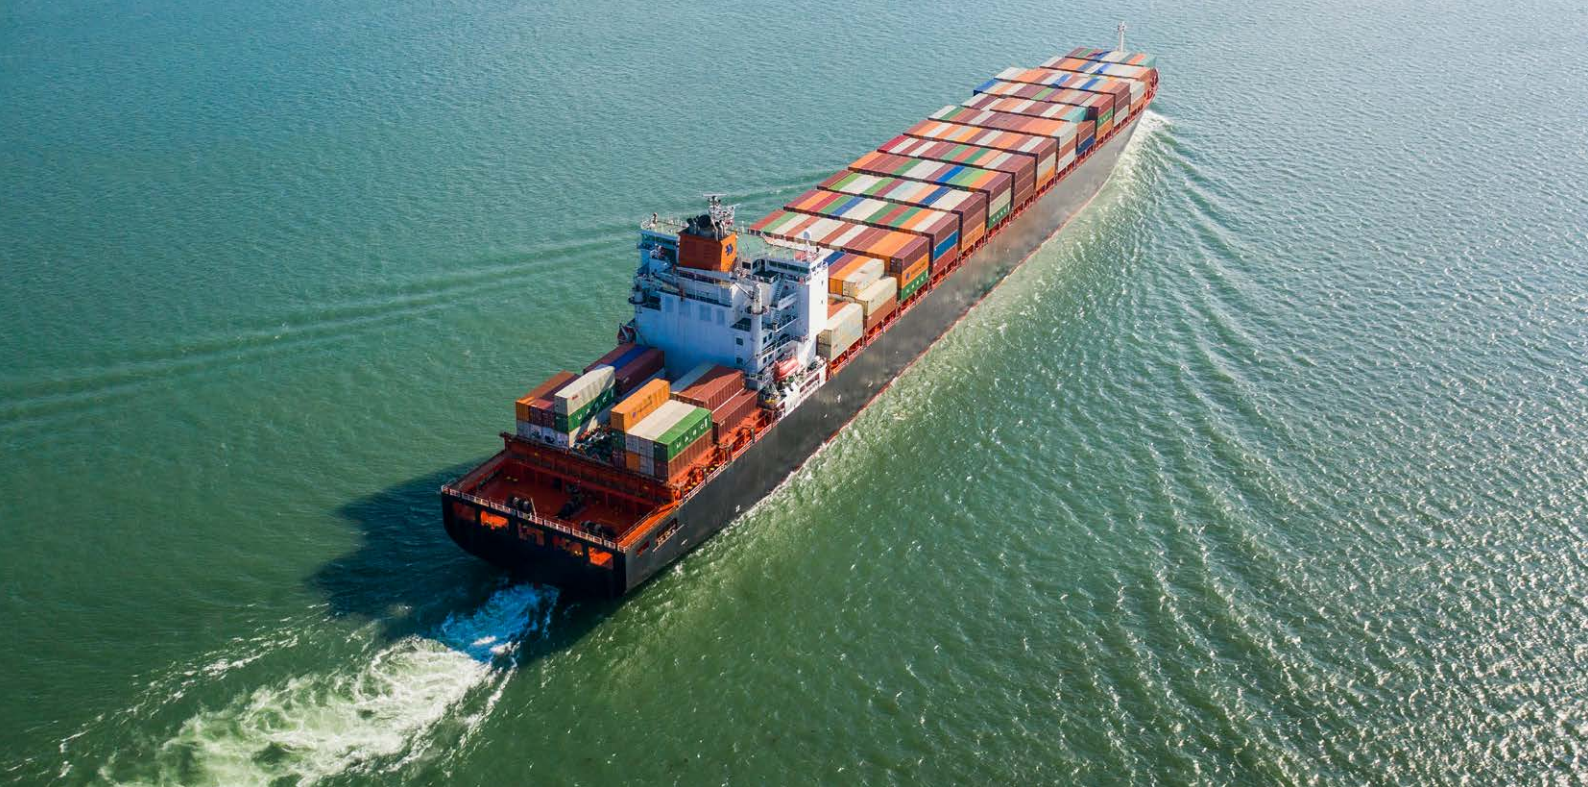
**Tug and Bow Thruster Used:** At the pilot's command, Tug A pulled the vessel's stern off the quay while the bow thruster

pushed the bow to starboard, moving the vessel out and parallel to the berth.
