# Severe Mooring Incident on container vessel

A large container vessel was preparing to depart a berth at a major seaport in the afternoon. After completing cargo operations, the vessel's crew readied the ship for departure. Port movements had been delayed due to weather conditions, but once conditions improved, it was cleared to proceed.

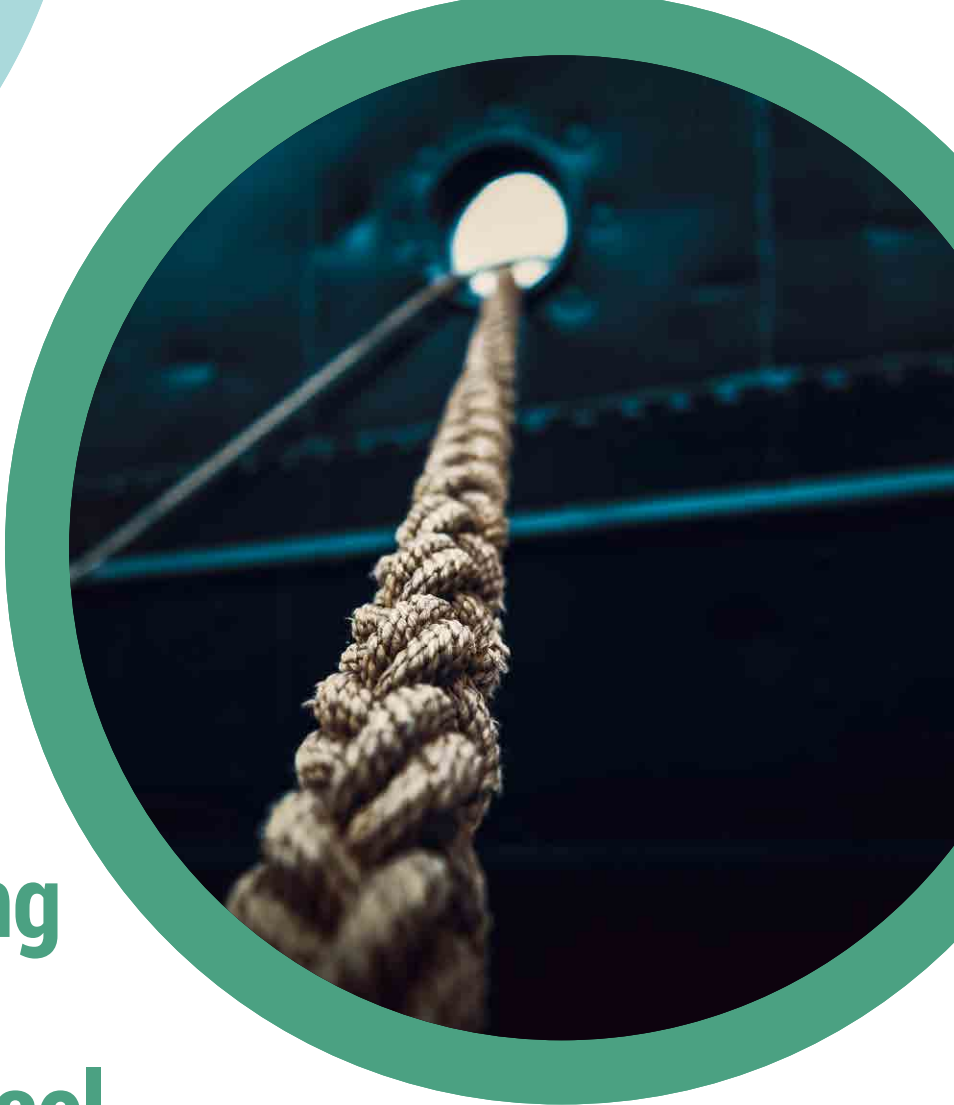
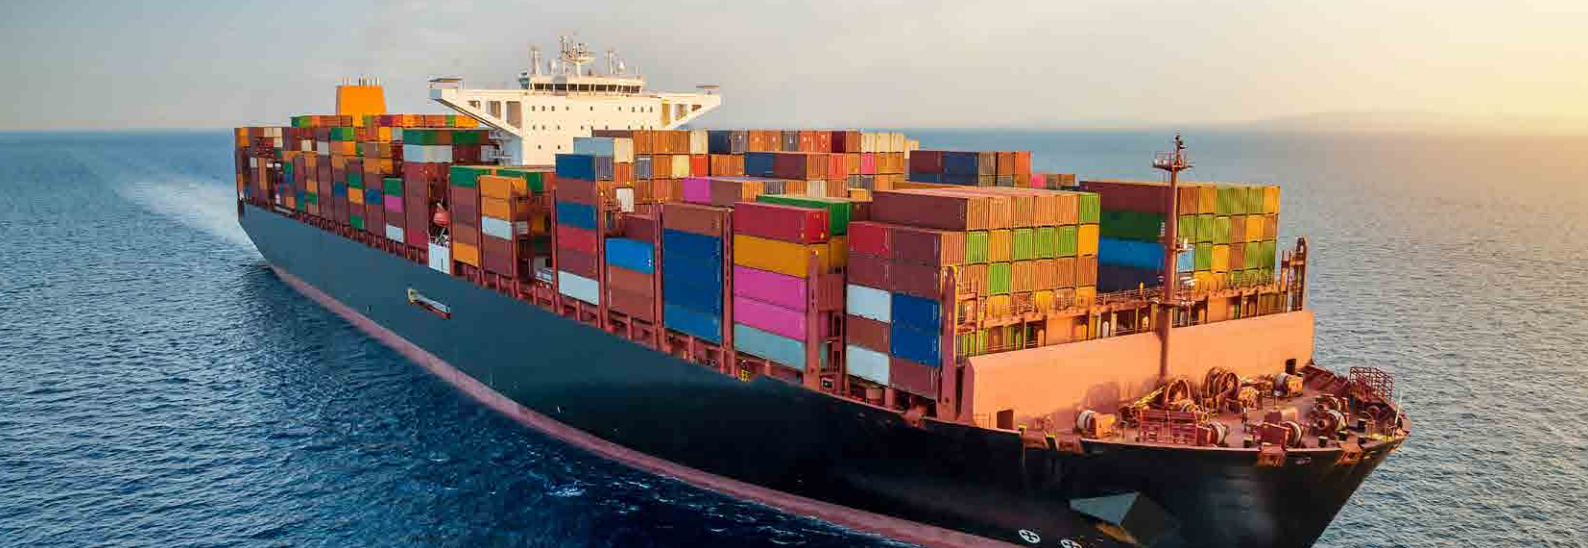
Before the rope stopper could be properly engaged and without any clear signal from the vessel, the tug began to move away. This premature movement dramatically increased tension in the line, which had not yet been fully secured.

Under sudden and excessive strain, the line stretched taut, jumped from its intended lead, and snapped back violently. The Carpenter, partially prepared to avoid the recoil, was still

struck and thrown to one side. The OS, positioned closer to the snapback path, was hit with full force.
