Case Study - Leaking Cargo Hold Hatch

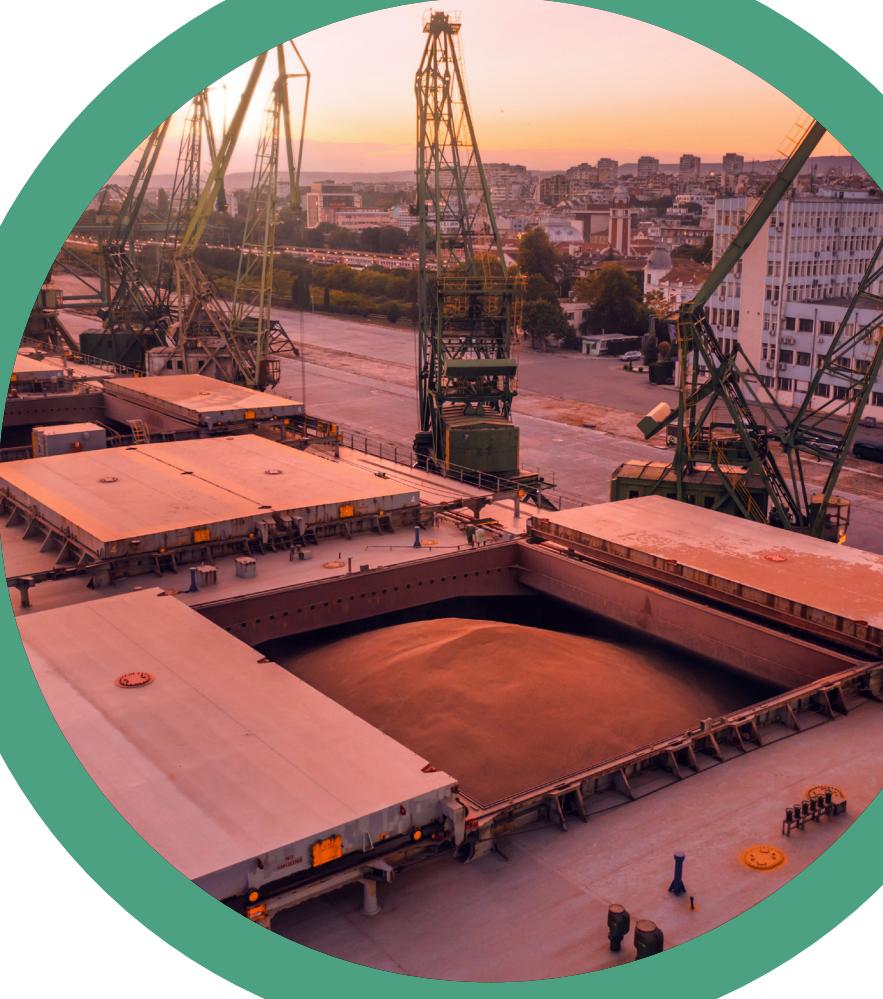
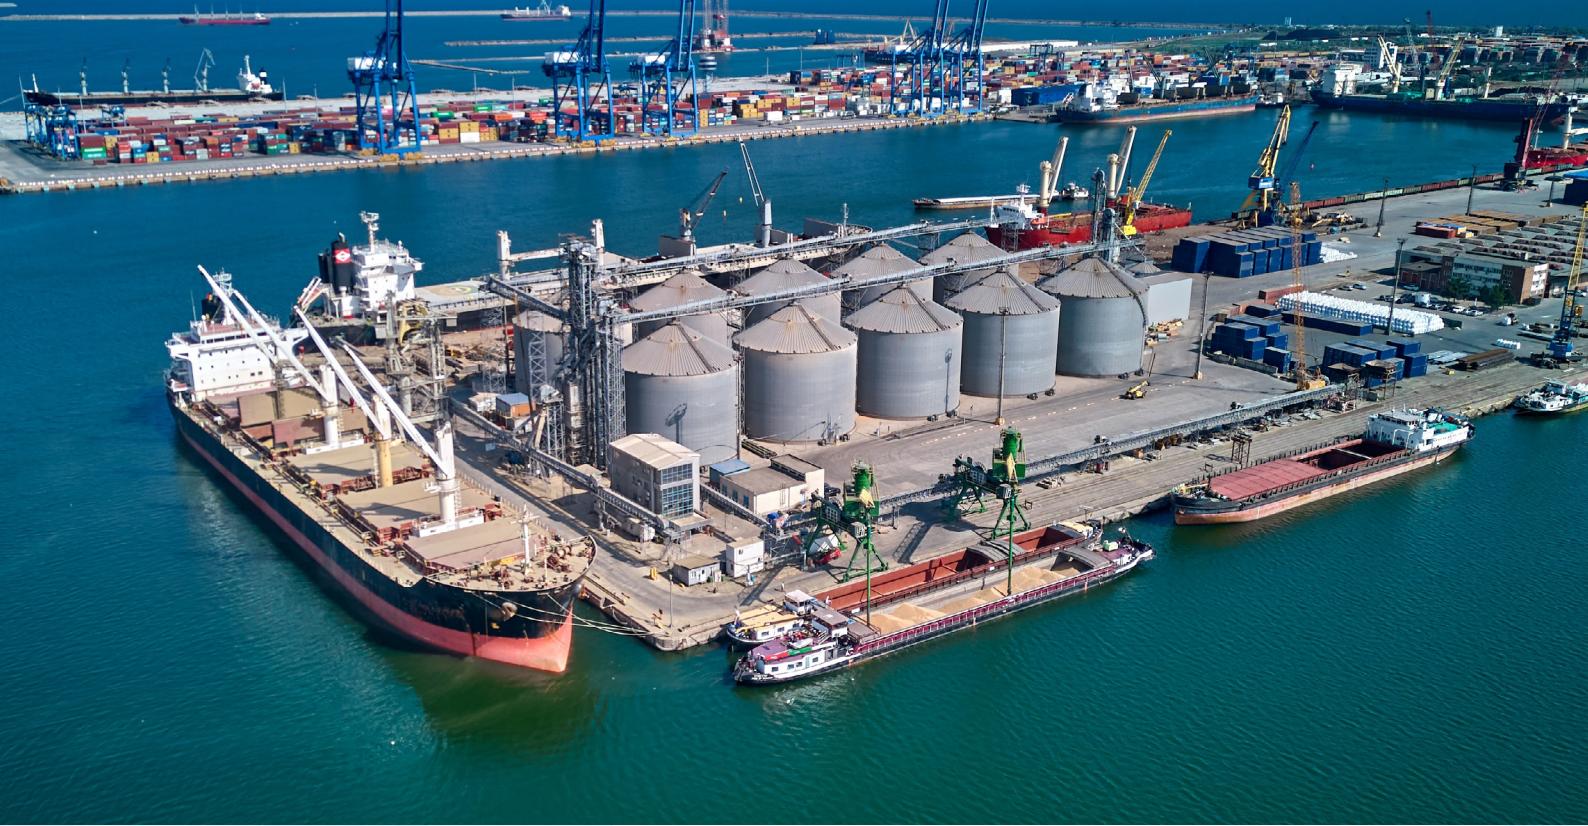
Upon arrival at the discharge port, inspection revealed seawater traces on the inner hatch coaming plating of cargo holds 1 and 2. The forward location of these holds made them more exposed to shipping seas during the storm. Cargo damage was confirmed: grain beneath the hatch panels on the starboard side had suffered wetting and mould damage. A joint survey was conducted, including ultrasonic and chalk testing of the hatch cover arrangements.

The ultrasonic test showed that the cross-joints between forward and aft hatch cover panels of hold no. 1 were leaking. In addition, chalk tests on hold no. 2 confirmed poor compression between sealing rubbers and the cross-joint compression bars.

The surveyor noted that several gasket sections were aged and should have been renewed. Sealing rubbers require replacement of entire lengths once deteriorated as isolated patch repairs are no longer regarded as acceptable. The remaining cargo holds were in satisfactory condition and discharged without incident.
