Case Study - Dragging anchor led to collision

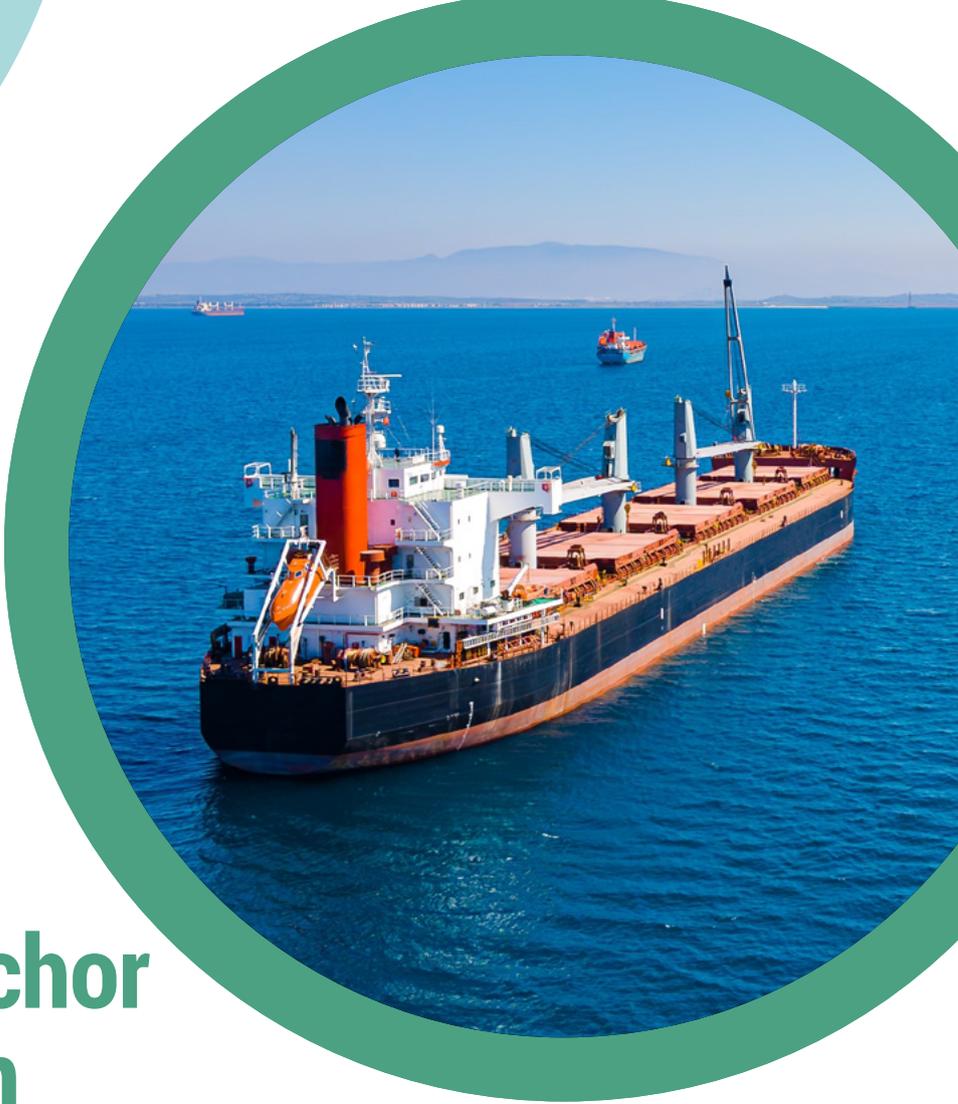
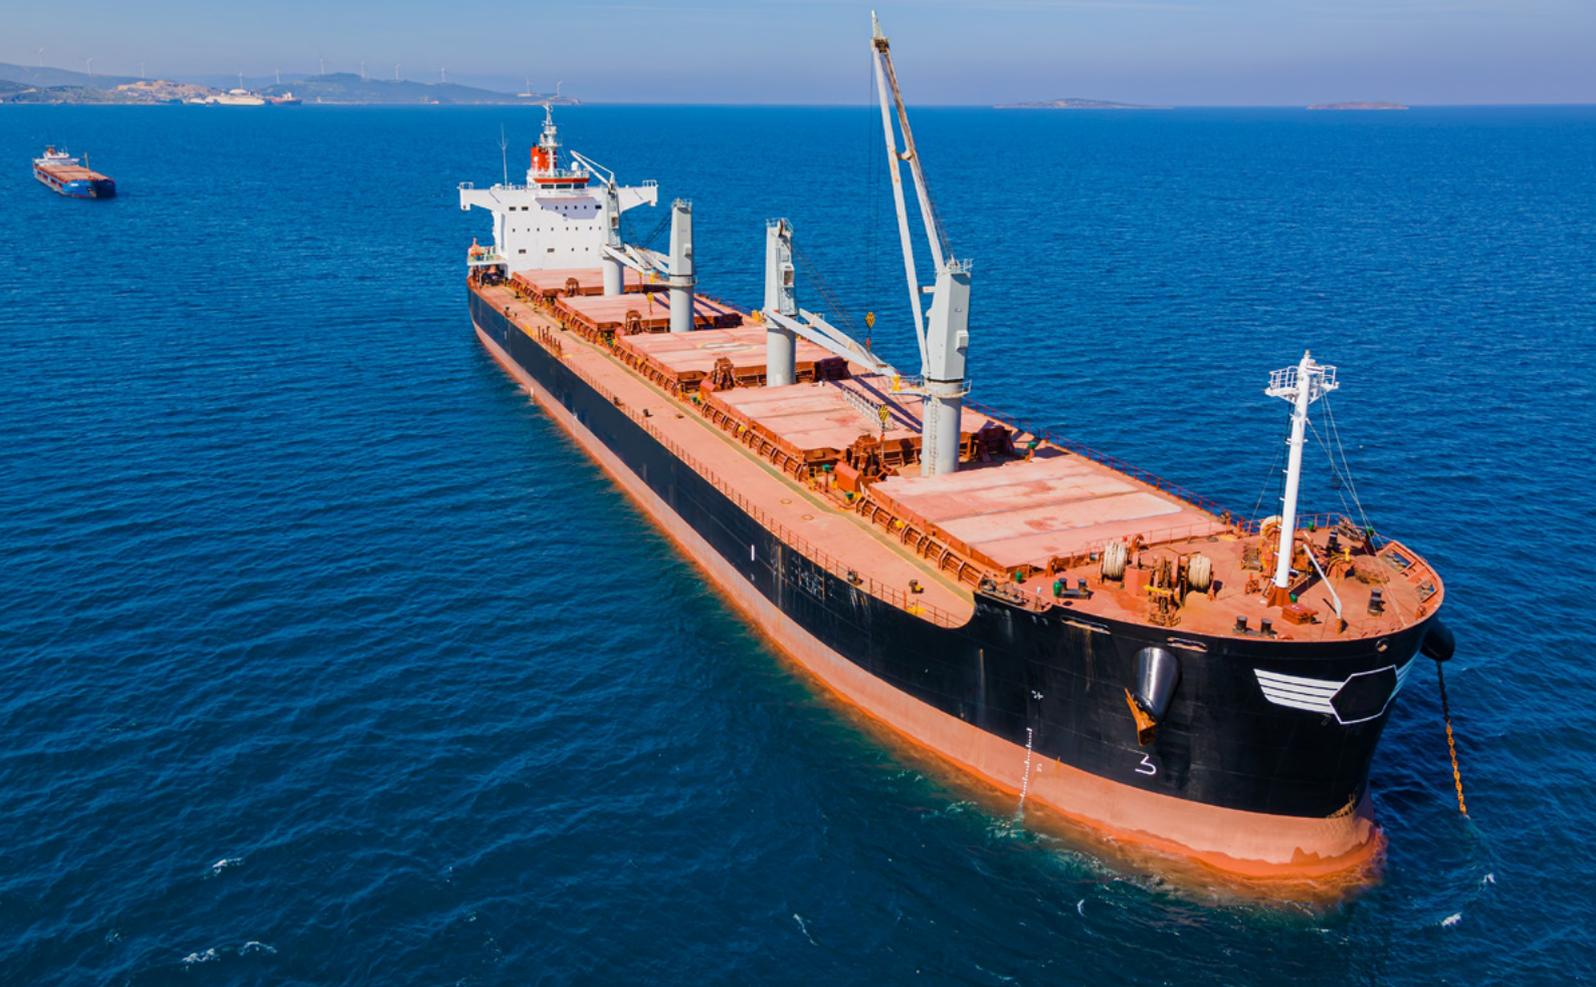
Approximately one hour later, at 17:34, vessel A started to drag, quickly accelerating to a dragging speed of 1.0 knots and subsequently 2.0 knots towards vessel B. The crew attempted emergency measures, including preparing the main engine and heaving the anchor. However, delays in bringing the main engine into operation

and ill-considered manoeuvring worsened the situation. Ultimately, at 17:53, vessel A collided with vessel B, making contact on her port side amidships area.

The collision resulted in significant damage, including breaches to ballast tanks on Vessel A and damage to the bow and starboard anchor of vessel B. Fortunately, there were no injuries or pollution incidents reported.

Heave up the anchor and leave the anchorage if these environmental loads are exceeded:

Sheltered waters:

- Current velocity: max. 2.5m/s
- Wind velocity: max. 25m/s.

- No waves (sheltered waters)

Outside sheltered waters:

- Current velocity: max 1.5 m/sec
- Wind velocity: max 11 m/sec
- Significant wave height max 2 m
