Case Study - Wrong charts lead to grounding

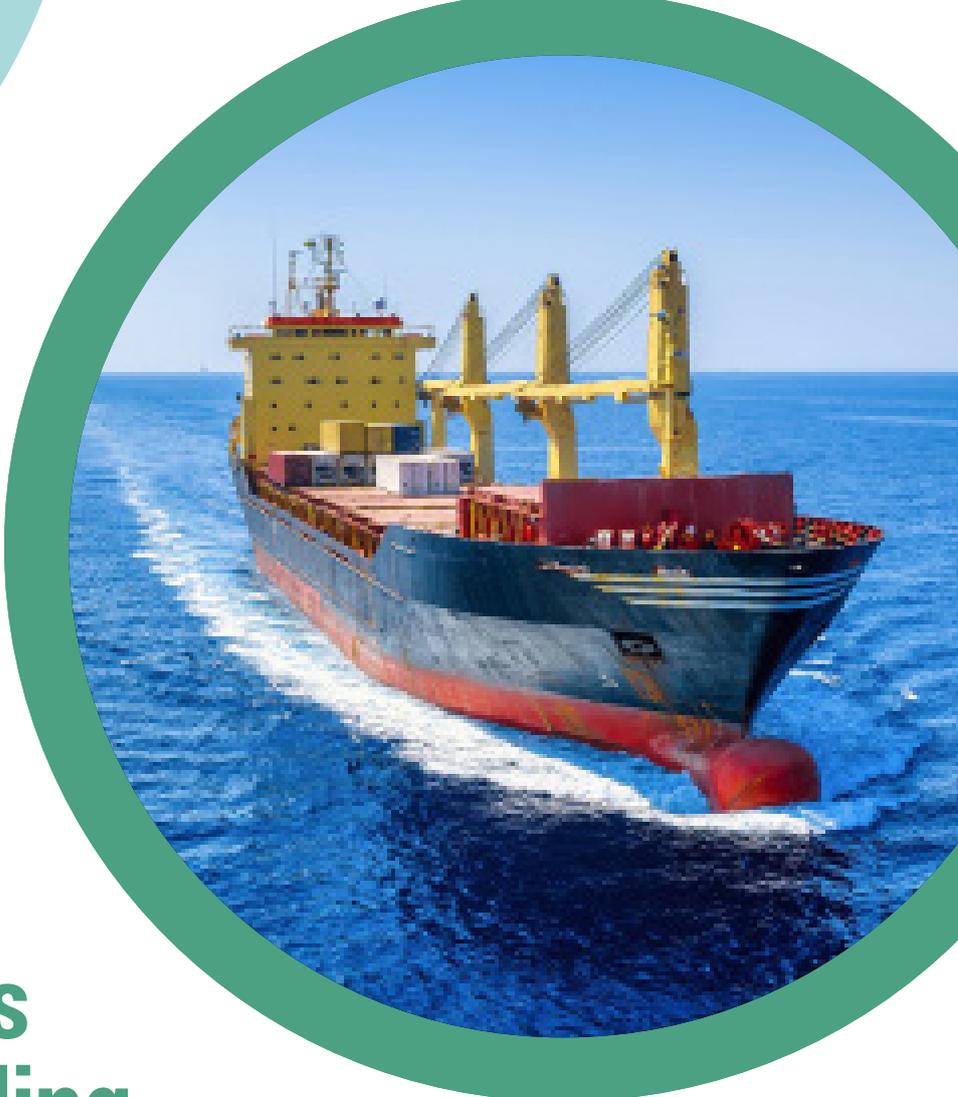
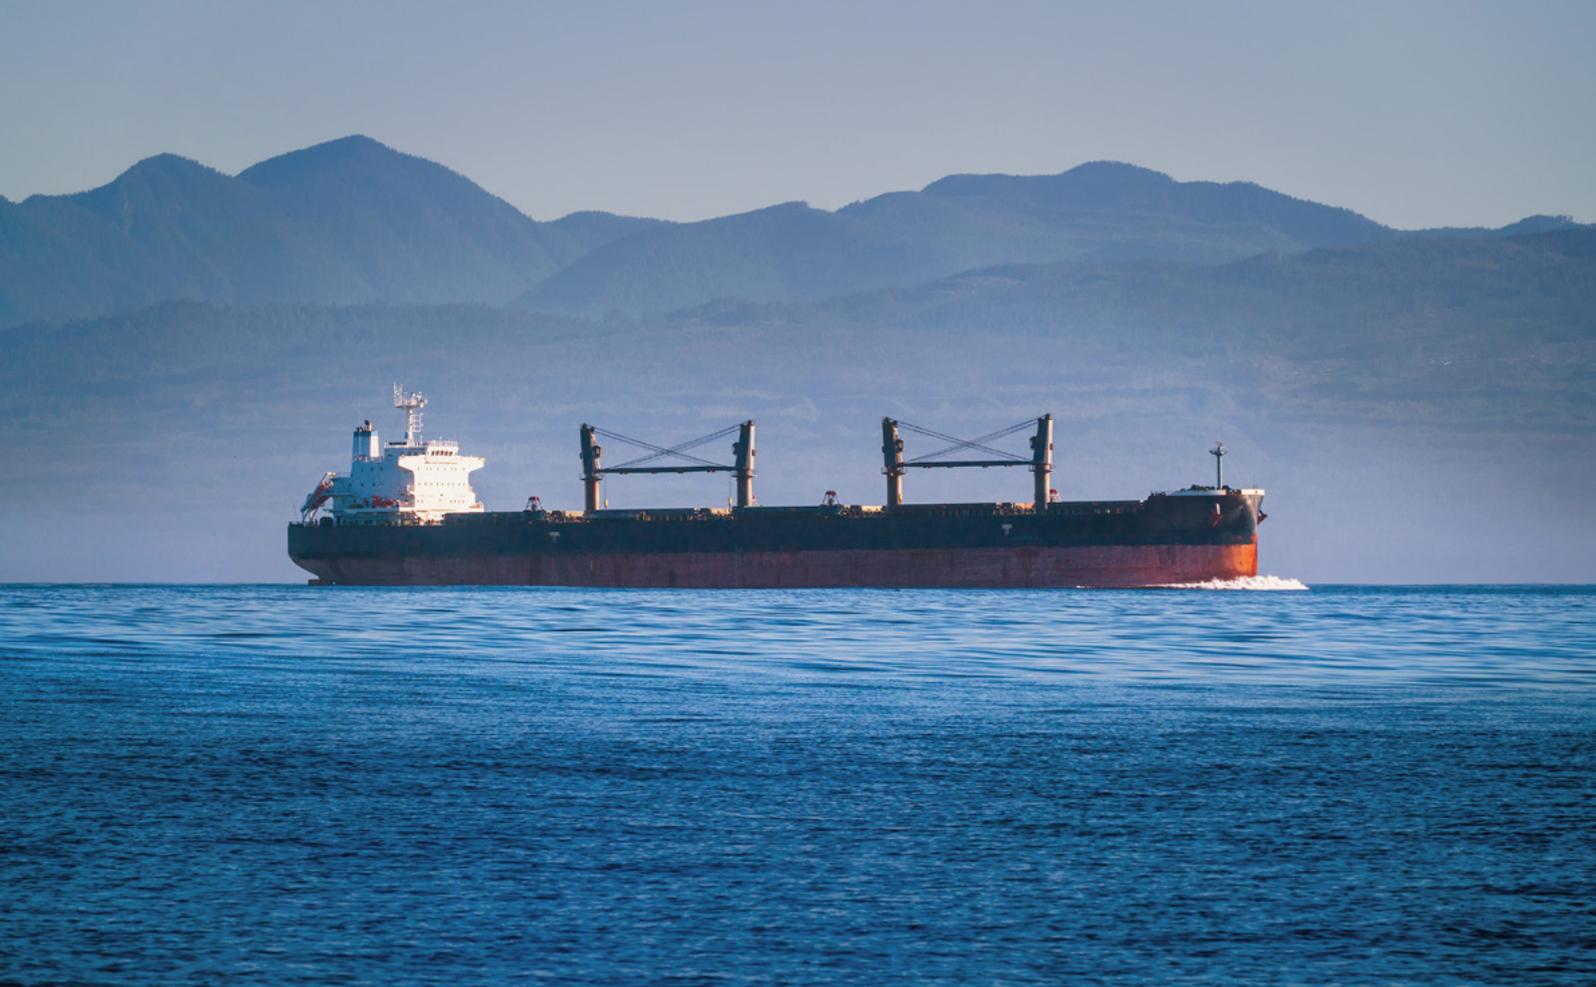
to insufficient river depth, claiming incorrect tidal information, despite the vessel's ECDIS indicating a position significantly to port of the charted channel centerline. AIS data subsequently verified the vessel was approximately 80 meters from the channel axis and 30 meters beyond the channel limit at the time of grounding.

Investigations highlighted significant discrepancies between the vessel's ECDIS display and the pilot's personal tablet-based ENC chart, which displayed

the vessel inaccurately positioned within the channel boundaries. Preliminary surveyor findings indicated that the grounding was most likely due to the out-of-date chart utilized by the pilot.

It was noted that the electronic charts displayed on the pilot's and salvage master's tablets were not official navigation charts. According to maritime rules, the only official charts recognized are those displayed on certified ECDIS equipment or official paper charts issued by a recognised hydrographic service.
