4.1

Collision as vessel was overtaken

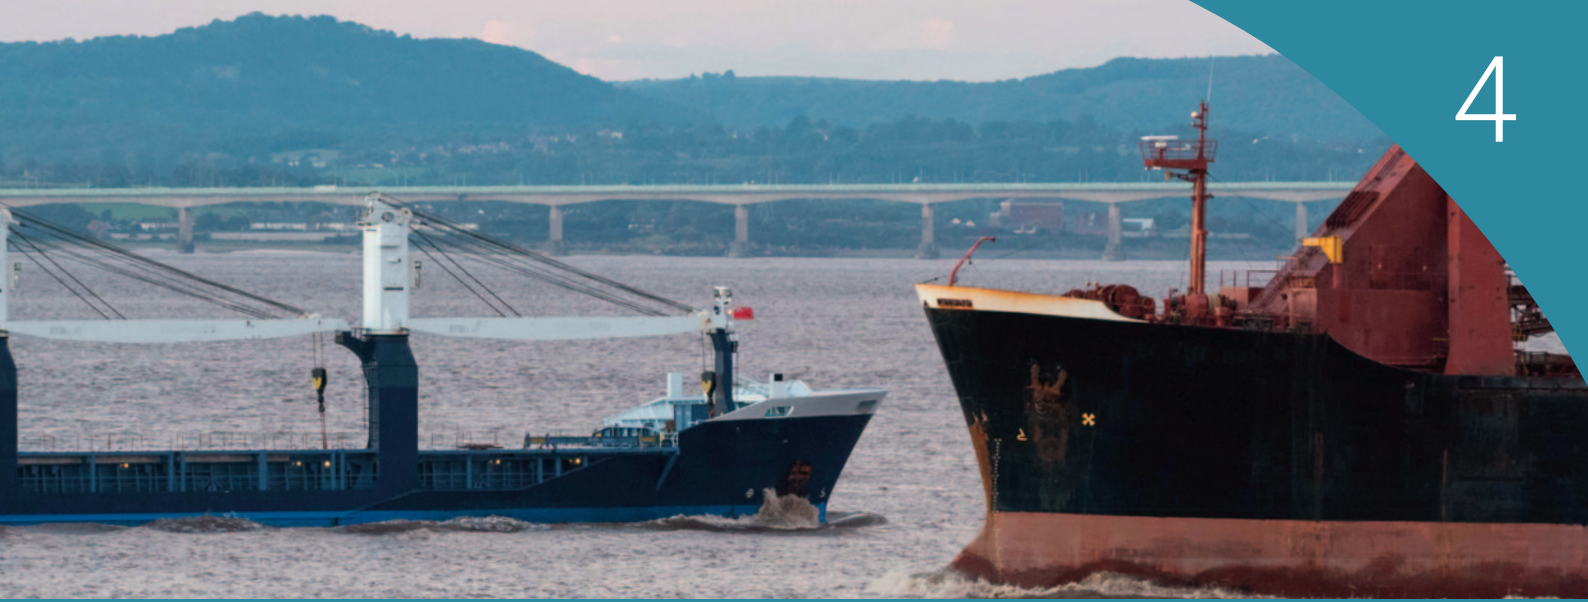
Soon after the collision the Master came onto the bridge. He noticed that the engines were still full ahead and the rudder was hard to starboard, but the vessel was not turning. He reduced the engines to 60%. Vessel A was not moving. Vessel B had struck vessel A on the starboard side in way of cargo hold 2. After a while vessel B moved astern, and the vessels disengaged. The Master contacted vessel B but the OOW on vessel B responded that they had only been involved in a near miss. After a while they admitted that they had been involved in a collision.
