4.5

Collision due to miscommunication when approaching port

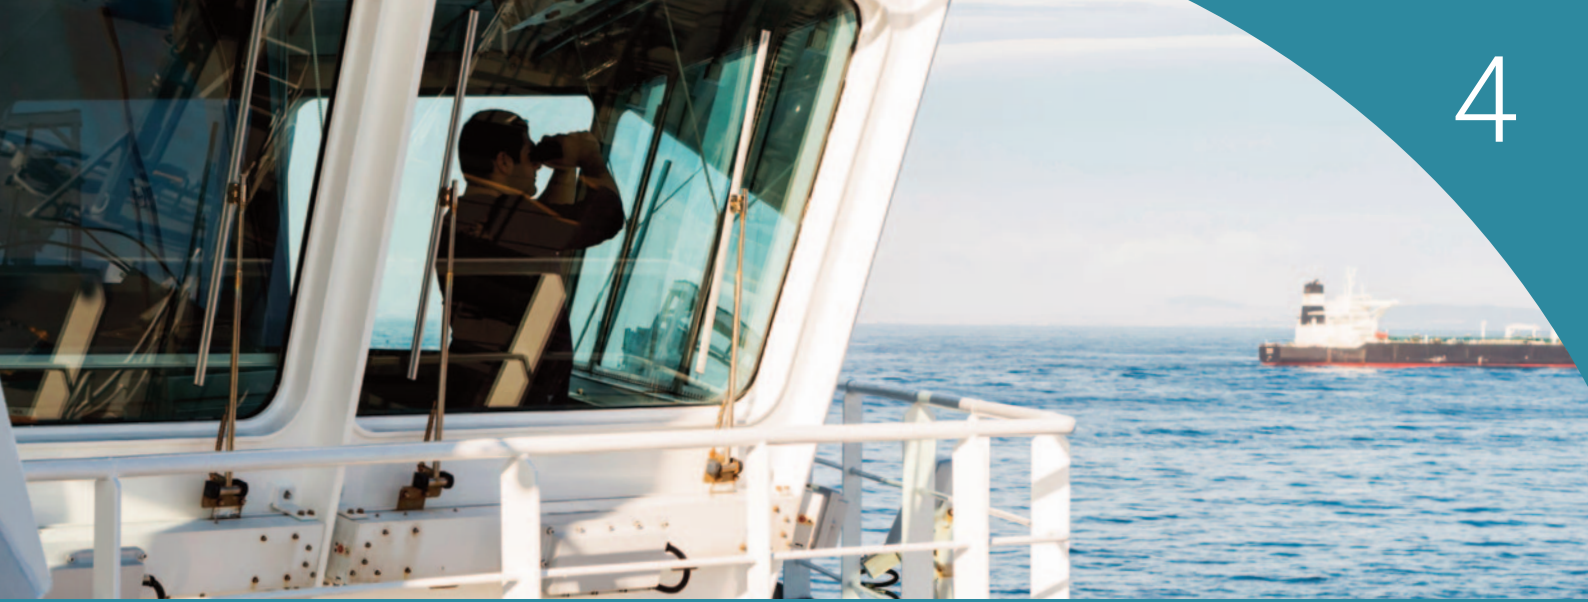
C -2 minutes: When vessel B was about 0.5 NM off the starboard bow it started to alter to starboard and towards vessel A and the red side light on B could be seen. The pilot on vessel A was alarmed by vessel B and called on the VHF and yelled 'green to green vessel B' and at the same time ordered hard to port and stop engine. An officer on vessel B replied, 'too close have to pass port to port' and continued to alter to starboard.

Collision: The pilot on vessel A ordered hard to starboard and full astern but it was too late, and the vessels collided. Vessel B's port side shell plating was torn open from cargo hold 2 to cargo hold 6.

Reviewing the radar screenshots recorded by the VDR on vessel A shows that the vessels were positioned to make a safe 'starboard to starboard' passing had they kept their courses. At this point there was no risk of collision. However, just before the vessels began to pass each other, vessel B called 'port to port' on the VHF and altered starboard to cross ahead of vessel A. The distance between the two vessels was about 0.5 NM when vessel B called port to port. The sudden starboard alteration by vessel B changed a safe starboard-to-starboard passing into a risk of collision. Vessel B caused a risk of collision to arise.

Vessel B was outside of the fairway and then suddenly altered to starboard at a distance of 0.5 NM and tried to cross ahead of vessel A, which is in violation with (d).
