## 4.3

## Collision in river

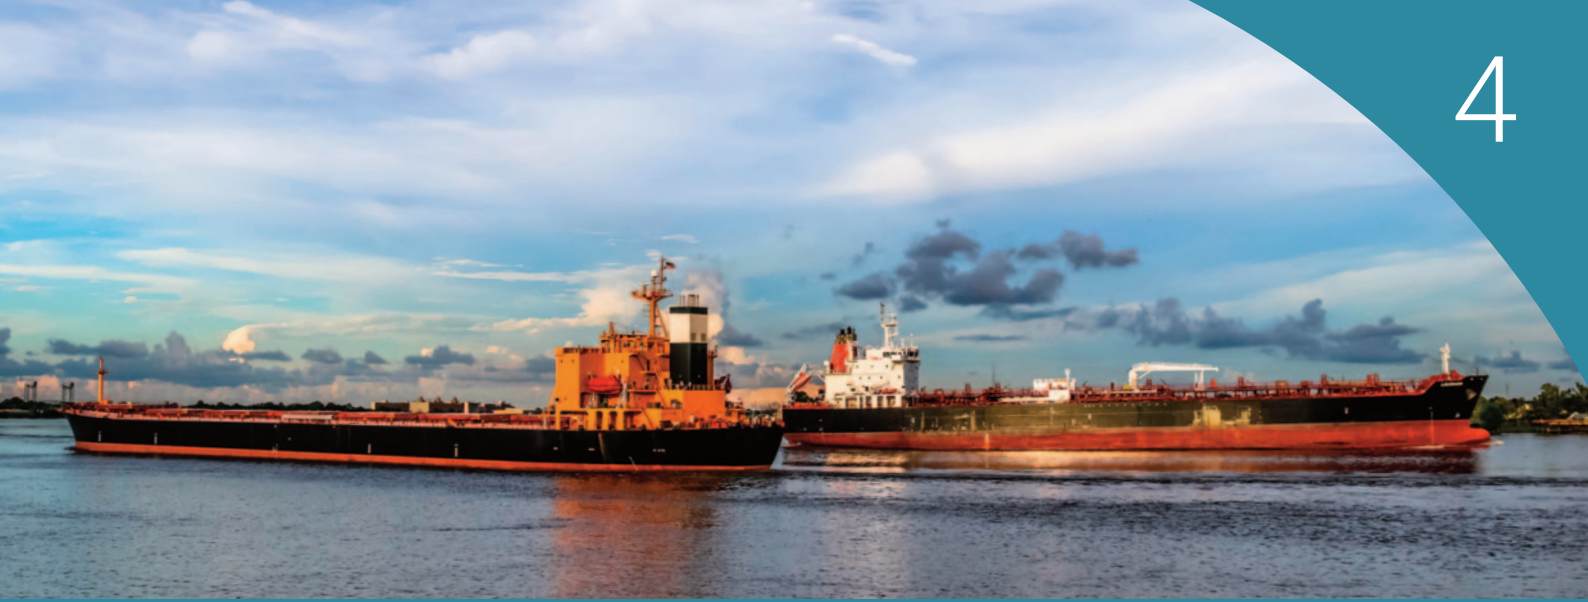
It was the middle of the night and vessel A, a 6,500 TEU container vessel, was sailing out from a port in a busy river with a pilot conning the vessel. The weather was fine with clear skies and winds at around Beaufort scale 6. All navigation equipment on vessel A was in good working order except for the AIS transceiver, which was not working.

Vessel A was on an easterly course in the outbound deep-water channel of the river fairway. Vessel B was proceeding on a reciprocal course in the inbound fairway of the river. The vessels were in sight of each other. The Master, Chief Officer, lookout, helmsman and the pilot were on the bridge of vessel A.

Vessel B, a handymax bulk carrier, then reduced speed in order to time arrival for its berth. However, the bridge team on vessel B underestimated the impact of the wind and current, and the vessel was set towards the outbound fairway and its heading altered to port and towards vessel A. This caused vessel B to enter the outbound fairway.

Vessel A was sailing in the fairway of the extended deep-water channel but towards the centreline between the inbound and outbound fairway. The bridge team saw that vessel B had slowed down and that its heading was changing towards them.

There was some room for vessel A to turn to starboard and still remain in the fairway, but it was limited. The vessels were approaching each other, and vessel A was not able to turn to starboard and clear vessel B and still remain in the fairway.

The pilot on vessel A flashed the signal lamp and called vessel B on the VHF but vessel B did not respond. The pilot ordered full astern and tried to alter course to starboard with the bow thruster. This did not prevent the collision. The Master on vessel A saved the VDR data after the accident. There were no injuries or pollution.

- If we look at this case from vessel A's point of view, there are several problems in this collision which could have been resolved if the pilot had clarified the intentions of vessel B.

- It is important to continually evaluate all traffic, especially if the vessel is in a congested area such as approaching or departing a port. In the port state investigation, vessel A was found to be positioned close to its starboard side of the fairway, and this was identified as a fault. However, vessel B was found to be preponderantly to blame. The bridge team was not maintaining a proper look-out, they did not respond on the VHF and vessel B failed to stay clear of vessel A as it drifted into the opposite side of the fairway. The investigation also raised the issue of vessel A not having a working AIS.

- It is important that the bridge team has a departure briefing, where different scenarios are discussed, and the potential risks identified. When the pilot boards, the Master should discuss the plan for the pilotage. It is also important that the Master asks about local regulations, concerned traffic, expected currents and winds, and knows what the passing requirements are and how the pilot plans to approach the departure. If the local language is spoken the pilot must share the conversation, in English, with the bridge team.
