4.7

Contact while berthing in river

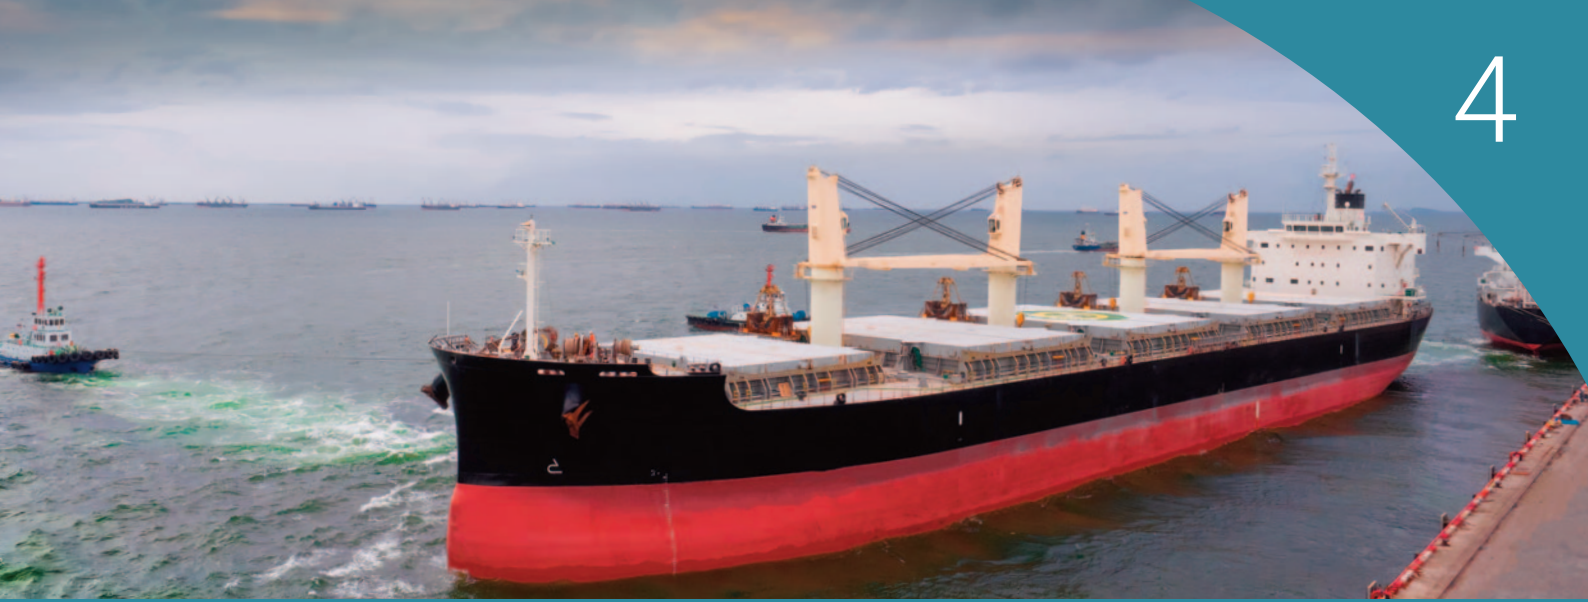
During the berthing the Chief Officer was by the radar and the ECDIS on the bridge, monitoring progress. The vessel had a speed of about 2 knots over the ground in the river and was on a NNW course. There was a strong SSE current at around 2-3 knots and a NE wind at Beaufort scale 3. During the final berthing manoeuvre the vessel passed one of the berthed vessels with only 20 metres clearance on the portside. The wind set the vessel towards the berthed vessel.

Despite the Master's efforts to turn the bow to starboard the vessel continued turning to port and the bow collided with the berthed vessel. The vessel's superstructure was forward, so the bridge wing also caused damage to the berthed vessel.

- When the Master approached the berth, he should have evaluated if the available tugs should be used or not. If he was unsure about the clearance, he should have asked the pilot for tug assistance before berthing.

- It is important that the Master and pilot discuss what is anticipated and how to carry this out in the safest way. When the vessel was sailing up the river there were strong currents and some wind. During the manoeuvre the Master had the conn but needed constant updates from the pilot and Chief Officer about how strong the current was. These discussions should also have taken place during the pilot briefing. Having an NNW course and NE winds on the starboard bow will push the bow to port, especially when the vessel is lining up for the final approach and altering slowly to port and slowing down. The current will also make the approach more difficult as more power must be used during the final manoeuvre as the current would push the bow to starboard.

- The entire bridge team should be involved in berthing. In this instance the Chief Officer was by the radar and ECDIS and was the person who could have informed the Master about changing current or wind. The current also took the pilot by surprise. An efficient bridge team are assigned roles where they all know what they are expected to do and what the other persons are supposed to do. If someone makes a mistake this should be identified by a member of the bridge team. The Chief Officer was on the bridge and he should have supported the Master with information. This is further explained in the Club's **Bridge Instruction** booklet.
