4.8

Excessive speed when approaching berth

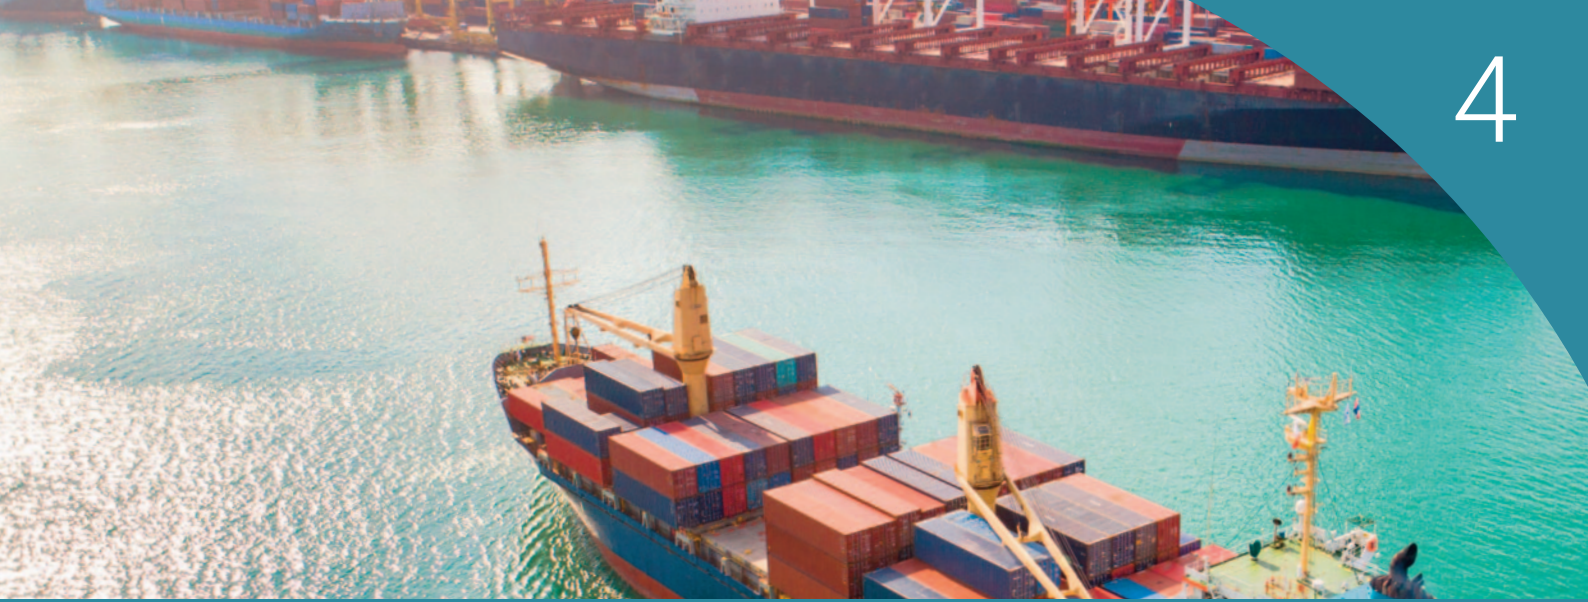
The vessel started to alter to port and was facing the berth at a 90 degree angle when it was only 50 metres away. The pilot realised the danger and ordered slow astern and hard to port, followed instantly with full to port on the bow thruster. As the speed was excessive for the bow thruster nothing happened.

At the same time the Master realised that the vessel was not slowing down so he ordered the port anchor to be dropped and full astern on the engines. It was too late, and the bulbous bow hit the quay at a 90 degree angle.

The vessel had to dry dock and repair the bulbous bow. The berth also needed extensive repairs.

- The vessel was approaching at excessive speed. Maintaining a speed of 9 knots when starting to swing around and as close as 50 metres highlights that the berthing plan was not safe and that the bridge team had not planned it accordingly regarding wind and speed.
- The Master did not challenge the pilot until it was obvious that the vessel would make heavy contact with the quay. It is imperative during the pilot briefing that the approach is discussed in detail with the entire bridge team, so orders can be challenged if there is concern.
- Two tugs were standing by but were not connected. Once again, if the vessel had slowed down and had the tugs connected the berthing manoeuvre would have been controlled. If tugs have been ordered why not use them?
