# Case Study - Catastrophic Engine Fire Caused Serious Injury

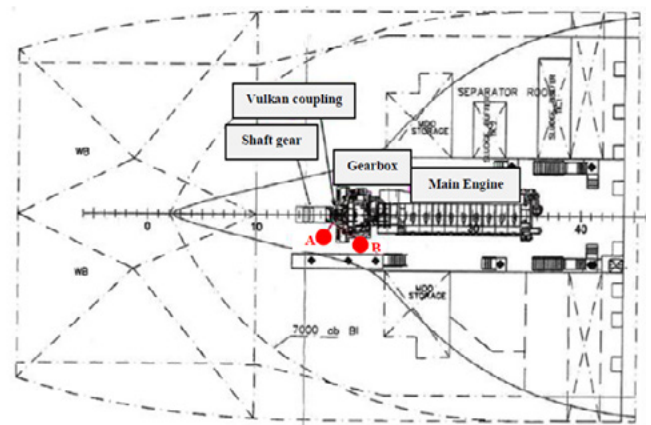
Figure 5a: Relative position of the chief engineer (A) and the wiper (B)

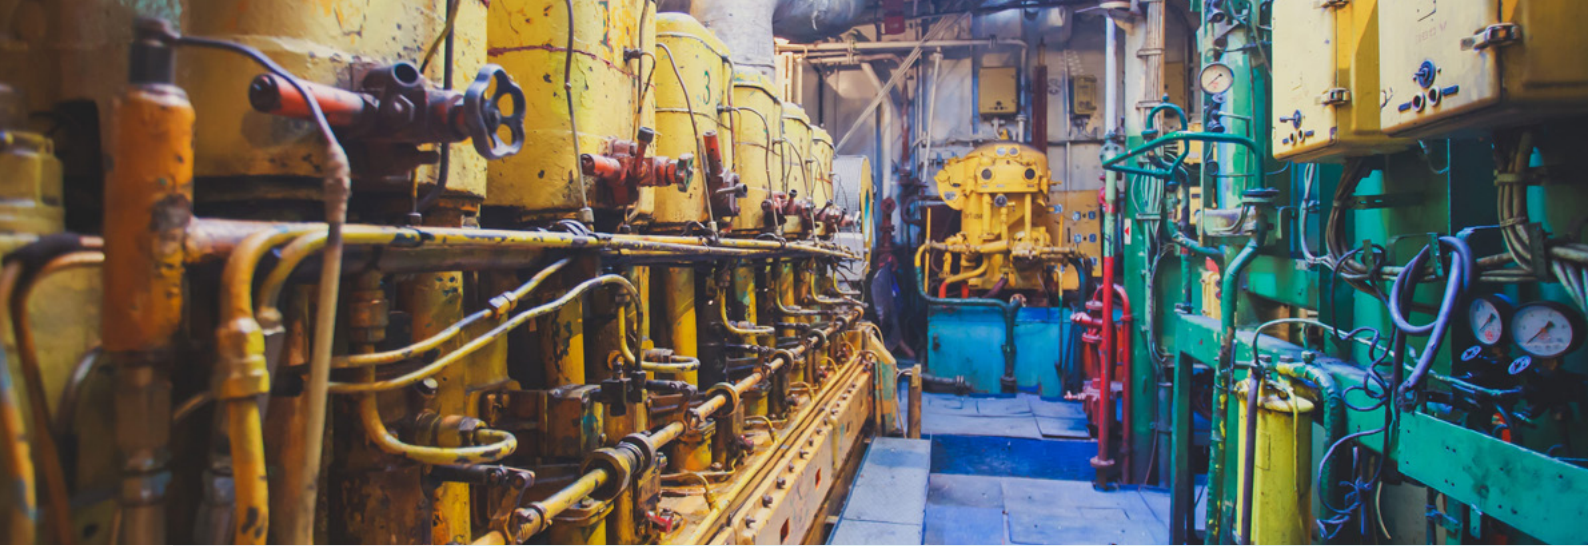
Based on their interpretation of the drawing, the engineers concluded that removing the bolts and spacer ring between the two halves of the flexible coupling would be sufficient to disconnect the shaft generator. The coupling guard was removed, and the bolts and spacer ring on the shaft generator side were taken out, effectively "splitting" the coupling.

Within seconds, the flexible coupling catastrophically failed. The coupling, still mounted on the gearbox PTO but unsupported on the shaft generator side, disintegrated violently. Coupling components and the guard were ejected across the engine room platform.

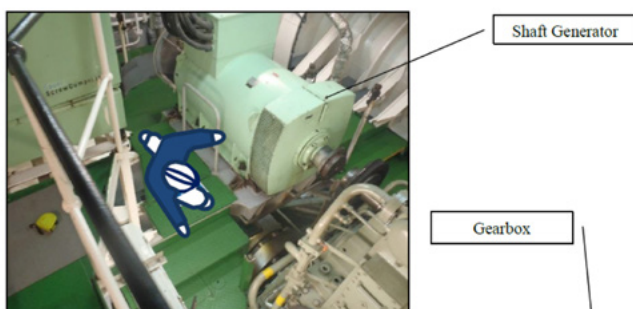
Figure 5b: Position of the chief engineer just before the accident

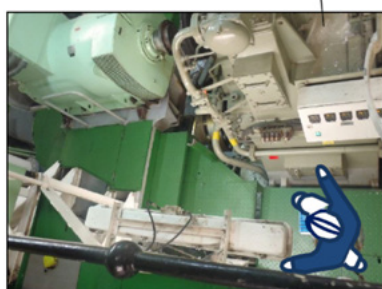
Figure 5c: Position of the wiper just before the accident
