# Loss Prevention Training Online

## HANDOUTS

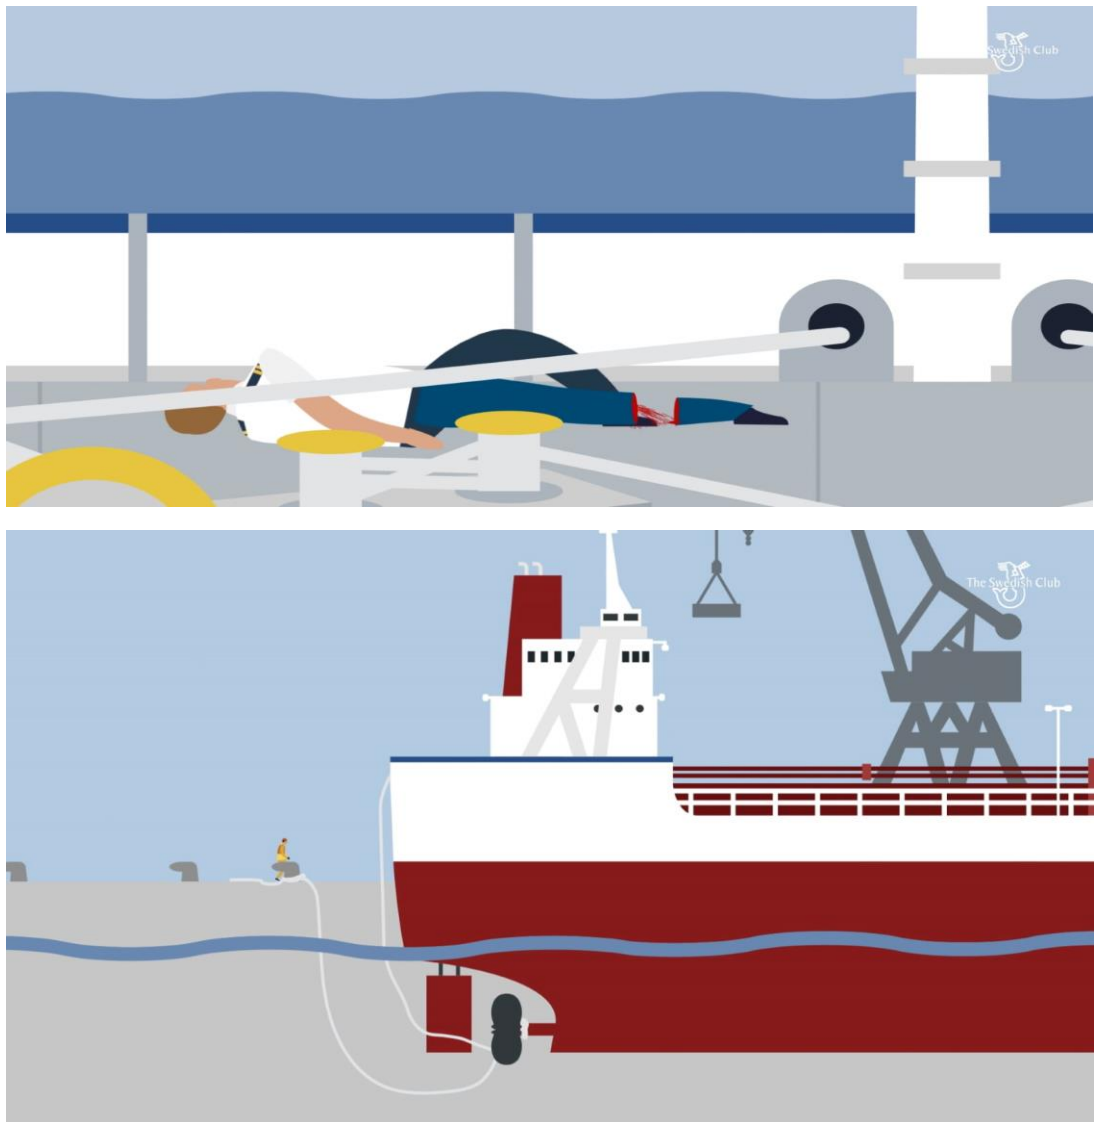
Suddenly the Third Officer started to scream. The AB turned around and could see the Third Officer was caught between the mooring line and the fairlead. The mooring line's speed was now so fast that it cut through the officer's clothes, and he was bleeding badly. The mooring line was actually cutting through the Third Officer's leg which was cut off just below the knee.

The Chief Officer realised that the mooring rope was stuck in the propeller and screamed over the VHF to the Master to stop the engine. The Master pushed the emergency stop, and the propeller stopped.

- Another risk was that the mooring line was partly around the bollard, with a bight and a right angle to the normal pull direction. This arrangement caused the snapback zone to cover the entire area between the bollard and railing. When the rope ran out rapidly and became caught in the propeller, it snapped back to where the Third Officer was standing. The Third Officer was outside the normal snapback zone, showing the importance of evaluating each situation independently. The entire mooring deck could be considered a snapback zone. Mooring is a normal operation; however, it is a high-risk operation, and the risks need to be evaluated every time.

- It is important to always be aware of your surroundings and not stand too close to fairleads and ropes. Inexperienced crew members should be trained about these risks.

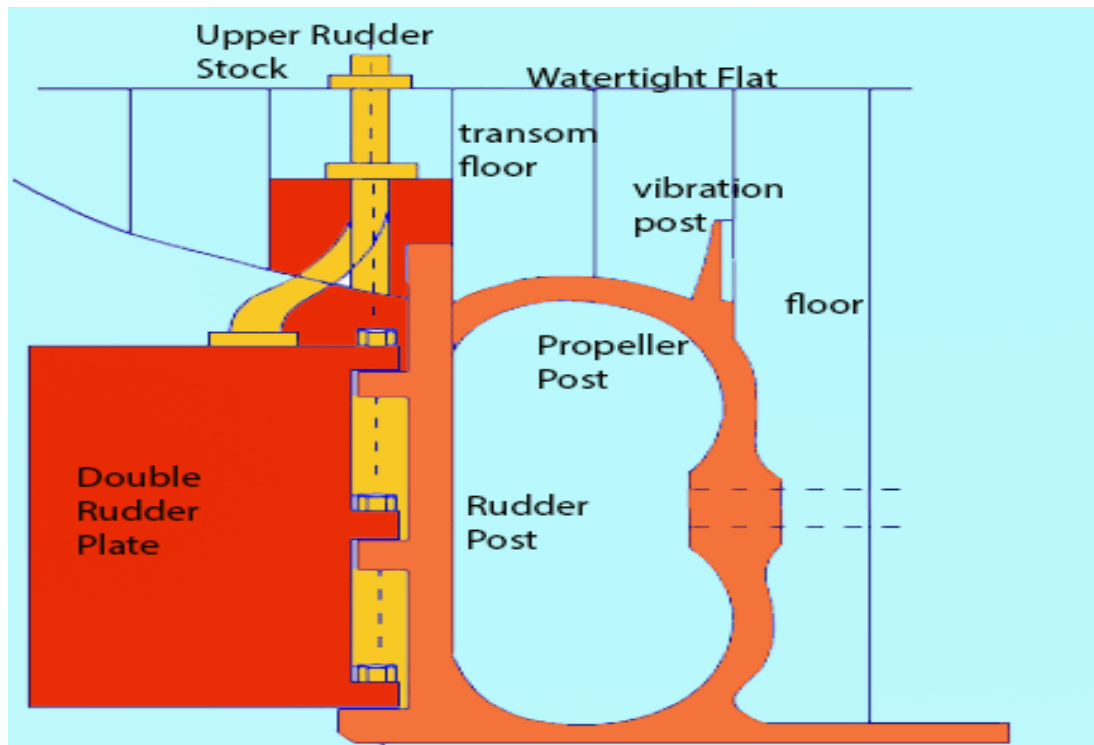
There was no access to the rudder trunk as it is space taken up by the rudder stock. The rudder trunk is only accessible from the outside of the vessel. This was a so-called unbalanced rudder, which means that the rudder stock is attached aft of the rudder hinges. The hinges are at the forward end of the rudder.

- It is extremely unlikely that a person would be able to sit on the rudder and not be washed out of the rudder trunk during a sea passage. If people in the rudder trunk are not found before departure or shortly after departure, they will most likely be lost at sea.
- To prevent stowaways from achieving access, please consider the following if the vessel is in a port with a high risk of stowaways,
  - ✓ If the rudder is above the waterline, using the rescue boat, inspect the rudder and if possible, the rudder trunk before departure.
  - ✓ Install protective grating or steel bars onto the steering gear trunk to prevent access from the rudder.

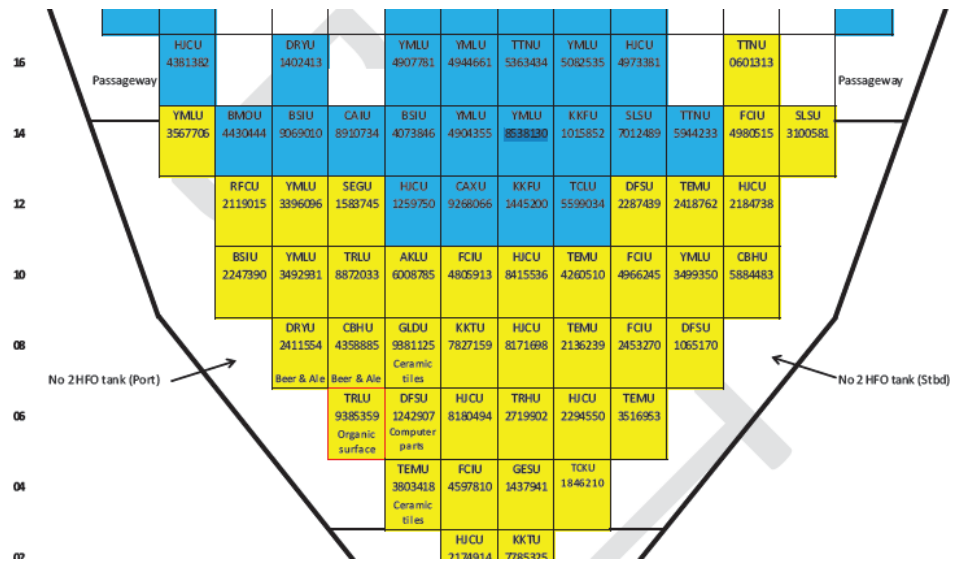
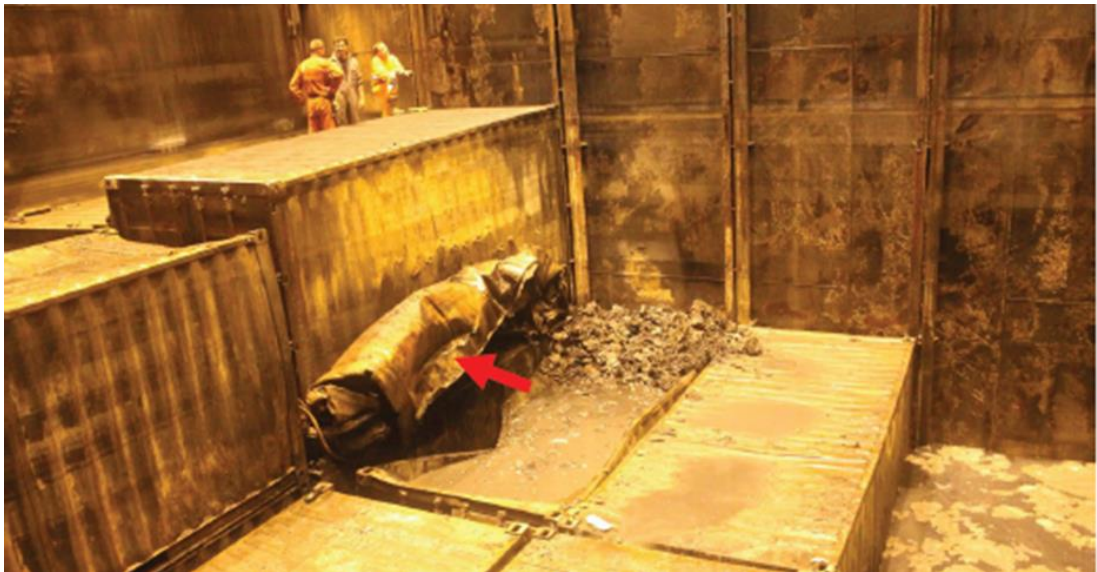
The container where the fire started was not declared as dangerous cargo but was actually loaded with calcium hypochlorite and had been misdeclared by the shipper. The charterer had loaded the container as per the rules of the IMDG code. As per the manifest, the container was allowed to be loaded in the cargo hold, but as the cargo was calcium hypochlorite, it should not have been loaded below deck or in the position it was stowed in.

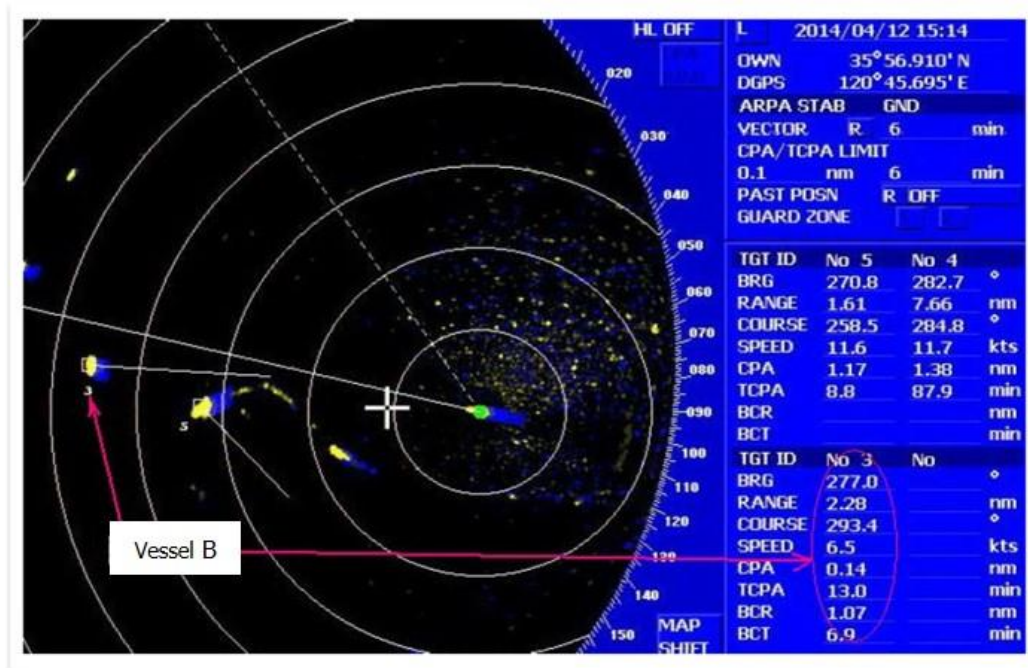
**C -15 minutes:** Vessel B was on course of 293°, and the CPA was 0.14 NM. Vessel A was maintaining its course and speed.

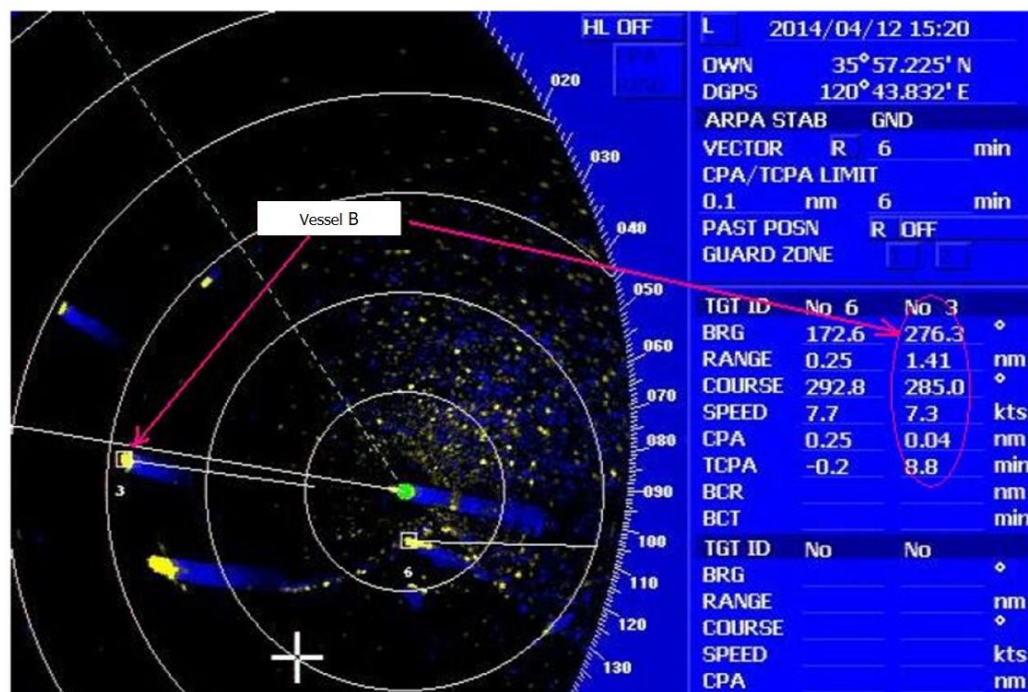
**C -10 minutes:** Vessel B's course was 285°, CPA 0.04 NM and distant 1.4 NM.

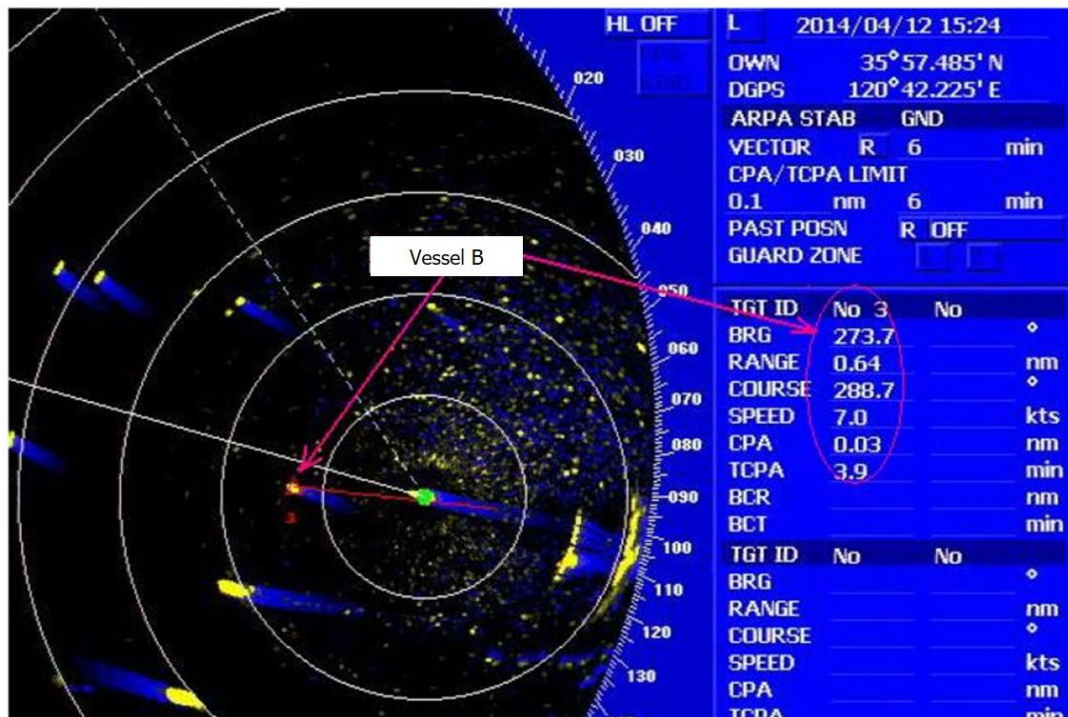
**C -5 minutes:** Vessel B's course was 289°, CPA 0.03 NM and distant 0.65 NM.

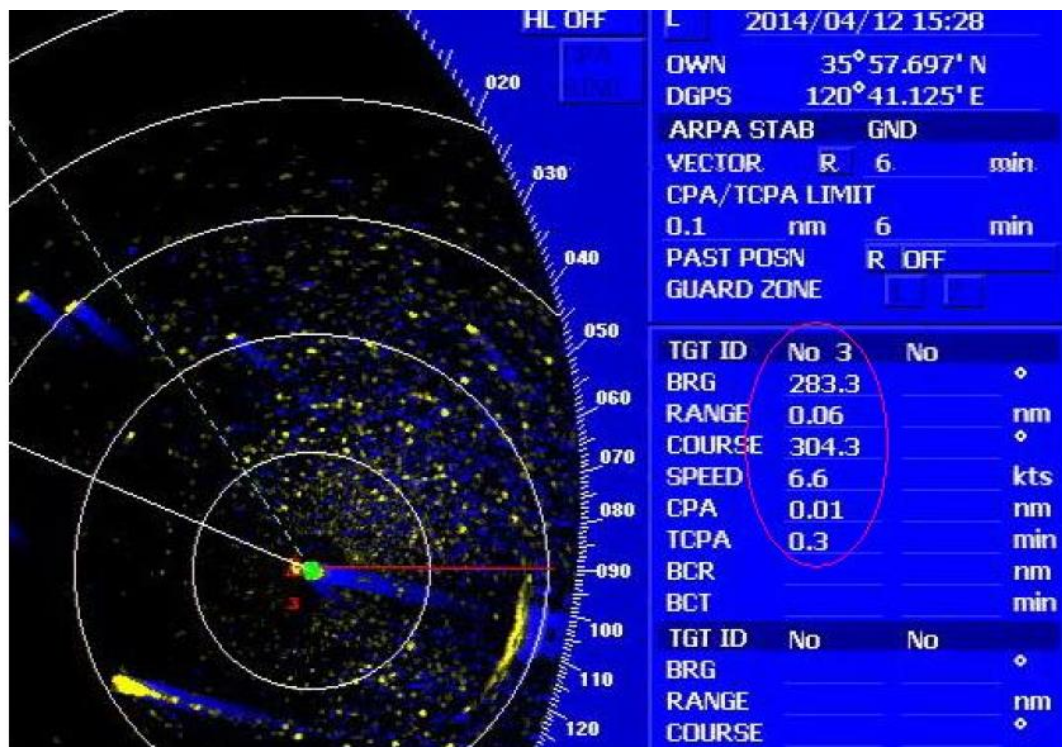
**C -2 minutes:** Vessel B's course was 304° and CPA 0.01 NM and distant 0.3 NM. Vessel B was still on the port bow of vessel A. At this point, the Master on vessel A realised that vessel B was very close and ordered hard to starboard and stop engines.

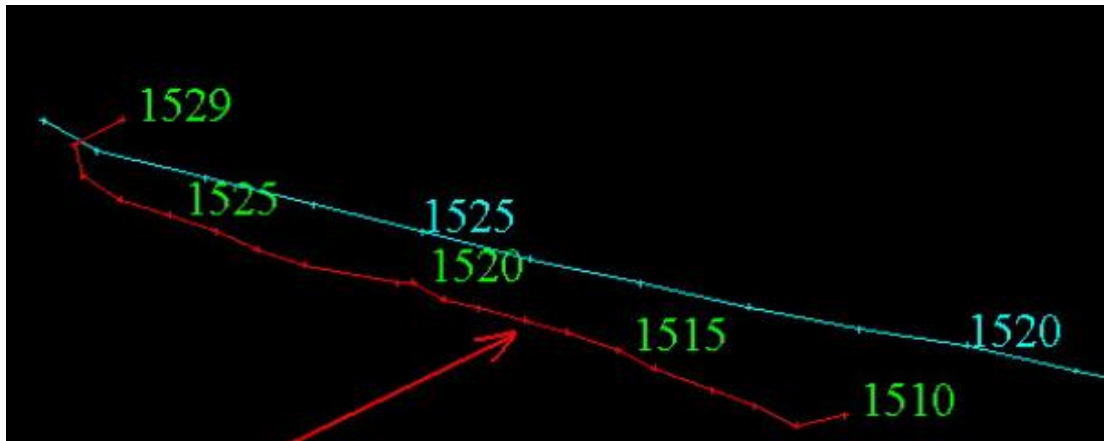
**Collision:** It was too late to avoid the collision and vessel A struck vessel B on its starboard side about midships. The Master saw that vessel B was a small tanker. Shortly afterwards, vessel B began to list heavily to starboard, and the crew were forced to deploy the life rafts and abandon ship. They were all rescued by vessel A.

- When sailing in restricted visibility, all vessels have a responsibility to stay clear of each other. All vessels also have a responsibility to proceed at a safe speed which ensures that they can stop quickly. Maintaining full speed in restricted visibility under these navigational circumstances could be considered proceeding at an unsafe speed. Vessel A was approaching a pilot station in restricted visibility which meant there was also an increased risk of encountering a greater concentration of different types of vessels.
