# Case Study - Davit Wire Failure During Rescue Boat Drill

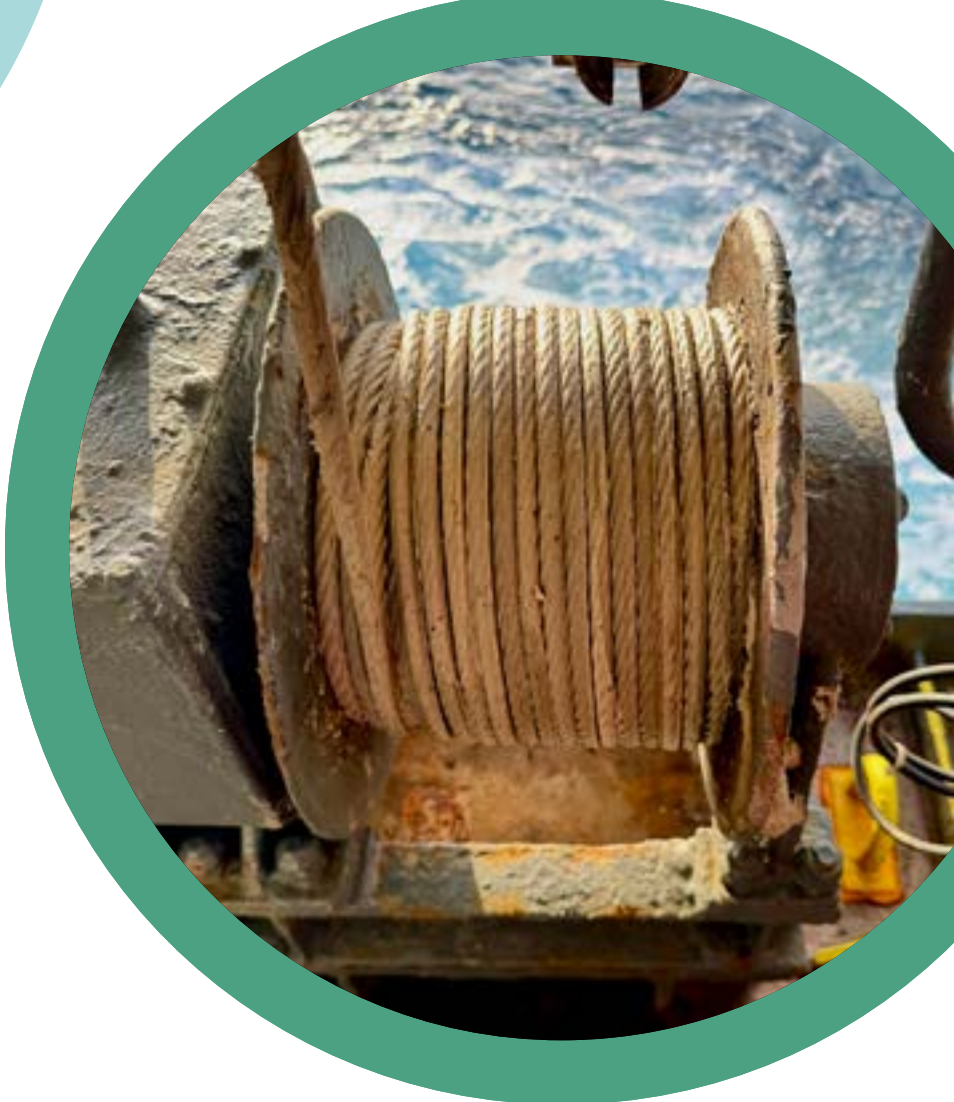
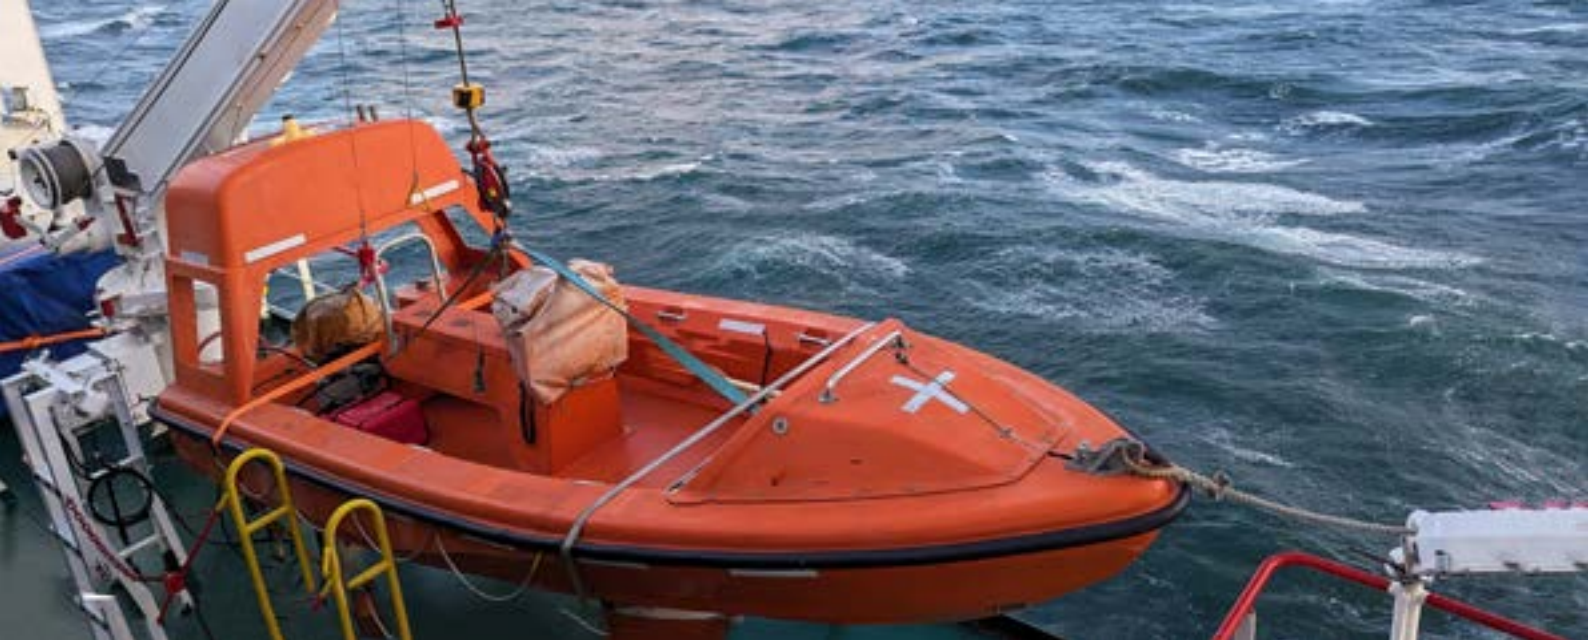
As the boat was hoisted towards the stowed position, the Bosun relied on the proximity switch to automatically stop the winch motor before the davit arm reached its limit. However, as the proximity switch was not functioning, the motor continued to run. Instead of stopping, the system applied increasing load to the wire. The absence of a correctly rated fuse allowed the motor to deliver excessive power.

The resulting overload caused the davit wire to fail suddenly. The rescue boat fell from a height of more than 20 metres into the water, with the three crew members still inside.
