Fatal fall from ladder

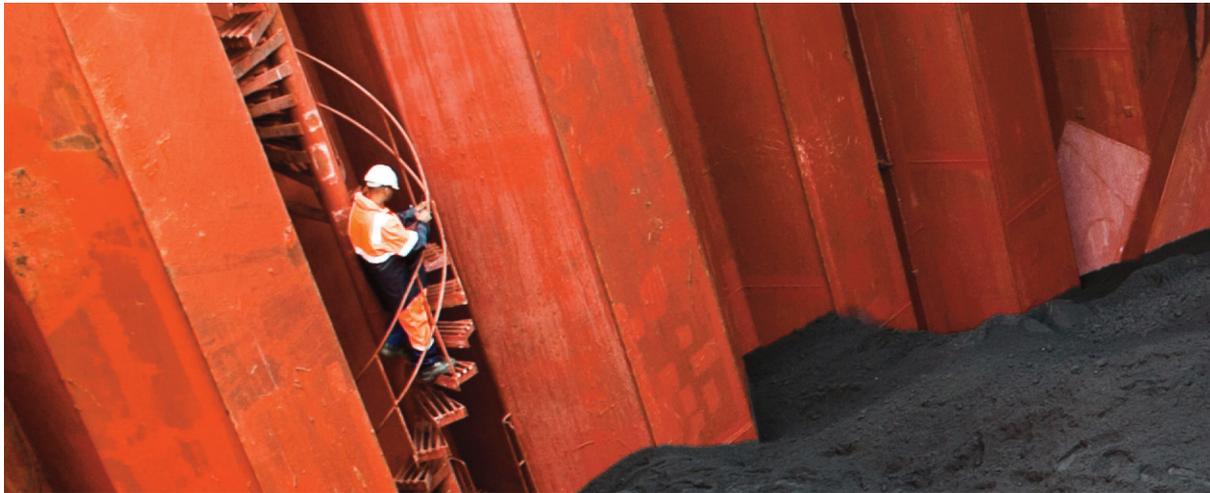
When they were leaving they had to first climb up a vertical ladder, then ascend a spiral staircase and for the last 2.5 metres climb up another vertical ladder to get out of the cargo hold.

Climbing up the last ladder he only used one hand as he had the tea cup in the other. He was not wearing a safety harness. When he was almost at the top he slipped and fell down. Unfortunately, he did not hit the platform below but fell more than 20 metres and landed at the bottom of the cargo hold.

It was later found that a steel bar was missing from one of the lower railings at the beginning of the spiral ladder. The railing was most likely damaged during the loading by one of the crane grabs, or an excavator as it was covered by the cargo when it arrived at the discharge port.

- The definition of 'working at height' should be addressed in the risk assessment, in addition to details of the safety measures that need to be taken.

- In the risk assessment it should state whether the specific job requires a work permit.
- It is up to every company to define if they consider it an acceptable risk to enter the cargo hold on a vertical ladder without a safety harness attached.

- Most of us would agree that it is safer to use both hands when climbing a ladder. However, when climbing ladders is a daily occurrence it is easy to forget that the consequences of slipping can be fatal. Advice from COSWP states that climbing a ladder three points (foot or hands) should always be in contact with the ladder. When the consequences of falling from that ladder are so severe, a harness should really be used.

- It is understood that many ports require that stevedores wear a safety harness when climbing the cargo ladder. It is important that the Chief Officer emphasises the importance of complying with this requirement.

- After both loading and discharging, the Chief Officer should inspect the ladders to ensure they have not been damaged during the cargo operation.
- This accident highlights the minimal effort it takes to do a job safely, and the consequences of not making that effort.
