## Stowaways in the steering gear trunk

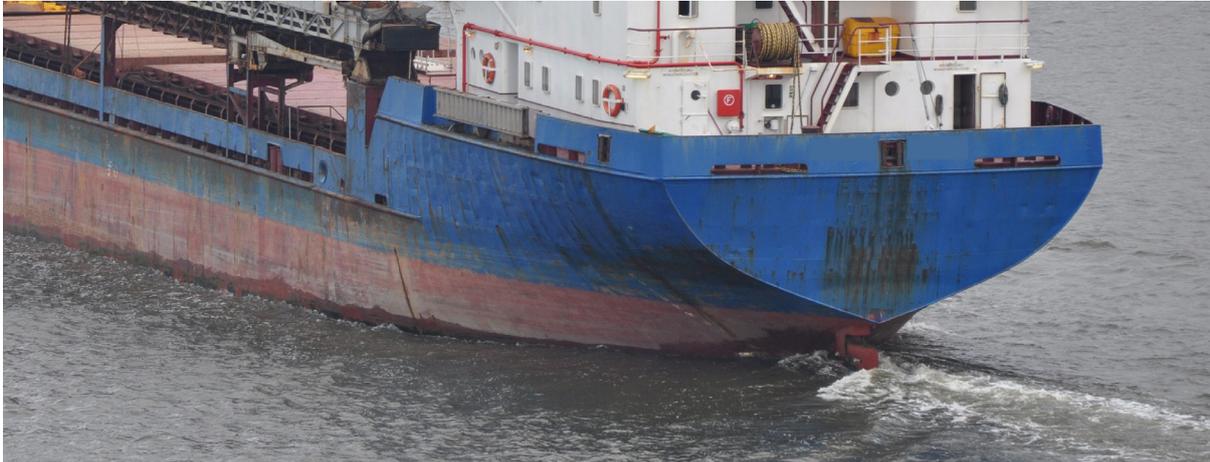
There was no access to the rudder trunk as it is space taken up by the rudder stock. The rudder trunk is only accessible from the outside of the vessel. This was a so-called unbalanced rudder, which means that the rudder stock is attached aft of the rudder hinges. The hinges are at the forward end of the rudder. The vessel was in open sea and the Master brought the vessel to a stop. The crew lowered a camera on the stern to see if they could see anything by the rudder. When they recovered the camera and watched what they had filmed they could see three people sitting on the rudder.

The crew lowered the rescue boat and picked up the three men. The stowaways had used a small rowing boat to reach the vessel and had then managed to climb up the rudder and then into the rudder trunk. So that the stowaways could disembark, the vessel had to divert to Cape Town.

- Inspect the rudder and if possible the rudder trunk with the rescue boat before departure if the rudder is above the waterline.
- Install protective grating or steel bars onto the steering gear trunk to prevent access from the rudder.
