The Swedish Club

MONTHLY SAFETY SCENARIO

Fire in engine room

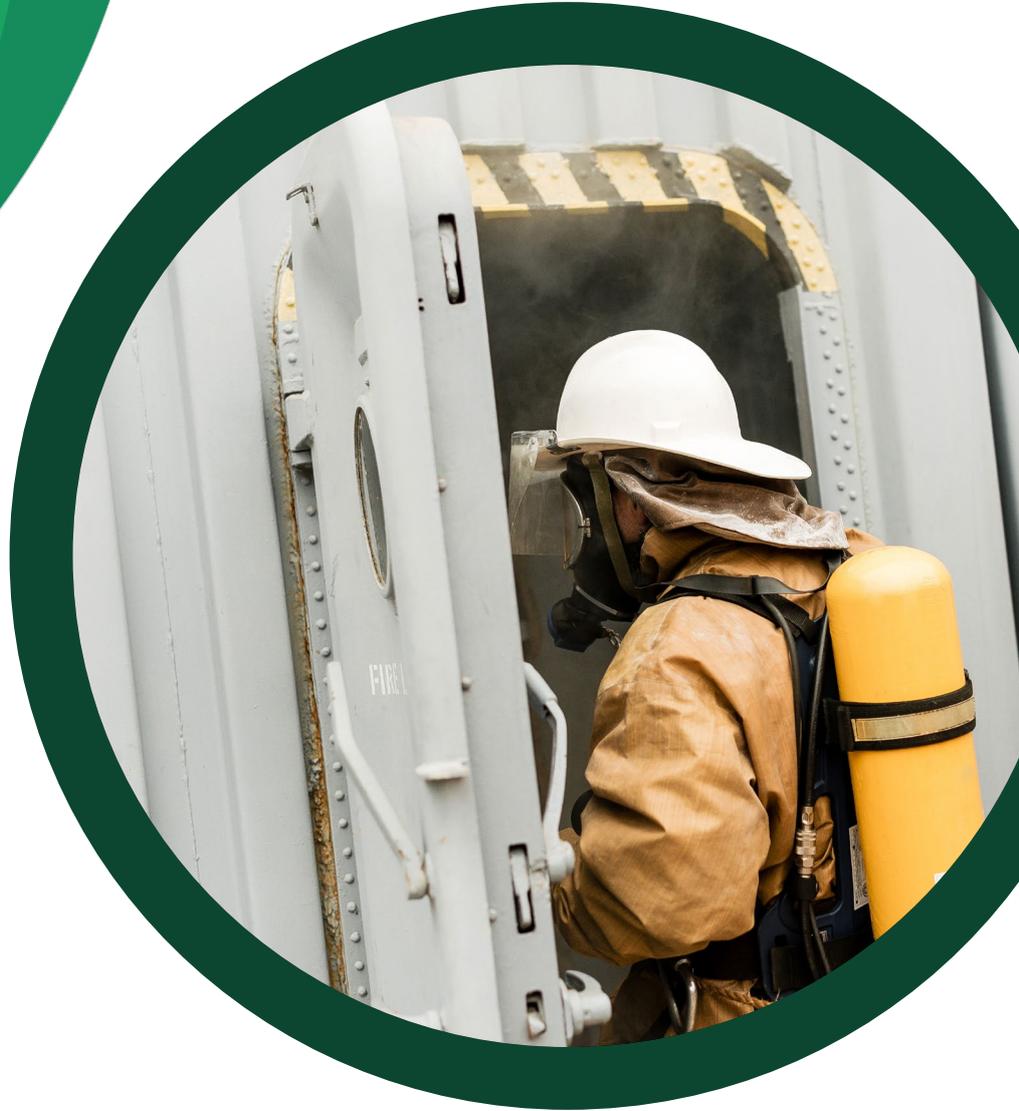
The Third Engineer called the Chief Officer and told him that the second auxiliary engine was online and that he could start the ballast operation. Ten minutes later a huge explosion was heard in the engine room. The Third Engineer could see flames and smoke coming from the auxiliary engines.

In the investigation that followed it was discovered that a fuel valve had broken above the auxiliary engines and sprayed fuel oil over an exhaust pipe which caused the fire.

It is worth mentioning as per SOLAS regulations that there should be insulation on the exhaust pipe and that the valve should also be protected.

Many engine room fires are caused because of bad insulation. The cause is often linked to a previous maintenance job where the insulation has not been put back correctly, or it has been contaminated by oil.

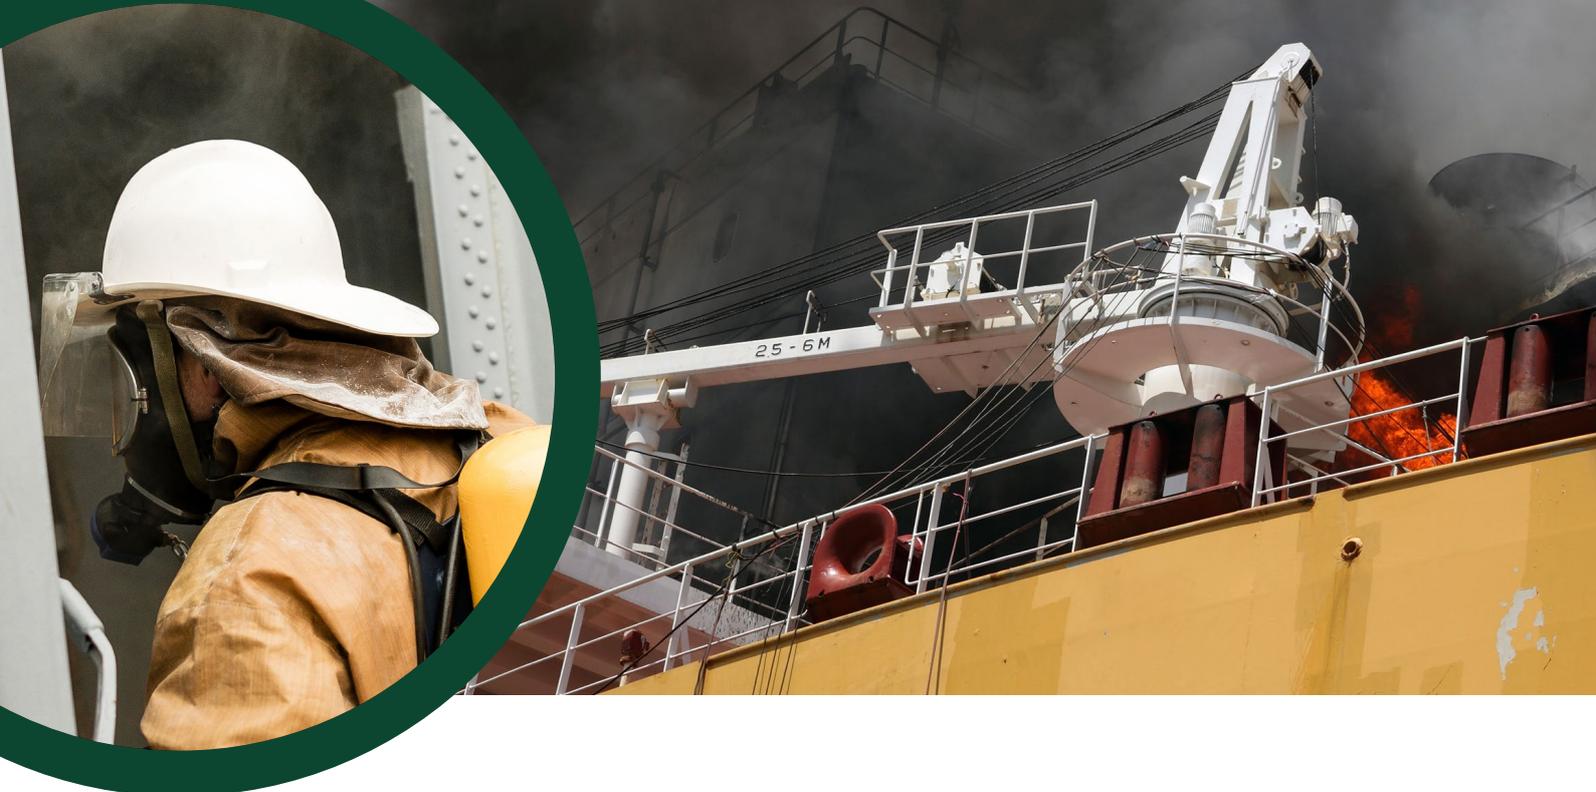
The Master decided to release 40 cylinders of CO₂ into the engine room. Half an hour later another 30 cylinders were released. The

crew monitored the temperature of the engine room which was coming down. About an hour after the first CO₂ was released, smoke stopped coming out of the funnel.
