Rescue boat drill ended with injuries

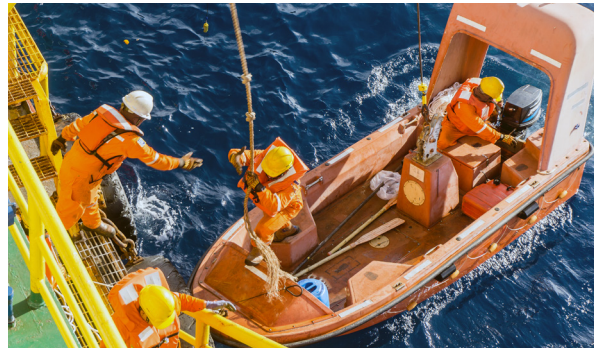
The chief officer pulled the slewing wire until the boat was positioned so it could be lowered. He then pulled the lowering wire until the boat was three meters above the surface, where he removed the safety pin. At the same time the slewing wire, which was hanging free, somehow got caught in the release lever for the hook and caused the boat to drop into the water.

A port state inspector boarded the vessel to investigate the incident, he raised a couple of deficiencies and was concerned that the safety pin had been removed too early.

- Operating instructions for the rescue boat on load release hook and safety locking pin, not included in SOLAS training manual.
- Operating instructions for control/handling of remote-control wires for slewing of davit and lowering of rescue boat, not included in SOLAS training manual.
- Flag state and Class should be informed about incident. Which they were not.
- Rescue boat launching instructions and rescue boat training to be reviewed.

The company had no specific instructions in the training manual, SMS, PMS or in any other manual on how the rescue boat should be launched.

In SOLAS chapter III regulation 35.3 there is a requirement for detailed instructions in the training manual on how the rescue boat should be launched. Also, in SOLAS chapter III reg 3.3.6 there is a requirement that the rescue boat should be launched every month or a minimum of every three months.

It is imperative to ensure that no wires or ropes get caught in any equipment when the rescue boat is being lowered. The company should ensure that the crew are aware of this risk and implement procedures to prevent this.

It is essential that all officers know how to launch and manoeuvre the rescue boat and not just the designated officer for an emergency. In this case the designated officer lacked proper knowledge. The company should ensure that all officers know how to launch the rescue boat.
