MARINE SAFETY ALERT
Inspections and Compliance Directorate

Safety Alert 11 -18

***A PFD that's Unwearable
Makes an Emergency Situation Unbearable!***

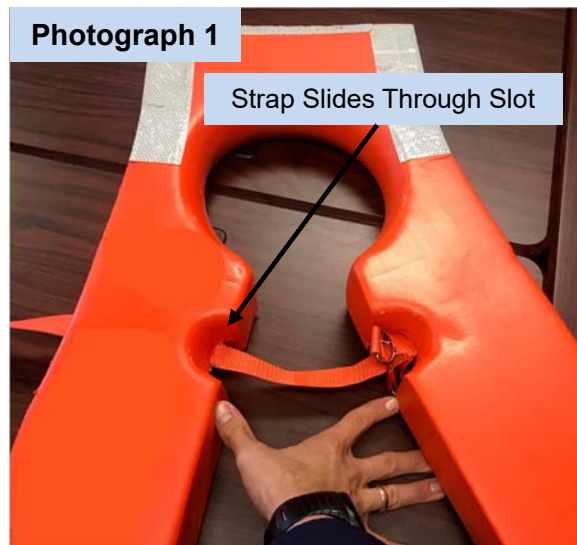
Photograph 1

Normally, when a wearer dons the type of PFD shown, a person grabs both sides of the vest to pull the sides apart and the waist band strap moves freely through a slit opening (see photographs 1 and 2). The user is then able to easily don the PFD by placing it over the head, passing the strap around the body, clipping the end onto the securing D-ring, and tightening the strap securely.

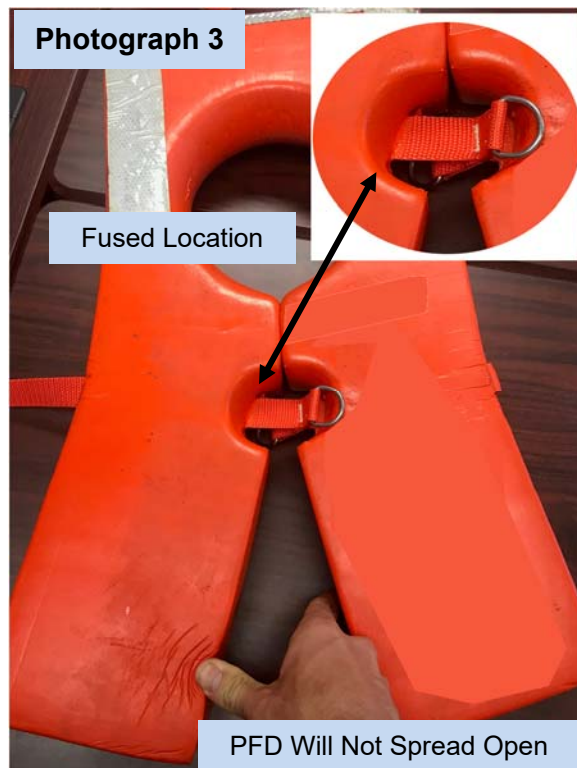
Photograph 3

During recent PFD inspections, inspectors discovered that the securing strap was secured at its bitter end, and was also fused to the side of the PFD by what appeared to be the shell coating or color-matching material (see photographs 3 and 4). As a result, a user is unable to separate the halves of the PFD to open the gap and place over the head to wear.

Based on the number of problematic PFDs discovered, the Coast Guard is **strongly recommending** that owners and operators using this type of PFD inspect each one for this condition. If problematic PFDs are discovered, owners and operators are encouraged to report their findings to the Coast Guard Office of Design and Engineering Standards via email to: TypeApproval@uscg.mil. Please include the name of manufacturer, design number, lot numbers, and quantity of PFDs impacted. Also indicate if the coating had been touched up at any time, and the total number of similar unaffected PFDs onboard.
