Stowaways

14.1

Stowaways in the steering gear trunk

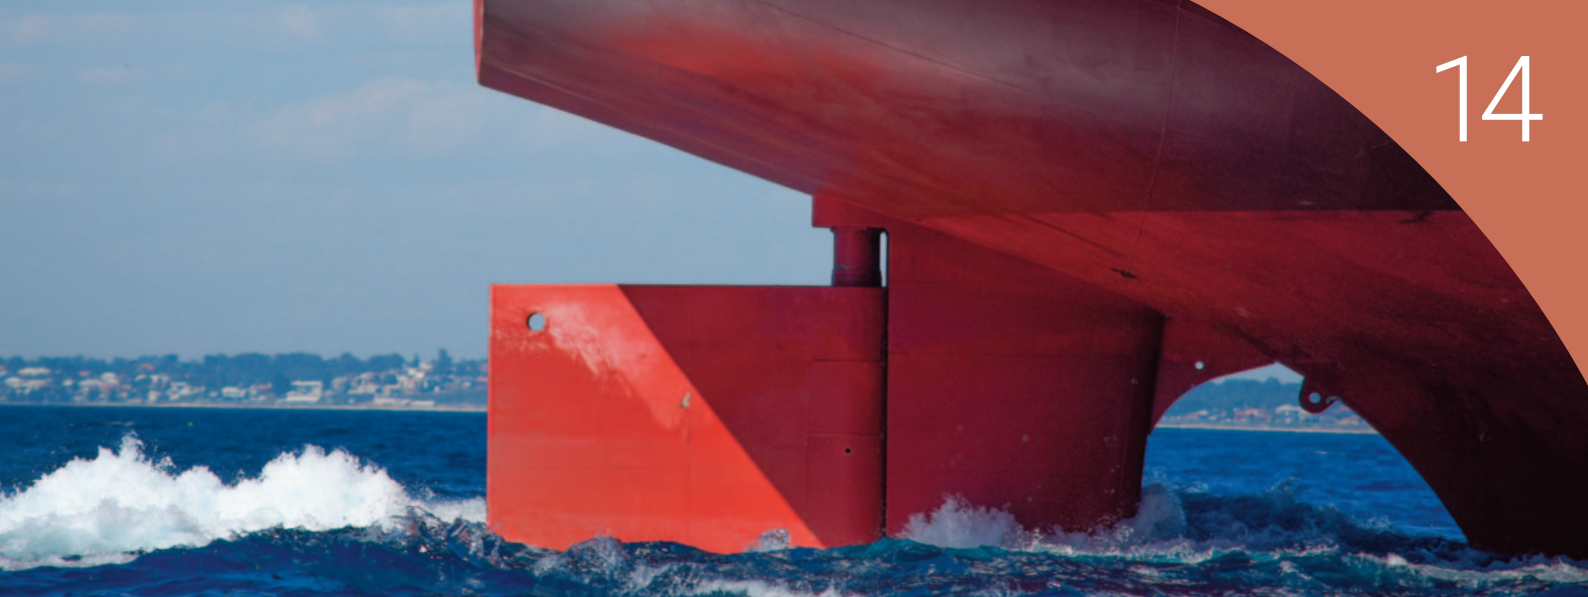
There was no access to the rudder trunk as it is space taken up by the rudder stock. The rudder trunk is only accessible from the outside of the vessel. This was a so-called unbalanced rudder, which means that the rudder stock is attached aft of the rudder hinges. The hinges are at the

forward end of the rudder. The vessel was in open sea and the Master brought the vessel to a stop. The crew lowered a camera on the stern to see if they could see anything by the rudder. When they recovered the camera and watched what they had filmed they could see three people sitting on the rudder.

The crew lowered the rescue boat and picked up the three men. The stowaways had used a small rowing boat to reach the vessel and had then managed to climb up the rudder and then into the rudder trunk. So that the stowaways could disembark, the vessel had to divert to Cape Town.

- It is extremely unlikely that a person would be able to sit on the rudder and not be washed out of the rudder trunk during a sea passage. If people in the rudder trunk are not found before departure or shortly after departure, they will most likely be lost at sea.
- To prevent stowaways achieving access, please consider the following if the vessel is in a port with a high risk of stowaways,
 - (i) Inspect the rudder and if possible the rudder trunk with the rescue boat before departure if the rudder is above the waterline.
 - (ii) Install protective grating or steel bars onto the steering gear trunk to prevent access from the rudder.
