Leaking cargo hatch covers

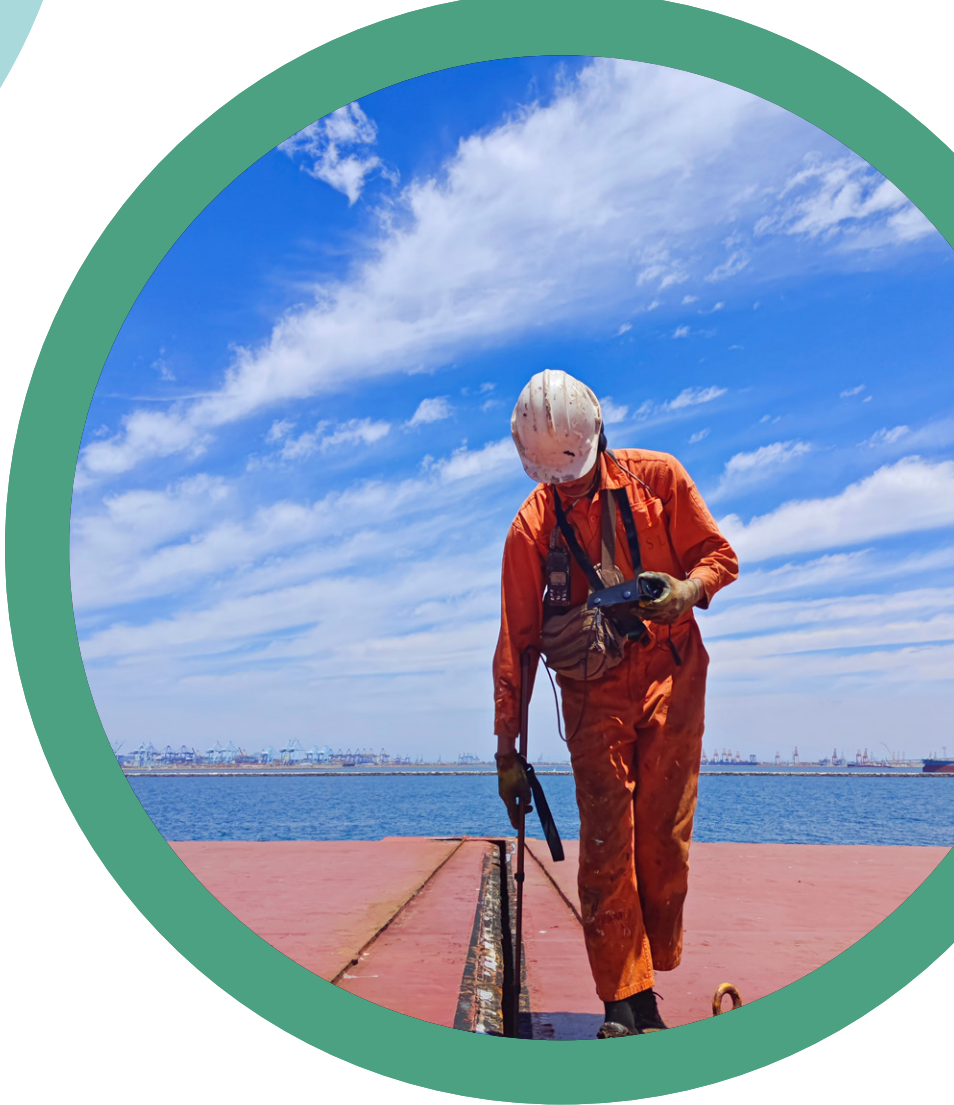
The surveyor tested the water integrity of the cargo hatch covers with an ultrasonic device which detected significant defects to the sealing arrangements. The gaskets were in poor condition and the hatch covers tested positive for chloride which indicates that saltwater has leaked.

The non-return valves for the drain channel were also in a poor condition as they were clogged and the ball inside was not moving. The transverse packing on the hatch covers was leaking, there were some cracked corners and leaking side joints.

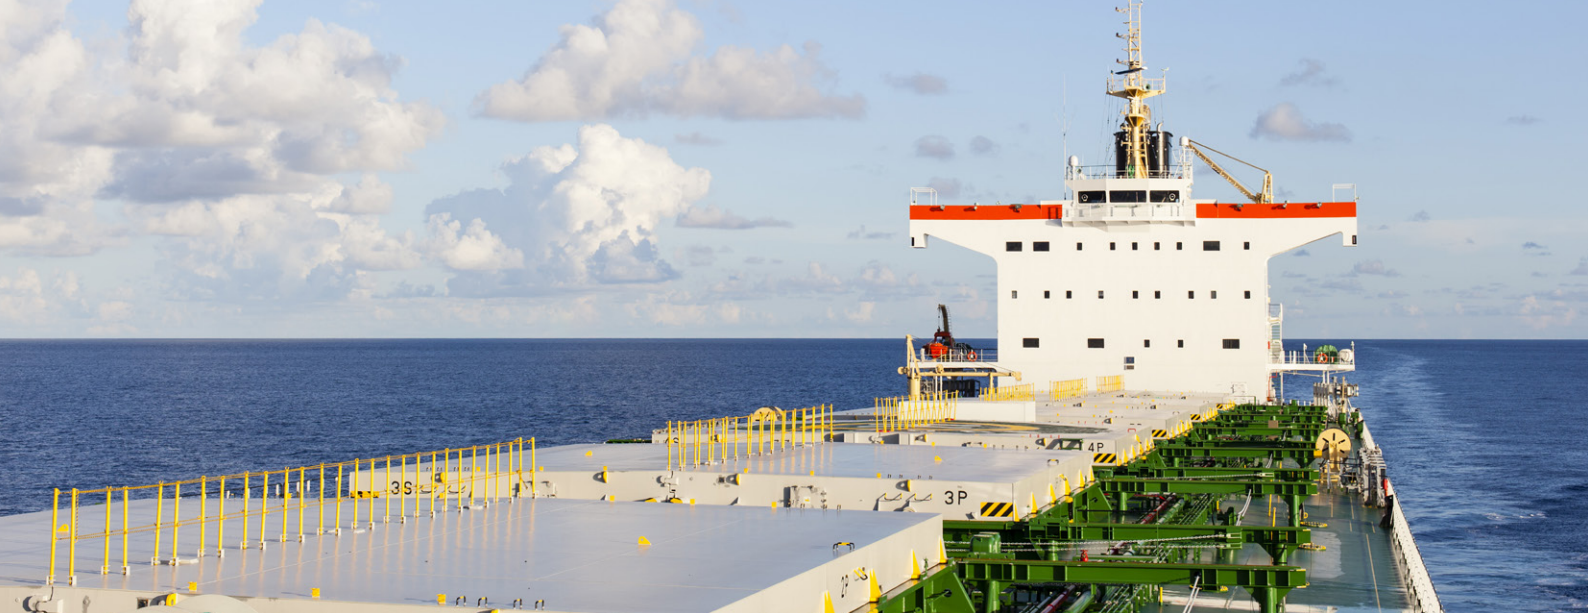
The surveyor also found a number of leaking ventilation covers.

The cargo hatches and gaskets were in a poor condition. The cleats could not be tightened beyond hand tightening.
