Wet Damage on Bulk Carriers

How to avoid wet damage on bulk carriers

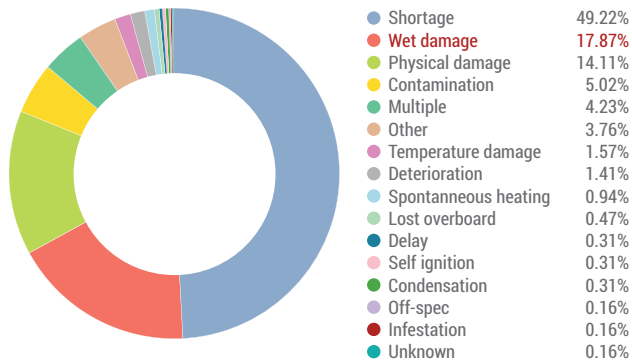
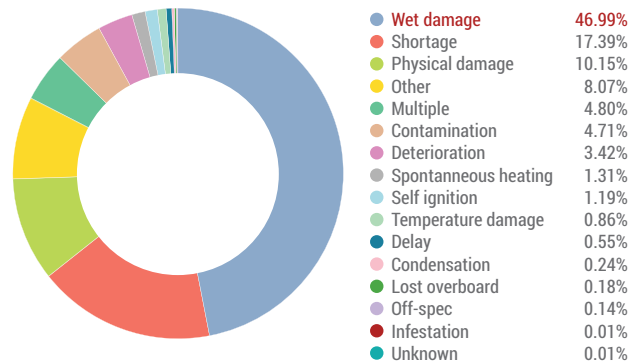
It can be seen from the charts that wet damage is the second most common claim type and the most costly. These figures are based on more than 600 cargo claims on bulk carriers.

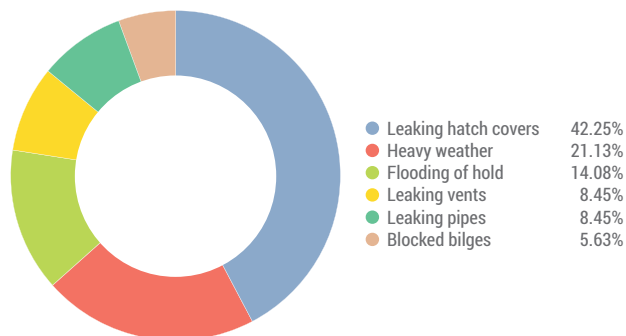
For wet damage claims, heavy weather and leaking hatch covers are both the most common and the most costly type. Indeed heavy weather and leaking hatch covers are coinciding incidents as the cargo hatch covers may be washed over by green sea on deck when the vessel sails through heavy weather.

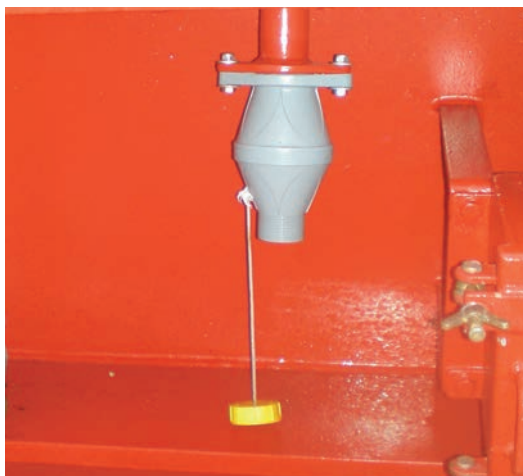
Drain valves are located close to hatch corners and the joints between the hatch cover panels. In rough sea the ship hull flexes, generating movement between the hatch cover panels and the coaming. This might cause leakage in the hatch cover sealing system. Leak water passing the seals is captured by the drain channels and the water is led to drain pipes on the coaming.

Non-return drain valves are installed to the drain pipes. They allow water to drain out onto the deck but stop water from the deck entering the cargo hold.
