Loss of anchor

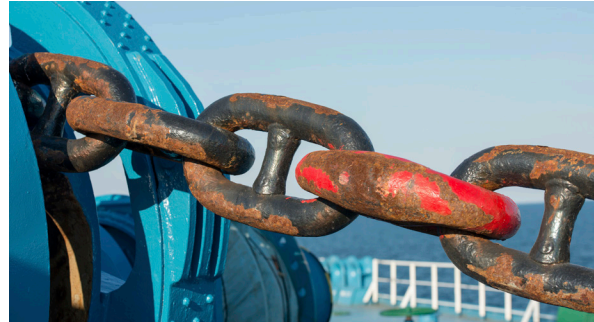
The vessel was waiting for its berth to become available so it was decided to anchor. A pre-anchor briefing was held on the bridge where how many shackles to be used was discussed and what different tasks the crew had during the anchoring operation. One week earlier the bosun had inspected the windlass including the brake linings and had reported that all was in good condition.
