MONTHLY SAFETY SCENARIO

MAY 2025

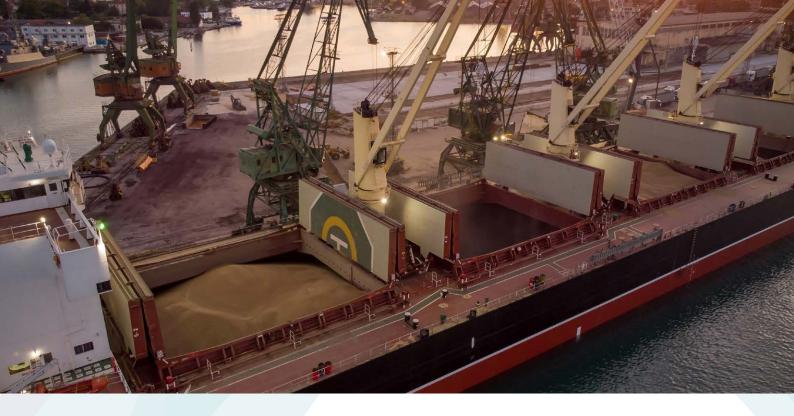
Around this time, Longshoreman A who had spoken to the Chief Officer from the gangway, returned to the dock to again instruct the Chief Officer where to position the vessel alongside the dock. About a minute or so after they spoke, the forward spring line on the port bow winch parted near the forward port fairlead.

The Chief Officer and the Master, saw the line hit the worker, who stumbled briefly before falling.

The Chief Officer did not initially notice that the worker's

arm had been severed. The Master also saw the parted line strike the Longshoreman. The Master immediately notified the shoreside personnel to call for emergency medical assistance and the Chief Officer waved and yelled to the shoreside personnel to get help for the injured Longshoreman. Several shoreside individuals came to his aid and he was taken to the local hospital. A diving crew was later deployed to search for the severed arm, but it could not be recovered. The Longshoreman survived but could not work as a Longshoreman anymore.
